Contract #: 04-0120F4Cty: SF/ALA Rte: 80 PM: 13.2/13.9File #: 69.28**WELDING INSPECTION REPORT****Resident Engineer:** Pursell, Gary**Address:** 333 Burma Road**City:** Oakland, CA 94607**Report No:** WIR-007328**Date Inspected:** 01-Jun-2009**Project Name:** SAS Superstructure**OSM Arrival Time:** 700**Prime Contractor:** American Bridge/Fluor Enterprises, a JV**OSM Departure Time:** 1900**Contractor:** Zhenhua Port Machinery Company, Ltd (ZPMC), Changxing Island **Location:** Shanghai, China**CWI Name:** Sun Wei / Sun Bo**CWI Present:** Yes No**Inspected CWI report:** Yes No N/A**Rod Oven in Use:** Yes No N/A**Electrode to specification:** Yes No N/A**Weld Procedures Followed:** Yes No N/A**Qualified Welders:** Yes No N/A**Verified Joint Fit-up:** Yes No N/A**Approved Drawings:** Yes No N/A**Approved WPS:** Yes No N/A**Delayed / Cancelled:** Yes No N/A**Bridge No:** 34-0006**Component:** TOWER**Summary of Items Observed:**

WELDING INSPECTION REPORT

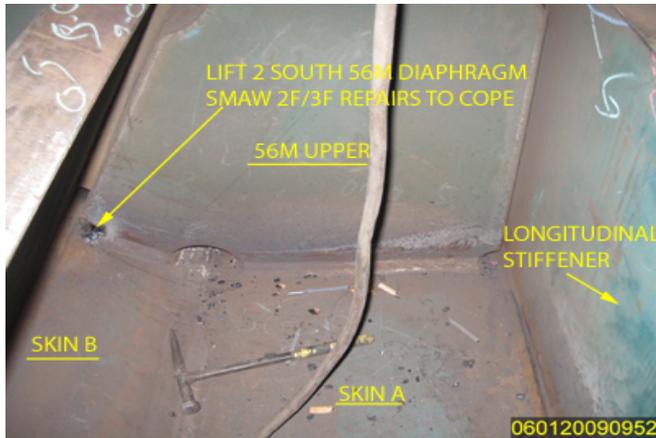
The QA Inspector randomly observed ZPMC welder Fan Chun Lei 040491, utilizing the Shielded Metal Arc Welding (SMAW) Process in the 2F (Horizontal Fillet) Position with ZPMC Weld Procedure Specification (WPS) WPS-345-SMAW-2G (2F)-Repair and WPS-345-SMAW-3G (3F)-Repair in the 3F (Vertical Fillet), to weld repairs to copes Lift 2 South Tower 56M Upper Diaphragm to Skin Plate B welds. The QA Inspector randomly observed ZPMC QC monitoring weld parameters. Weld parameters appeared to comply with contract requirements. The attached photograph provides additional detail.

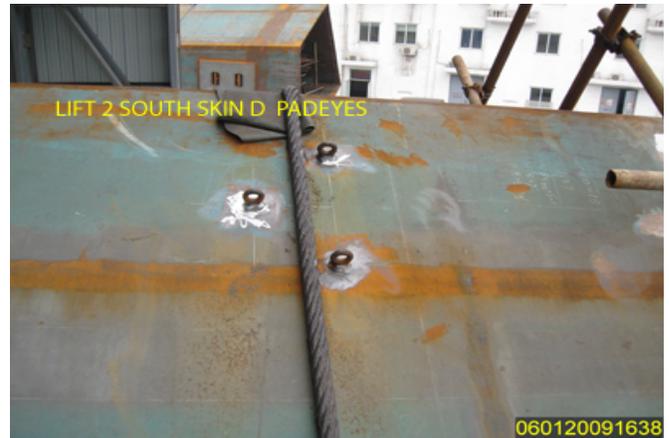
The QA Inspector performed a 100 % Visual Testing (VT) Inspection and 15% Magnetic Particle Testing (MT) Verification of the welds attaching the padeyes to Skin Plates C, D and E on Lift 2 South Tower Shaft per ZPMC NDT Notification Sheet 003293. The QA Inspector visually observed 3 areas which required blending and one area of undersized weld. ZPMC blended the affected areas and added weld metal to the undersized weld. There appeared to be no indications after the re-work by ZPMC and the QA Inspector accepted the above listed welds. The attached photograph provides additional detail.
