DEPARTMENT OF TRANSPORTATION

Quality Assurance and Source Inspection

Contract #: 04-0120F4Cty: SF/ALA Rte: 80 PM: 13.2/13.9File #: 69.28**WELDING INSPECTION REPORT****Resident Engineer:** Pursell, Gary**Address:** 333 Burma Road**City:** Oakland, CA 94607**Report No:** WIR-007331**Date Inspected:** 06-Jun-2009**Project Name:** SAS Superstructure**OSM Arrival Time:** 700**Prime Contractor:** American Bridge/Fluor Enterprises, a JV**OSM Departure Time:** 1900**Contractor:** Zhenhua Port Machinery Company, Ltd (ZPMC), Changxing Island **Location:** Shanghai, China**CWI Name:** Xu Le Feng, Liu Yang**CWI Present:** Yes No**Inspected CWI report:** Yes No N/A**Rod Oven in Use:** Yes No N/A**Electrode to specification:** Yes No N/A**Weld Procedures Followed:** Yes No N/A**Qualified Welders:** Yes No N/A**Verified Joint Fit-up:** Yes No N/A**Approved Drawings:** Yes No N/A**Approved WPS:** Yes No N/A**Delayed / Cancelled:** Yes No N/A**Bridge No:** 34-0006**Component:** TOWER**Summary of Items Observed:**

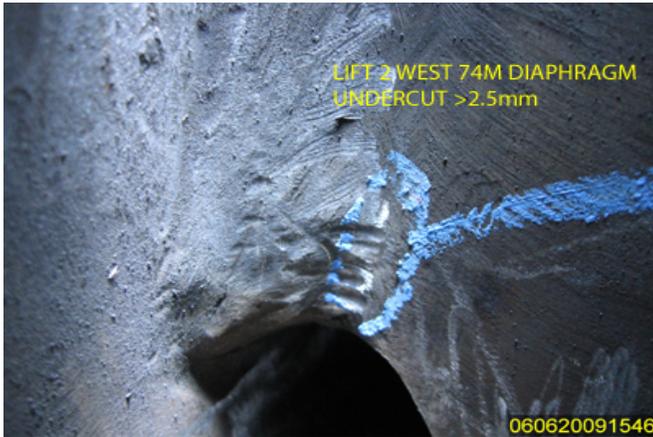
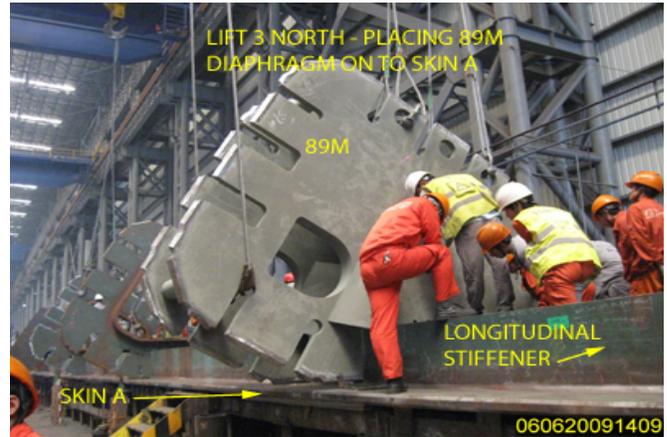
The QA Inspector randomly observed ZPMC production personnel placing and fitting up diaphragms to Skin A of Lift 3 North Tower Shaft. The attached photograph provides additional detail.
