**DEPARTMENT OF TRANSPORTATION**

Contract #: 04-0120F4Cty: SF/ALA Rte: 80 PM: 13.2/13.9File #: 69.28**WELDING INSPECTION REPORT****Resident Engineer:** Pursell, Gary**Address:** 333 Burma Road**City:** Oakland, CA 94607**Report No:** WIR-007356**Date Inspected:** 01-Jun-2009**Project Name:** SAS Superstructure**OSM Arrival Time:** 1845**Prime Contractor:** American Bridge/Fluor Enterprises, a JV**OSM Departure Time:** 645**Contractor:** Zhenhua Port Machinery Company, Ltd (ZPMC), Changxing Island **Location:** Shanghai, China**CWI Name:** Wu Zhi Cheng**CWI Present:** Yes No**Inspected CWI report:** Yes No N/A**Rod Oven in Use:** Yes No N/A**Electrode to specification:** Yes No N/A**Weld Procedures Followed:** Yes No N/A**Qualified Welders:** Yes No N/A**Verified Joint Fit-up:** Yes No N/A**Approved Drawings:** Yes No N/A**Approved WPS:** Yes No N/A**Delayed / Cancelled:** Yes No N/A**Bridge No:** 34-0006**Component:** OBG**Summary of Items Observed:**

# WELDING INSPECTION REPORT

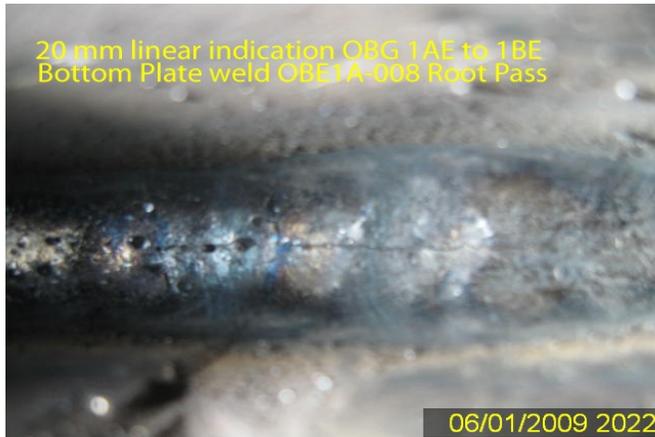
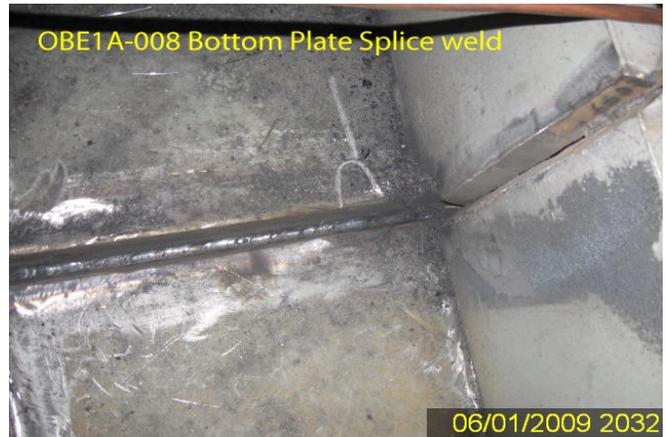
During random visual inspection of OBG segment 1AE to 1BE Bottom Plate complete joint penetration weld root pass (OBE1A-008), four linear indications were observed. The four indications ranged in length from 5 mm to 20 mm. The linear indications were shown to ZPMC QC. The welders removed the visible indications and proceeded to weld over the excavated areas using FCAW before QC confirmed that the indications were fully removed by NDT on two of the locations. This violates AWS D1.5, Section 3.7.2.4 which states "The extent of the crack shall be ascertained by the use of MT, PT or other equally positive means; the metal shall be removed for the full length of the crack plus 50 mm beyond each end of the crack, and rewelded". An incident report was issued for the above mentioned defects.
