Contract #: 04-0120F4Cty: SF/ALA Rte: 80 PM: 13.2/13.9File #: 69.28**WELDING INSPECTION REPORT****Resident Engineer:** Pursell, Gary**Address:** 333 Burma Road**City:** Oakland, CA 94607**Report No:** WIR-007374**Date Inspected:** 12-Jun-2009**Project Name:** SAS Superstructure**OSM Arrival Time:** 1900**Prime Contractor:** American Bridge/Fluor Enterprises, a JV**OSM Departure Time:** 700**Contractor:** Zhenhua Port Machinery Company, Ltd (ZPMC), Changxing Island **Location:** Shanghai, China**CWI Name:** See Below**CWI Present:** Yes No**Inspected CWI report:** Yes No N/A**Rod Oven in Use:** Yes No N/A**Electrode to specification:** Yes No N/A**Weld Procedures Followed:** Yes No N/A**Qualified Welders:** Yes No N/A**Verified Joint Fit-up:** Yes No N/A**Approved Drawings:** Yes No N/A**Approved WPS:** Yes No N/A**Delayed / Cancelled:** Yes No N/A**Bridge No:** 34-0006**Component:** OBG and Tower Fabrication**Summary of Items Observed:**

On this date CALTRANS OSM Quality Assurance (QA) Inspector, Mr. Paul Dawson, arrived on site at the Zhenhua Port Machinery Company (ZPMC) facility at Changxing Island, in Shanghai, China, for the purpose of monitoring welding and fabrication of th

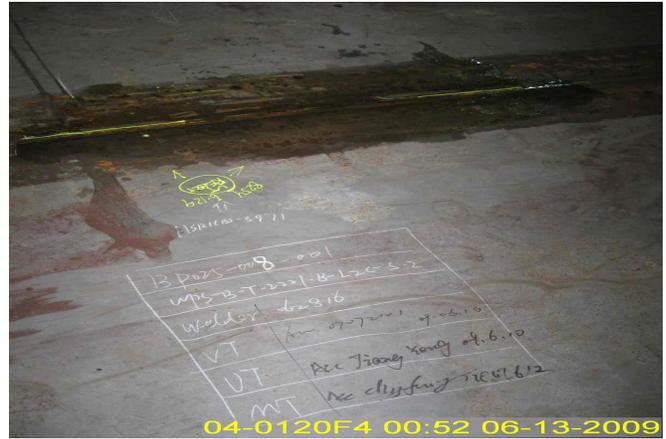
ZPMC issued an "Inspection Notification Sheet" #03395 requesting QA to perform ultrasonic inspections of base plate welds BP025-008-001, BP025-008-002 and BP025-008-003. ZPMC ultrasonic Inspectors had previously accepted 100 percent length of all of these welds. This QA Inspector performed random ultrasonic inspections of welds BP025-008-002 and BP025-008-003 and items observed by this QA Inspector appear to comply with AWS D1.5 UT requirements. The QA Inspector observed weld BP025-008-001 has two class "A" rejections and the QA Inspector issued an incident report to document ZPMC not rejecting this weld.

For additional information on these inspections see the TL6027 Ultrasonic Test Report and the photographs below
