DEPARTMENT OF TRANSPORTATION

Contract #: 04-0120F4Cty: SF/ALA Rte: 80 PM: 13.2/13.9File #: 13.28**WELDING INSPECTION REPORT****Resident Engineer:** Pursell, Gary**Address:** 333 Burma Road**City:** Oakland, CA 94607**Report No:** WIR-007393**Date Inspected:** 23-Jun-2009**Project Name:** SAS Superstructure**OSM Arrival Time:** 700**Prime Contractor:** American Bridge/Fluor Enterprises, a JV**OSM Departure Time:** 1530**Contractor:** Oregon Iron Works Clackamas, Or.**Location:** Clackamas, OR**CWI Name:** Mike Gregson, Rob Walters**CWI Present:** Yes No**Inspected CWI report:** Yes No N/A**Rod Oven in Use:** Yes No N/A**Electrode to specification:** Yes No N/A**Weld Procedures Followed:** Yes No N/A**Qualified Welders:** Yes No N/A**Verified Joint Fit-up:** Yes No N/A**Approved Drawings:** Yes No N/A**Approved WPS:** Yes No N/A**Delayed / Cancelled:** Yes No N/A**Bridge No:** 34-0006**Component:** Hinge K Pipe Beams**Summary of Items Observed:**

WELDING INSPECTION REPORT

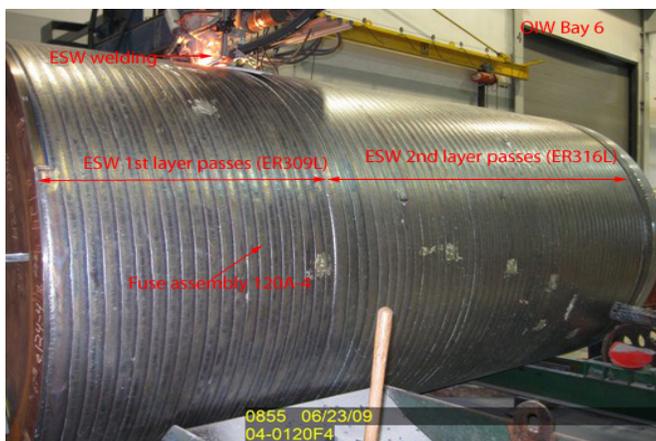
Hinge-K Pipe Beam Fuse Assembly 120A-4: 6/23/09

QA Inspector noticed that the stainless steel overlay welding was in-process, on this fuse assembly 120A-4. QA Inspector witnessed welder #F17, Mr. Igor Frolov, performing electro slag welding (ESW) in the flat position, utilizing Soudokay brand Soudotape 316L stainless steel consumable strip. QA Inspector noted that the first overlay weld passes were 100% complete, utilizing Soudokay brand Soudotape 309L stainless steel consumable strip and the second layers were approximately 70% complete. QA Inspector noticed QC Inspector's Mike

Gregson and Rob Walters were present, to verify in-process welding parameters (amps/volts) and monitor in-process continuous pre-heat temperatures. QA Inspector spoke with QC Inspector Rob Walters and Mr. Rob Walters explained that welding amps were recorded as 1200 amps/25.5 volts, with travel speed at 229mm/minute and a pre-heat temperature of approximately 70 degrees Fahrenheit. QA Inspector verified Mr. Igor Frolov was currently qualified for this welding process/position and randomly recorded pre-heat temperatures of approximately 70 degrees Fahrenheit. QA Inspector noted that Mr. Igor Frolov appeared to be in compliance with the applicable approved welding procedure specification (WPS 7003). See attached photo of assembly 120A-4 below.

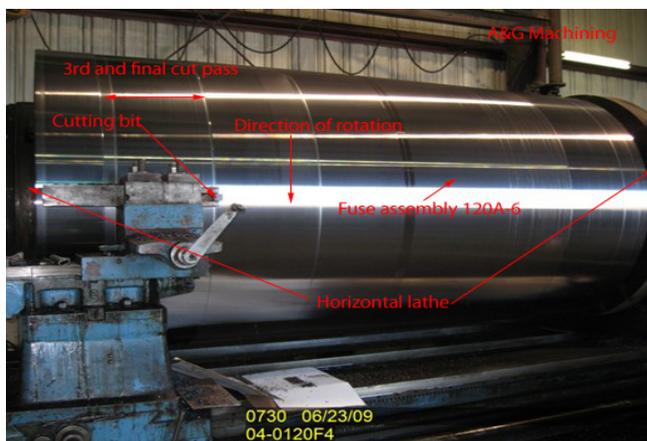
Hinge-K Pipe Beam Fuse Assembly 120A-6: 6/23/09

QA Inspector arrived at A&G Machining on this date and witnessed A&G performing the third and final cut pass, for rough machining on this fuse assembly 120A-6. QA Inspector spoke with A&G machinist and A&G explained that this final cut pass was approximately .160" (4mm) and would probably be completed on this date. A&G explained to QA Inspector that a final outside diameter of 1903mm would be maintained and that an OIW machinist would be arriving on 6/25/09 to verify dimensional outside diameter measurements and transfer this fuse assembly 120A-6, back to OIW fabrication shop. QA Inspector noted that once this assembly 120A-6 arrives at OIW fabrication shop, 100% magnetic particle testing will be performed by qualified OIW QC Inspectors and 100% final ultrasonic weld inspection will be performed on the CJP weld splice. QA Inspector noted that A&G appeared to be in compliance with contract requirements. See picture below of fuse assembly 120A-6, in process of rough machining.
