DEPARTMENT OF TRANSPORTATION

Contract #: 04-0120F4Cty: SF/ALA Rte: 80 PM: 13.2/13.9File #: 69.28**WELDING INSPECTION REPORT****Resident Engineer:** Pursell, Gary**Address:** 333 Burma Road**City:** Oakland, CA 94607**Report No:** WIR-007417**Date Inspected:** 07-Jun-2009**Project Name:** SAS Superstructure**OSM Arrival Time:** 1900**Prime Contractor:** American Bridge/Fluor Enterprises, a JV**OSM Departure Time:** 700**Contractor:** Zhenhua Port Machinery Company, Ltd (ZPMC), Changxing Island **Location:** Shanghai, China**CWI Name:** See Below**CWI Present:** Yes No**Inspected CWI report:** Yes No N/A**Rod Oven in Use:** Yes No N/A**Electrode to specification:** Yes No N/A**Weld Procedures Followed:** Yes No N/A**Qualified Welders:** Yes No N/A**Verified Joint Fit-up:** Yes No N/A**Approved Drawings:** Yes No N/A**Approved WPS:** Yes No N/A**Delayed / Cancelled:** Yes No N/A**Bridge No:** 34-0006**Component:** OBG and Tower Fabrication**Summary of Items Observed:**

WELDING INSPECTION REPORT

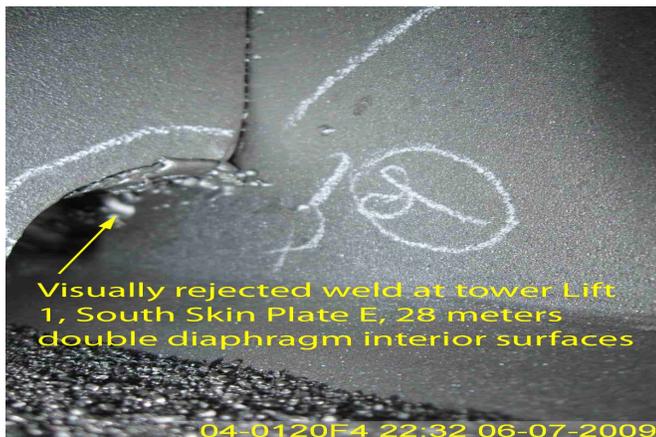
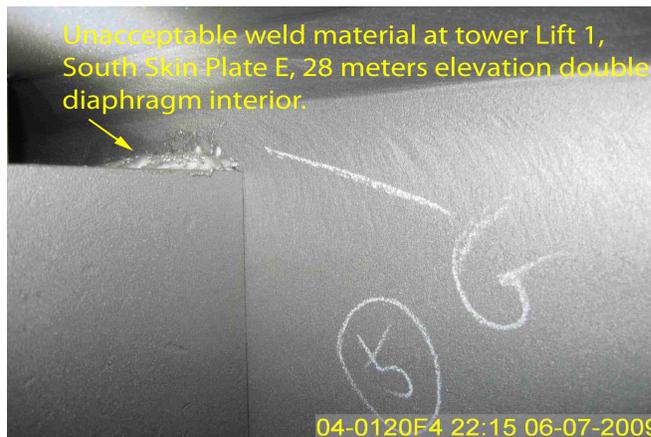
This QA Inspector performed random visual inspections of Tower Lift 1, South Skin Plate E double diaphragm interior surfaces at elevation 28 meters. The interior surfaces of this double diaphragm had recently been sandblasted and the surfaces are now free of rust oxide and other contaminants that had previously obscured portions of the welds. This QA Inspector visually observed approximately eleven weld locations that require grinding or welding to resolve the visual rejections. This QA Inspector obtained digital photographs of the rejected welds and the photographs have been stored on the common computer drive for future reference. This QA Inspector also made a sketch of the weld locations and a copy of the sketch has been placed in the tower visual tracking notebook which has other QA Inspectors' sketches of visual rejection locations. Below are photographs showing two of the areas that this QA Inspector identified as requiring rework.
