DEPARTMENT OF TRANSPORTATION

Quality Assurance and Source Inspection

Contract #: 04-0120F4Cty: SF/ALA Rte: 80 PM: 13.2/13.9File #: 70.28**WELDING INSPECTION REPORT****Resident Engineer:** Pursell, Gary**Address:** 333 Burma Road**City:** Oakland, CA 94607**Report No:** WIR-007455**Date Inspected:** 27-Jun-2009**Project Name:** SAS Superstructure**OSM Arrival Time:** 730**Prime Contractor:** American Bridge/Fluor Enterprises, a JV**OSM Departure Time:** 1600**Contractor:** Japan Steel Works**Location:** Muroan, Japan

Bridge No: 34-0006**Summary of Items Observed:**

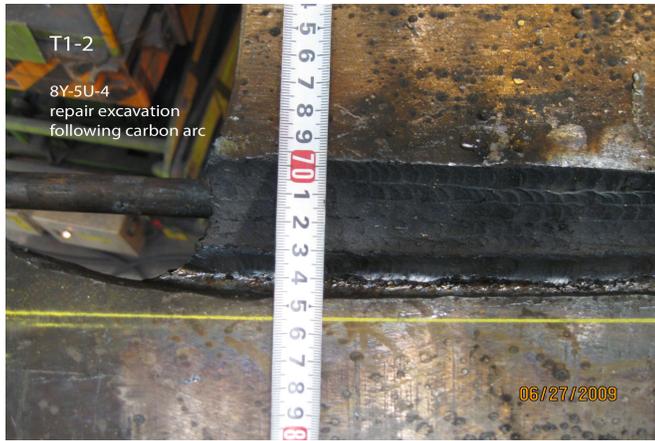
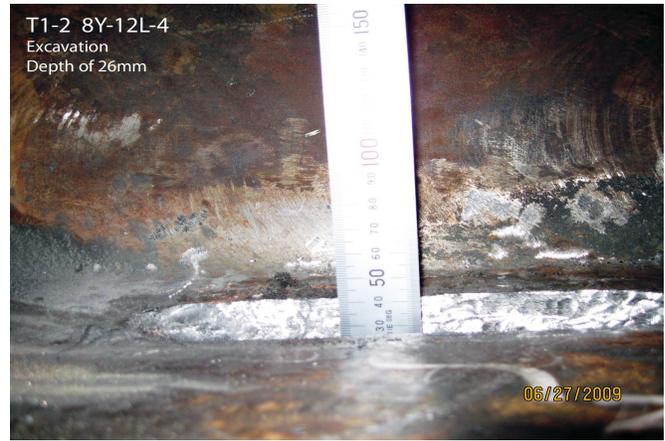
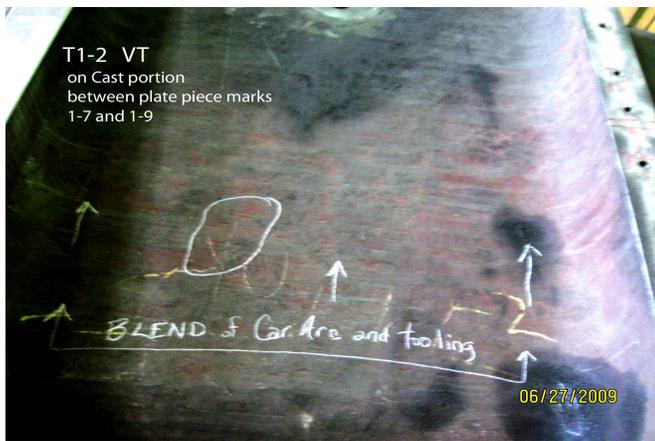
T1-2 ~ Upon arrival of QA Caltrans Inspector Mr. Mike Brcic, joint 8Y-5L-3 and -4 was already carbon arc'd, now awaiting grinding and MT to verify indication removal. Excavation extended full length due to QC NDE personnel identifying the defect by Ultrasonic method of examination, reported on weld report submitted by JSW

for the week of 6/21 ~ 6/27. By mid day JSW personnel had ground joint repair bevels to 8Y-5L-3 and -4. They also ground out the indication noted originally by QA Inspector, Mike Brcic in joint 8Y-12L-4. See digital photos attached. Neither excavations have been confirmed defect free by MT at this time. Welders T. Ohkawa 03-3091 and T. Watanabe 08-5153 were actively welding stiffener plates 8ST-21 and 8ST-20 respectively, FCAW process with 1.6mm TM55 weld wire. Parameters were monitored before welder began and on a random basis thereafter by QC CWI Mr. Chung Fu Kuan.
