**DEPARTMENT OF TRANSPORTATION**

Office of Structural Materials

Contract #: 04-0120F4Cty: SF/ALA Rte: 80 PM: 13.2/13.9File #: 69.28**WELDING INSPECTION REPORT****Resident Engineer:** Pursell, Gary**Address:** 333 Burma Road**City:** Oakland, CA 94607**Report No:** WIR-007529**Date Inspected:** 19-Jun-2009**Project Name:** SAS Superstructure**OSM Arrival Time:** 700**Prime Contractor:** American Bridge/Fluor Enterprises, a JV**OSM Departure Time:** 1400**Contractor:** Zhenhua Port Machinery Company, Ltd (ZPMC), Changxing Island **Location:** Shanghai, China**CWI Name:** Xu Le Feng, Liu Yang**CWI Present:** Yes No**Inspected CWI report:** Yes No N/A**Rod Oven in Use:** Yes No N/A**Electrode to specification:** Yes No N/A**Weld Procedures Followed:** Yes No N/A**Qualified Welders:** Yes No N/A**Verified Joint Fit-up:** Yes No N/A**Approved Drawings:** Yes No N/A**Approved WPS:** Yes No N/A**Delayed / Cancelled:** Yes No N/A**Bridge No:** 34-0006**Component:** TOWER**Summary of Items Observed:**

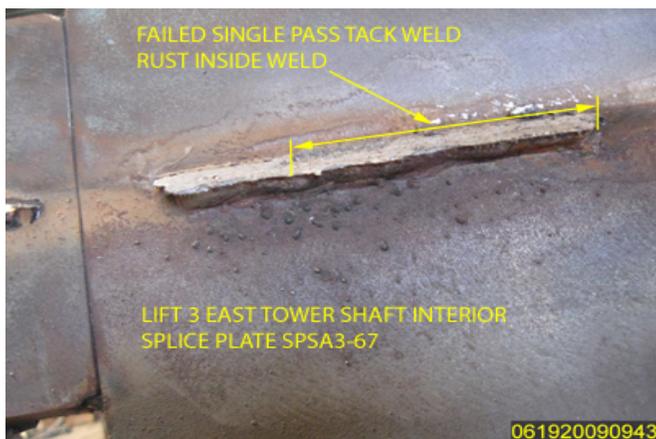
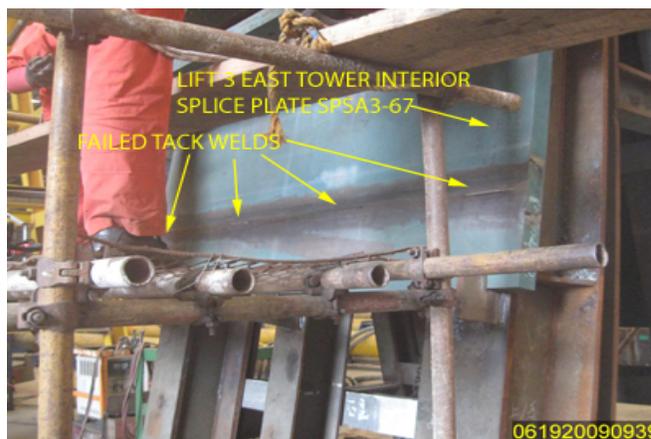
small A-Frame jig to allow for welding of the part in the 1 G position. The QA Inspector did not observe; but shortly after the placement of Lift 3 Skin Plate C Interior Splice Plate SPSA3-67 into a small A-Frame jig, Longitudinal Stiffener piece mark LS3-60 fell off SPSA3-67. ZPMC Quality Control (QC) informed the QA Inspector that it fell off when one of the welders stepped on it to weld the longitudinal stiffener that was positioned at the top of the jig. The QA Inspector randomly observed that there had been only 4 single pass tack welds on one side of LS3-60 and that they had all failed. The QA Inspector also randomly observed that 2 of the single pass tack welds appeared to have been cracked prior to the failure. There was rust observed inside the weld metal where the cracks were located. The QA Inspector randomly observed 2 ZPMC welders add additional tack welds to the remaining 2 longitudinal stiffeners before ZPMC riggers lifted SPSA3-67 from the A-Frame jig and placed it on the gantry platform. The QA Inspector randomly observed a ZPMC helper immediately begin to remove the remnants of the tack welds from the bevel of Longitudinal Stiffener LS3-60. The attached photographs provide additional detail.
