**DEPARTMENT OF TRANSPORTATION**

Contract #: 04-0120F4Cty: SF/ALA Rte: 80 PM: 13.2/13.9File #: 69.28**WELDING INSPECTION REPORT****Resident Engineer:** Pursell, Gary**Address:** 333 Burma Road**City:** Oakland, CA 94607**Report No:** WIR-007532**Date Inspected:** 24-Jun-2009**Project Name:** SAS Superstructure**OSM Arrival Time:** 700**Prime Contractor:** American Bridge/Fluor Enterprises, a JV**OSM Departure Time:** 1900**Contractor:** Zhenhua Port Machinery Company, Ltd (ZPMC), Changxing Island **Location:** Shanghai, China**CWI Name:** Xu Le Feng, Yu Dong Ping**CWI Present:** Yes No**Inspected CWI report:** Yes No N/A**Rod Oven in Use:** Yes No N/A**Electrode to specification:** Yes No N/A**Weld Procedures Followed:** Yes No N/A**Qualified Welders:** Yes No N/A**Verified Joint Fit-up:** Yes No N/A**Approved Drawings:** Yes No N/A**Approved WPS:** Yes No N/A**Delayed / Cancelled:** Yes No N/A**Bridge No:** 34-0006**Component:** TOWER**Summary of Items Observed:**

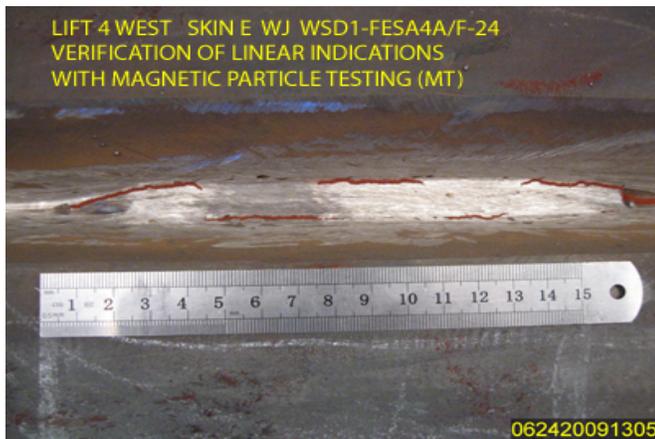
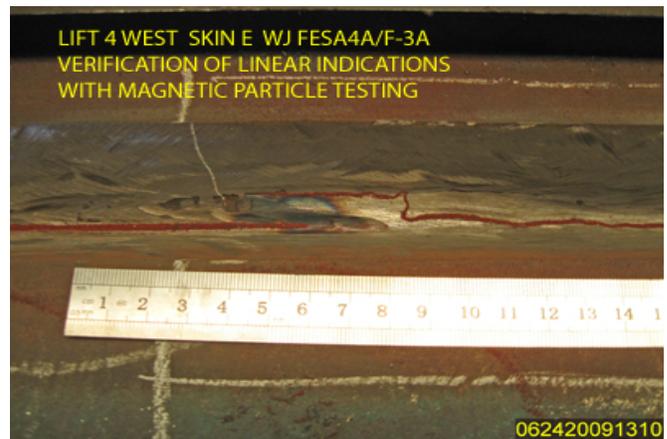
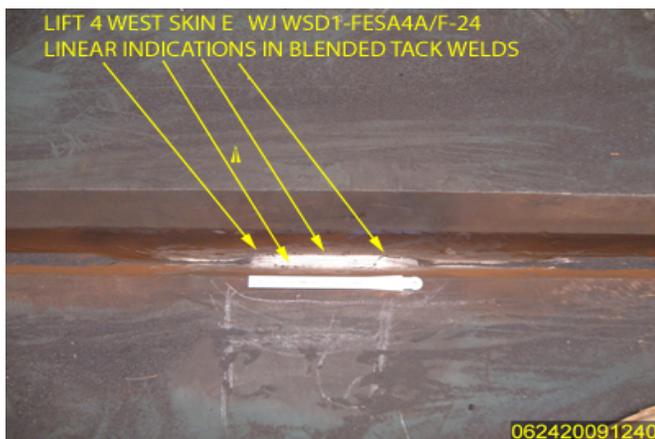
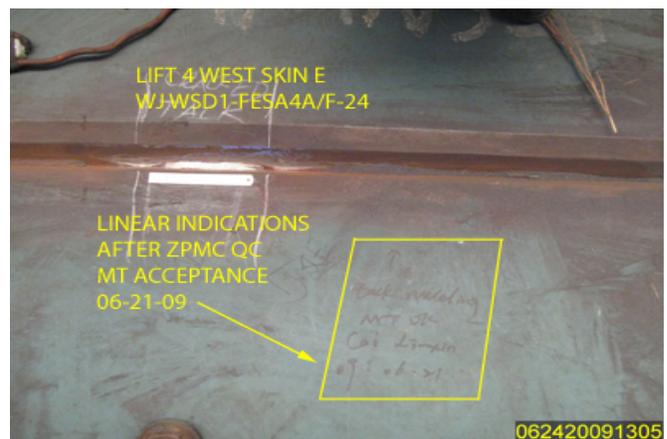
The QA Inspector randomly observed visually, several tack welds in the root of Lift 4 West Skin E at Weld Joint (WJ) Numbers WSD1-FESA4A/F-24 and WSD1-FESA4A/F-3A with several linear indications in each tack weld. The QA Inspector verified the linear indications with MT and informed ZPMC Quality Control (QC) personnel. ZPMC production personnel began immediately to remove the tack welds containing the linear indications with angle grinders. The QA Inspector randomly observed that all of the tack welds had been previously accepted by MT by ZPMC QC personnel. The QA Inspector generated a TL-15 for the tack welds on Lift 4 West Skin E at Weld Joint (WJ) Numbers WSD1-FESA4A/F-24 and WSD1-FESA4A/F-3A. The attached photographs provide additional detail.
