**DEPARTMENT OF TRANSPORTATION**

Contract #: 04-0120F4Cty: SF/ALA Rte: 80 PM: 13.2/13.9File #: 69.28**WELDING INSPECTION REPORT****Resident Engineer:** Pursell, Gary**Address:** 333 Burma Road**City:** Oakland, CA 94607**Report No:** WIR-007542**Date Inspected:** 25-Jun-2009**Project Name:** SAS Superstructure**OSM Arrival Time:** 700**Prime Contractor:** American Bridge/Fluor Enterprises, a JV**OSM Departure Time:** 1900**Contractor:** Zhenhua Port Machinery Company, Ltd (ZPMC), Changxing Island **Location:** Shanghai, China**CWI Name:** Xu Le Feng, Yu Dong Ping**CWI Present:** Yes No**Inspected CWI report:** Yes No N/A**Rod Oven in Use:** Yes No N/A**Electrode to specification:** Yes No N/A**Weld Procedures Followed:** Yes No N/A**Qualified Welders:** Yes No N/A**Verified Joint Fit-up:** Yes No N/A**Approved Drawings:** Yes No N/A**Approved WPS:** Yes No N/A**Delayed / Cancelled:** Yes No N/A**Bridge No:** 34-0006**Component:** TOWER**Summary of Items Observed:**

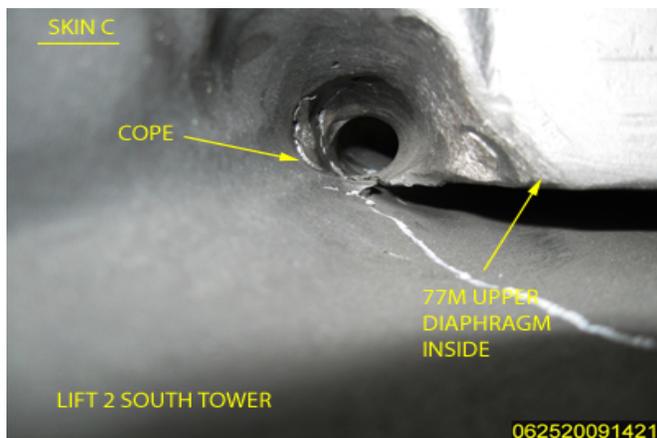
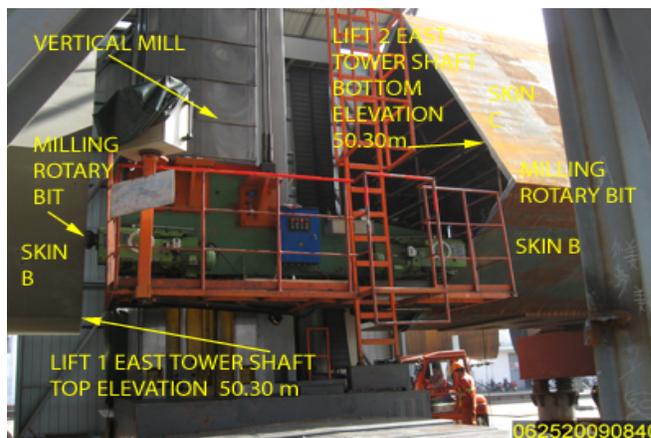
The QA Inspector randomly observed the vertical mill was in operation and that milling was being performed simultaneously on Skin Plates A through E on the upper elevation of Lift 1 East Tower Shaft and Skin Plates A through E on the lower elevation of Lift 2 East Tower Shaft.

The QA Inspector randomly observed that no contract work was being performed in the interior or on the exterior of or Lift 2 East Tower Shaft. The attached photographs provide additional detail.

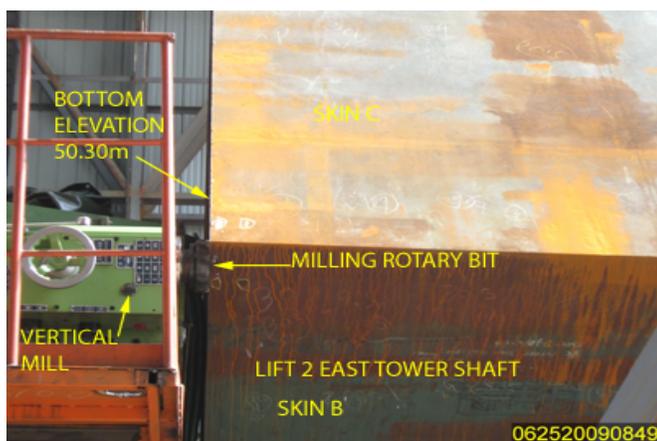
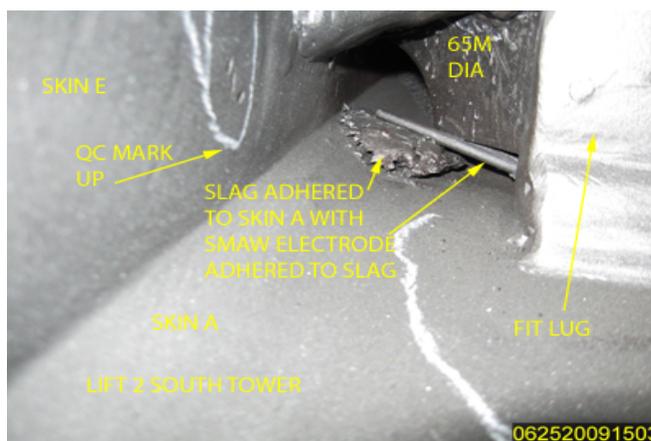
The QA Inspector was notified by ZPMC Quality Control (QC) personnel that Lift 2 South Tower Shaft would be ready for an after blast inspection from the bottom of the lift at elevation 83 M to 65 M Upper Diaphragm. The QA Inspector was at the blast shop at 1255 and randomly observed several ZPMC personnel vacuuming the

interior of Lift 2 South from 83 M to 65 M. There were no QC personnel in the area at this time. The QA Inspector observed 6 QC personnel enter Lift 2 East Tower Shaft at 1325 to begin their after blast Visual Inspection (VT). The QA Inspector waited until the 6 QC personnel finished their VT Inspection from elevation 83 M to 80.75 M and then entered Lift 2 South Tower Shaft to begin his after blast VT Inspection. By the time the QA Inspector reached the top of the inside of 77 M Double Diaphragm, the 6 QC personnel had finished their VT Inspection from elevation 83 M to 65 M Upper Diaphragm and began to exit lift 2 South Tower Shaft. The QA Inspector began his after blast VT Inspection on the outside of 77 M Lower Diaphragm as the last of the 6 QC personnel exited the tower shaft. Once all of the QC Inspectors were out of the tower shaft several ZPMC production personnel entered and began grinding areas that had been marked up by QC personnel and the QA Inspector. The QA Inspector continued his after blast VT Inspection with ZPMC production personnel grinding all around his person. The QA Inspector marked up several areas for re-work which were missed by QC, completed his after blast VT Inspection and exited Lift 2 South Tower Shaft. The attached photographs provide additional detail.
