DEPARTMENT OF TRANSPORTATION

Quality Assurance and Source Inspection

Contract #: 04-0120F4Cty: SF/ALA Rte: 80 PM: 13.2/13.9File #: 69.28**WELDING INSPECTION REPORT****Resident Engineer:** Pursell, Gary**Address:** 333 Burma Road**City:** Oakland, CA 94607**Report No:** WIR-007543**Date Inspected:** 26-Jun-2009**Project Name:** SAS Superstructure**OSM Arrival Time:** 700**Prime Contractor:** American Bridge/Fluor Enterprises, a JV**OSM Departure Time:** 1900**Contractor:** Zhenhua Port Machinery Company, Ltd (ZPMC), Changxing Island **Location:** Shanghai, China**CWI Name:** Xu Le Feng, Yu Dong Ping**CWI Present:** Yes No**Inspected CWI report:** Yes No N/A**Rod Oven in Use:** Yes No N/A**Electrode to specification:** Yes No N/A**Weld Procedures Followed:** Yes No N/A**Qualified Welders:** Yes No N/A**Verified Joint Fit-up:** Yes No N/A**Approved Drawings:** Yes No N/A**Approved WPS:** Yes No N/A**Delayed / Cancelled:** Yes No N/A**Bridge No:** 34-0006**Component:** TOWER**Summary of Items Observed:**

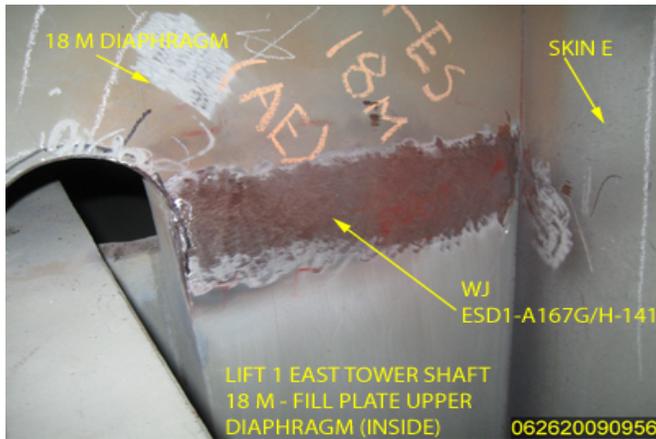
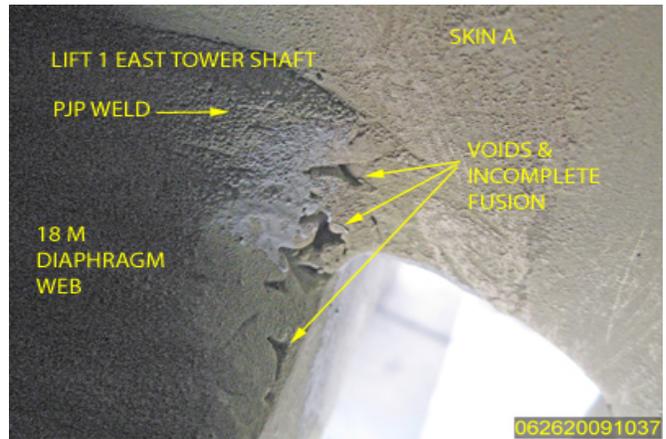
The QA Inspector performed a 100% Final Visual Testing (VT) Inspection of the inside of Weld Joint (WJ) ESD1-A167G/H-141 between the fill plate and 18 M Upper Diaphragm on Skin A per ZPMC NDT Notification Sheet 003518 and ZPMC NCR-0252. There appeared to be no indications and the QA Inspector accepted the above listed weld. During the above listed VT of WJ ESD1-A167G/H-141, the QA Inspector randomly observed an area at the end of the weld attaching the web of 18M Diaphragm to Skin A, that contained a large void and

incomplete fusion. The QA Inspector informed ZPMC Quality Control (QC). ZPMC QC informed the QA Inspector that the area would be repaired and that ZPMC would notify the QA Inspector when repairs were completed. The attached photographs provide additional detail of the initial VT of WJ ESD1-A167G/H-141 and of the anomaly 18M Diaphragm Web to Skin A weld.
