**DEPARTMENT OF TRANSPORTATION**

Contract #: 04-0120F4Cty: SF/ALA Rte: 80 PM: 13.2/13.9File #: 69.28**WELDING INSPECTION REPORT****Resident Engineer:** Pursell, Gary**Address:** 333 Burma Road**City:** Oakland, CA 94607**Report No:** WIR-007555**Date Inspected:** 29-Jun-2009**Project Name:** SAS Superstructure**OSM Arrival Time:** 700**Prime Contractor:** American Bridge/Fluor Enterprises, a JV**OSM Departure Time:** 1900**Contractor:** Zhenhua Port Machinery Company, Ltd (ZPMC), Changxing Island **Location:** Shanghai, China

# WELDING INSPECTION REPORT

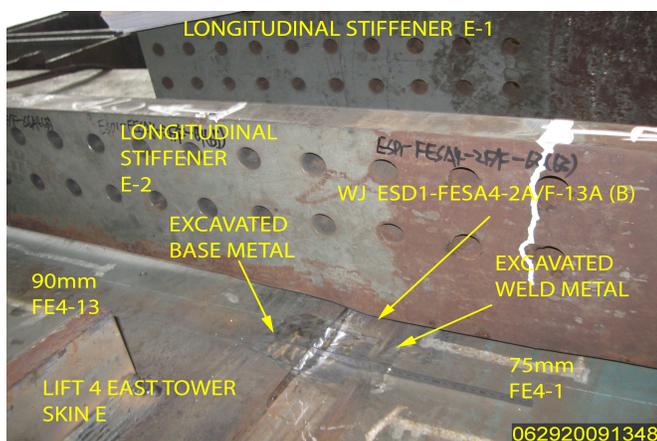
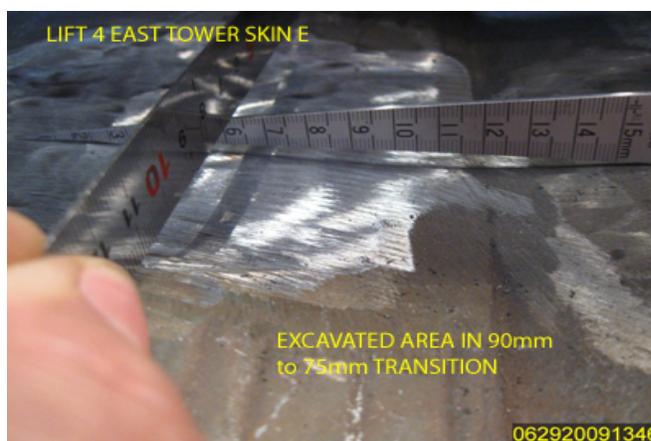
The QA Inspector randomly observed that weld metal and base metal had been removed at the transition joint from 90 millimeter (mm) FE4-13 to 75 mm FE4-1 of Skin Plate E for Lift 4 East Tower Shaft. The weld metal and base metal had been removed to allow for the fit up of Longitudinal Stiffener piece mark E2 at Weld Joint (WJ) ESD1-FESA4-2A/F-13A. The QA Inspector randomly observed that the transition on E2 was forward of the actual weld transition. The work was performed without the Engineer's approval and therefore not in compliance with contract requirements. The QA Inspector generated an Incident Report. The attached photographs provide additional detail.
