DEPARTMENT OF TRANSPORTATION

Contract #: 04-0120F4Cty: SF/ALA Rte: 80 PM: 13.2/13.9File #: 69.28**WELDING INSPECTION REPORT****Resident Engineer:** Pursell, Gary**Address:** 333 Burma Road**City:** Oakland, CA 94607**Report No:** WIR-007560**Date Inspected:** 03-Jul-2009**Project Name:** SAS Superstructure**OSM Arrival Time:** 1900**Prime Contractor:** American Bridge/Fluor Enterprises, a JV**OSM Departure Time:** 700**Contractor:** Zhenhua Port Machinery Company, Ltd (ZPMC), Changxing Island **Location:** Shanghai, China**CWI Name:** Xu Le Feng, Yu Dong Ping**CWI Present:** Yes No**Inspected CWI report:** Yes No N/A**Rod Oven in Use:** Yes No N/A**Electrode to specification:** Yes No N/A**Weld Procedures Followed:** Yes No N/A**Qualified Welders:** Yes No N/A**Verified Joint Fit-up:** Yes No N/A**Approved Drawings:** Yes No N/A**Approved WPS:** Yes No N/A**Delayed / Cancelled:** Yes No N/A**Bridge No:** 34-0006**Component:** TOWER**Summary of Items Observed:**

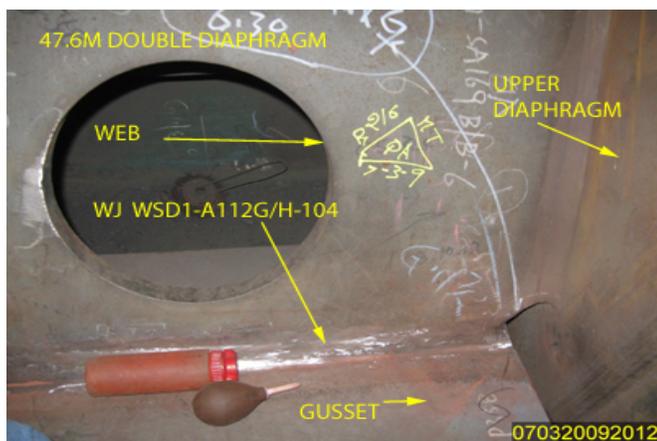
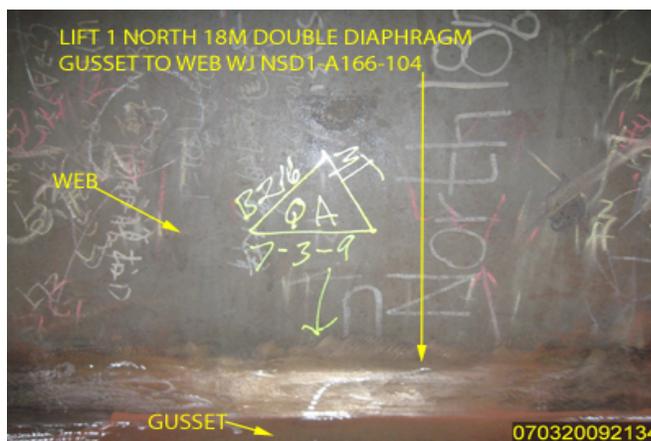
Unless otherwise noted, all work observed on this date appeared to generally comply with applicable contract documents.
