DEPARTMENT OF TRANSPORTATION

Contract #: 04-0120F4Cty: SF/ALA Rte: 80 PM: 13.2/13.9File #: 74.28**WELDING INSPECTION REPORT****Resident Engineer:** Pursell, Gary**Address:** 333 Burma Road**City:** Oakland, CA 94607**Report No:** WIR-007672**Date Inspected:** 10-Jul-2009**Project Name:** SAS Superstructure**OSM Arrival Time:** 700**Prime Contractor:** American Bridge/Fluor Enterprises, a JV**OSM Departure Time:** 1800**Contractor:** Goodwin Steel, UK**Location:** Stoke on Trent, UK**CWI Name:****CWI Present:**

Bridge No: 34-0006**Component:** Cable Band**Summary of Items Observed:**

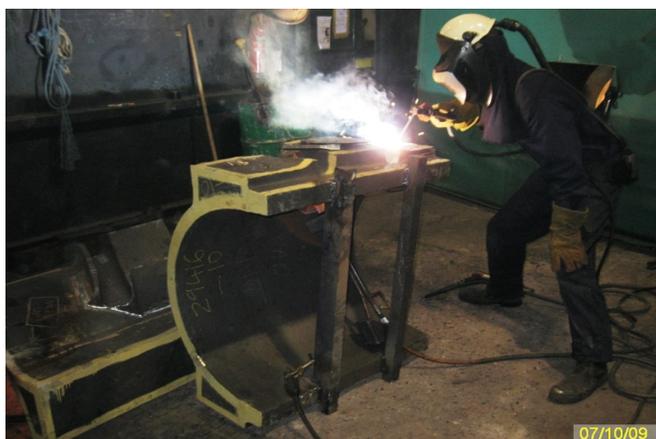
QA inspector witnessed buildup welding of castings GG29416-10 and GG29421-1. The welder, Mark Howard, was observed welding in the flat position utilizing approved welding procedure WPS04-0120F4B. Preheat and welding parameters were observed to be within the limits of the WPS. These repairs have received verbal approval by QA, but have not received approval by an independent CWI in accordance with the approved MITP sections Q2 and Q3. This issue was brought to the attention of Jason Cross. Jason Cross reported that he allowed welding to proceed due to an opening in the furnace schedule this Saturday and the approved CWIs were not available to perform the required inspections.

See attached digital image.
