DEPARTMENT OF TRANSPORTATION

Contract #: 04-0120F4Cty: SF/ALA Rte: 80 PM: 13.2/13.9File #: 13.28**WELDING INSPECTION REPORT****Resident Engineer:** Pursell, Gary**Address:** 333 Burma Road**City:** Oakland, CA 94607**Report No:** WIR-007689**Date Inspected:** 14-Jul-2009**Project Name:** SAS Superstructure**OSM Arrival Time:** 700**Prime Contractor:** American Bridge/Fluor Enterprises, a JV**OSM Departure Time:** 1530**Contractor:** Oregon Iron Works Clackamas, Or.**Location:** Clackamas, OR**CWI Name:** Mike Gregson, Jose Salazar**CWI Present:** Yes No**Inspected CWI report:** Yes No N/A**Rod Oven in Use:** Yes No N/A**Electrode to specification:** Yes No N/A**Weld Procedures Followed:** Yes No N/A**Qualified Welders:** Yes No N/A**Verified Joint Fit-up:** Yes No N/A**Approved Drawings:** Yes No N/A**Approved WPS:** Yes No N/A**Delayed / Cancelled:** Yes No N/A**Bridge No:** 34-0006**Component:** Hinge K Pipe Beams**Summary of Items Observed:**

Hinge-K Pipe Beam Assembly 102A-1: 7/14/09

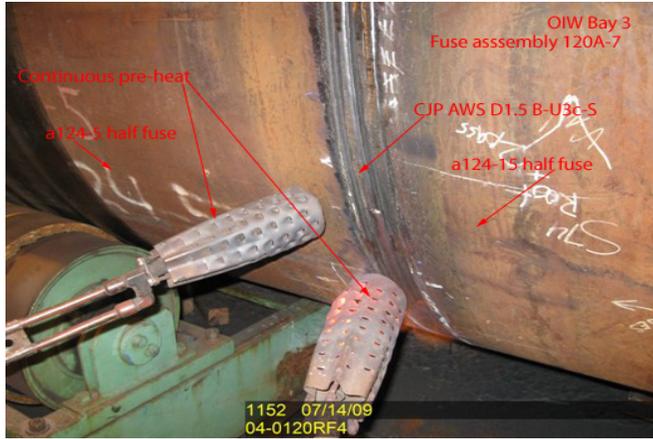
Hinge-K Pipe Beam Fuse Assembly 120A-7: 7/14/09

QA Inspector randomly witnessed welder #T23, Mr. John Tellone, perform submerged arc welding (SAW) on CJP (AWS D1.5 B-U3c-S), half fuse pipe assembly, (piece mark identified as a124-5), to half fuse pipe assembly, (piece mark identified as a124-15), in the flat position (1G). QA Inspector spoke with QC Inspector Mike Gregson and Mr. Gregson explained that the OIW welder #T23 was performing submerged arc welding in accordance with the OIW approved welding procedure specification (WPS 4020).

QA Inspector verified Mr. John Tellone was currently qualified for this welding process/position and performed a random pre-heat check and recorded temperatures of approximately 350 degrees Fahrenheit. QA Inspector also recorded random, in-process welding parameters (amps/volts) of 660 amps and 36 volts, which is in compliance with the OIW welding procedure specification (WPS 4020). See attached picture below.

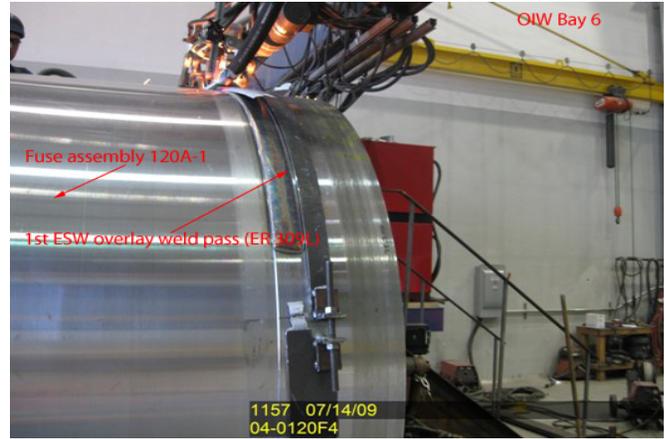
Hinge-K Pipe Beam Fuse Assembly 120A-1: 7/13/09

QA Inspector noticed that the first ESW stainless steel overlay passes were in-process, on this fuse assembly 120A-1. QA Inspector witnessed welder #F17, Mr. Igor Frolov performing electro slag welding (ESW) on the first layer welding passes, in the flat position, utilizing Soudokay brand Soudotape 309L stainless steel consumable strip. QA Inspector randomly noticed QC Inspector's Mike Gregson and Jose Salazar were present, to verify

in-process welding parameters (amps/volts) and monitor in-process continuous pre-heat temperatures. QA Inspector spoke with QC Inspector Jose Salazar and Mr. Salazar explained that welding amps were recorded as 1220 amps/25.2 volts, travel speed at 271mm/min. and a pre-heat temperature recorded at 225 Fahrenheit. QA Inspector verified Mr. Igor Frolov was currently qualified for this welding process/position and randomly recorded pre-heat temperatures of approximately 225 Fahrenheit. QA Inspector noted that Mr. Igor Frolov appeared to be in compliance with the applicable approved welding procedure specification (WPS 7003). See attached picture below.
