**DEPARTMENT OF TRANSPORTATION**

Contract #: 04-0120F4Cty: SF/ALA Rte: 80 PM: 13.2/13.9File #: 69.28**WELDING INSPECTION REPORT****Resident Engineer:** Pursell, Gary**Address:** 333 Burma Road**City:** Oakland, CA 94607**Report No:** WIR-007745**Date Inspected:** 27-Jun-2009**Project Name:** SAS Superstructure**OSM Arrival Time:** 1845**Prime Contractor:** American Bridge/Fluor Enterprises, a JV**OSM Departure Time:** 645**Contractor:** Zhenhua Port Machinery Company, Ltd (ZPMC), Changxing Island **Location:** Shanghai, China**CWI Name:** Chen Xi**CWI Present:** Yes No**Inspected CWI report:** Yes No N/A**Rod Oven in Use:** Yes No N/A**Electrode to specification:** Yes No N/A**Weld Procedures Followed:** Yes No N/A**Qualified Welders:** Yes No N/A**Verified Joint Fit-up:** Yes No N/A**Approved Drawings:** Yes No N/A**Approved WPS:** Yes No N/A**Delayed / Cancelled:** Yes No N/A**Bridge No:** 34-0006**Component:** OBG and Tower**Summary of Items Observed:**

# WELDING INSPECTION REPORT

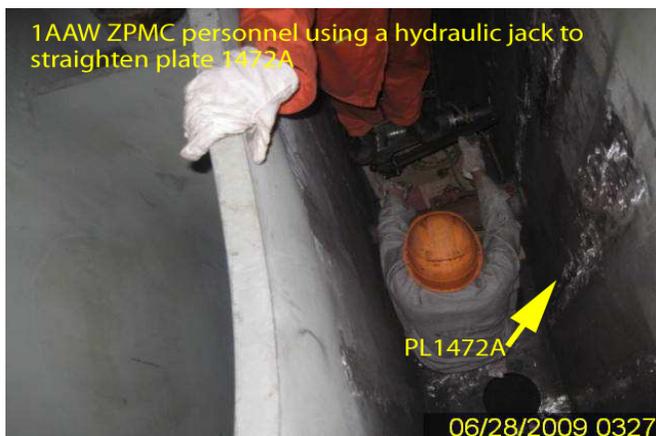
1AAW

This Caltrans QA inspector monitored activities related to internal stiffener replacement for Partial Joint Penetration (PJP) welds exceeding Welding Procedure Specification root gap tolerance on OBG segments 1AAW. This Quality Assurance (QA) Inspector observed ZPMC personnel performing mechanical straightening without applied heat on Edge Plate 1472A Segment 1AAW. QA observed ZPMC personnel using hydraulic jacks to apply force to the distorted portion of the Edge Plate 1472A there was no heating of the base metal during the operation. The Heat Straightening Request (HSR) presented by ZPMC personnel was identified as, HSR(B)-298. The HSR specified the use of heat during the straightening procedure. An incident report was issued for the above mentioned mechanical straightening. Please see the attached photo of mechanical straightening by ZPMC personnel.

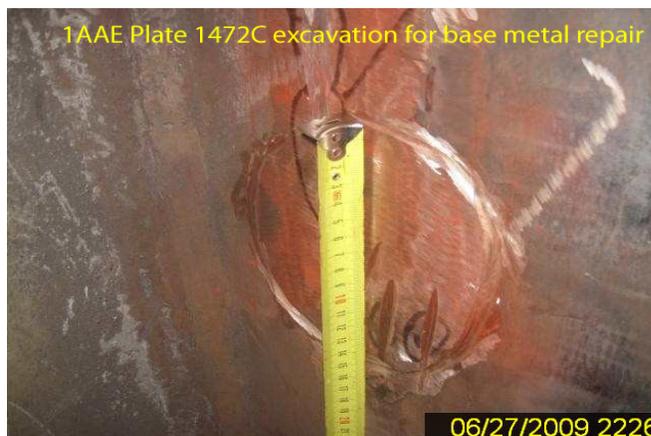
1AAE

During visual inspection of base metal excavations QA observed that ZPMC had excavated a 150 mm diameter circle in the edge plate approximately 2 mm deep and 15 mm in width. Please see the attached photo of the base

metal excavation area.
