**DEPARTMENT OF TRANSPORTATION**

Contract #: 04-0120F4Cty: SF/ALA Rte: 80 PM: 13.2/13.9File #: 13.28**WELDING INSPECTION REPORT****Resident Engineer:** Pursell, Gary**Address:** 333 Burma Road**City:** Oakland, CA 94607**Report No:** WIR-007759**Date Inspected:** 16-Jul-2009**Project Name:** SAS Superstructure**OSM Arrival Time:** 700**Prime Contractor:** American Bridge/Fluor Enterprises, a JV**OSM Departure Time:** 1530**Contractor:** Oregon Iron Works Clackamas, Or.**Location:** Clackamas, OR**CWI Name:** Mike Gregson, Jose Salazar**CWI Present:** Yes No**Inspected CWI report:** Yes No N/A**Rod Oven in Use:** Yes No N/A**Electrode to specification:** Yes No N/A**Weld Procedures Followed:** Yes No N/A**Qualified Welders:** Yes No N/A**Verified Joint Fit-up:** Yes No N/A**Approved Drawings:** Yes No N/A**Approved WPS:** Yes No N/A**Delayed / Cancelled:** Yes No N/A**Bridge No:** 34-0006**Component:** Hinge K Pipe Beams**Summary of Items Observed:**

OIW Fabrication Shop-Bay 3

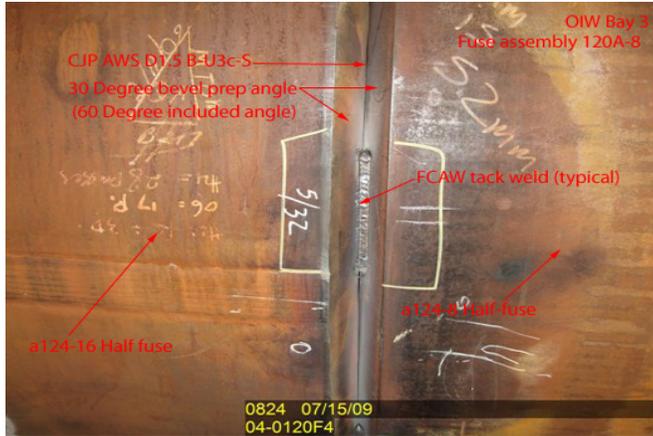
Hinge-K Pipe Beam Fuse Assembly 120A-8: 7/16/09

QA Inspector noticed that the half fuse sub-assemblies, identified as piece marks a124-8 & a124-16, had been previously fit up and tack-welded by OIW production personell and was sitting idle. QA Inspector noted that the weld joint was a CJP AWS D1.5 B-U3c-S and the welding procedure specification (WPS 4020) would be utilized during the FCAW/SAW process in accordance with AWS D1.5 and approved OIW contract requirements. QA Inspector noticed that QC Inspector Mike Gregson and Jose Salazar were present, on this date, to monitor welding parameters (amps/volts) and pre-heat temperatures, prior to welding on this CJP splice. See picture below.

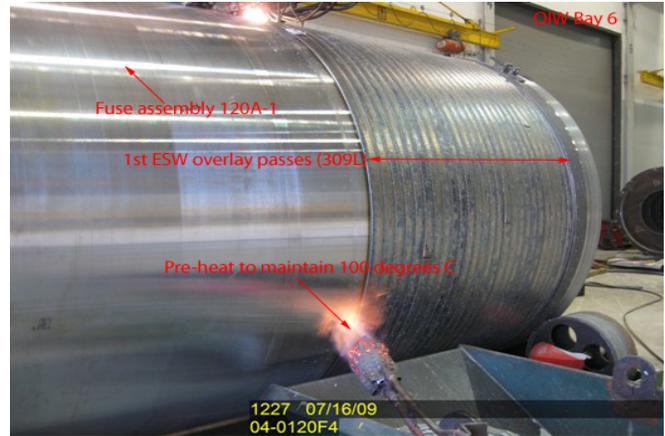
Hinge-K Pipe Beam Fuse Assembly 120A-1: 7/16/09

QA Inspector noticed that the first ESW stainless steel overlay passes were in-process, on this fuse assembly 120A-1. QA Inspector witnessed welder #F17, Mr. Igor Frolov performing electro slag welding (ESW) on the first layer welding passes, (approximately 40% complete), in the flat position, utilizing Soudokay brand Soudotape

309L stainless steel consumable strip. QA Inspector noted the first layer passes would be completed utilizing the 309L consumable strip and the remaining second & third layer passes would be completed utilizing Soudokay brand Soudotape 316L stainless steel consumable strip, per contract requirements. QA Inspector randomly noticed QC Inspector's Mike Gregson and Jose Salazar were present, to verify in-process welding parameters (amps/volts) and monitor in-process continuous pre-heat temperatures. QA Inspector spoke with QC Inspector Jose Salazar and Mr. Salazar explained that welding amps were recorded as 1220 amps/25.2 volts, travel speed at 271mm/min. and a pre-heat temperature recorded at 225 Fahrenheit. QA Inspector verified Mr. Igor Frolov was currently qualified for this welding process/position and randomly recorded pre-heat temperatures of approximately 225 Fahrenheit. QA Inspector noted that Mr. Igor Frolov appeared to be in compliance with the applicable approved welding procedure specification (WPS 7003). See attached picture below.

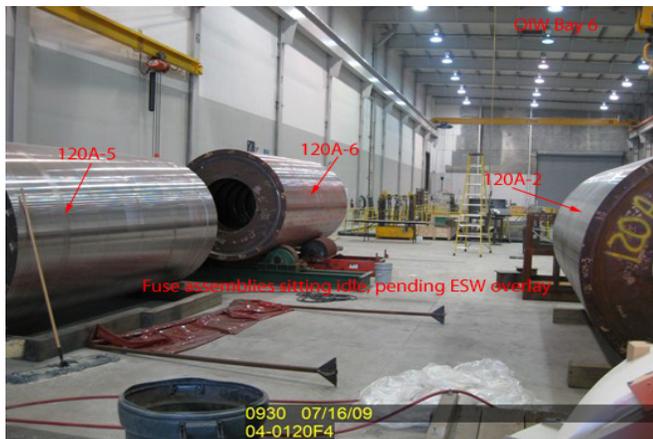
Hinge-K Pipe Beam Fuse Assembly 120A-2: 7/16/09

QA Inspector noticed this fuse assembly 120A-2 was sitting idle, pending 100% final magnetic particle testing on the exterior machined surface by qualified OIW QC personnel. QA Inspector previously spoke with QC Inspector Mike Gregson and Mr. Gregson explained that the exterior magnetic particle testing would be performed as soon as OIW production personnel place this assembly on the automated rollers. Mr. Gregson also explained that once the magnetic particle testing was complete, QA Inspector would be notified and QA Inspector will then perform approximately 10% magnetic particle testing, on the exterior machined surface, of this fuse assembly 120A-2. See attached picture below.
