DEPARTMENT OF TRANSPORTATION

Quality Assurance and Source Inspection

Contract #: 04-0120F4Cty: SF/ALA Rte: 80 PM: 13.2/13.9File #: 13.28**WELDING INSPECTION REPORT****Resident Engineer:** Pursell, Gary**Address:** 333 Burma Road**City:** Oakland, CA 94607**Report No:** WIR-007831**Date Inspected:** 17-Jul-2009**Project Name:** SAS Superstructure**OSM Arrival Time:** 700**Prime Contractor:** American Bridge/Fluor Enterprises, a JV**OSM Departure Time:** 1530**Contractor:** Oregon Iron Works Clackamas, Or.**Location:** Clackamas, OR**CWI Name:** Mike Gregson, Jose Salazar**CWI Present:** Yes No**Inspected CWI report:** Yes No N/A**Rod Oven in Use:** Yes No N/A**Electrode to specification:** Yes No N/A**Weld Procedures Followed:** Yes No N/A**Qualified Welders:** Yes No N/A**Verified Joint Fit-up:** Yes No N/A**Approved Drawings:** Yes No N/A**Approved WPS:** Yes No N/A**Delayed / Cancelled:** Yes No N/A**Bridge No:** 34-0006**Component:** Hinge K Pipe Beams**Summary of Items Observed:**

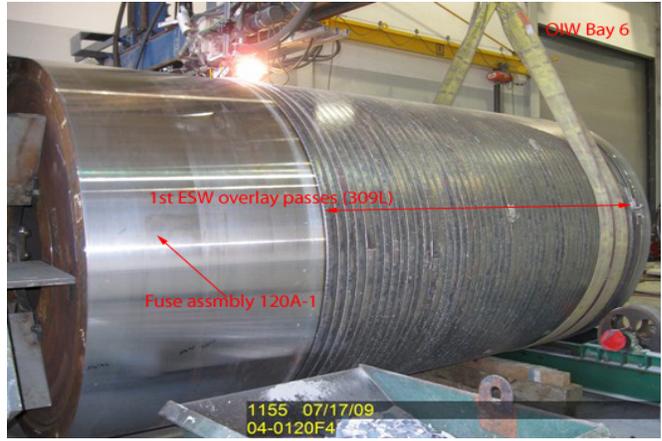
Hinge-K Pipe Beam Fuse Assembly 120A-1: 7/17/09

QA Inspector noticed that the first ESW stainless steel overlay passes were in-process, on this fuse assembly 120A-1. QA Inspector witnessed welder #F17, Mr. Igor Frolov performing electro slag welding (ESW) on the first layer welding passes, (approximately 75% complete), in the flat position, utilizing Soudokay brand Soudotape

309L stainless steel consumable strip. QA Inspector noted the first layer passes would be completed utilizing the 309L consumable strip and the remaining second & third layer passes would be completed utilizing Soudokay brand Soudotape 316L stainless steel consumable strip, per contract requirements. QA Inspector randomly noticed QC Inspector's Mike Gregson and Jose Salazar were present, to verify in-process welding parameters (amps/volts) and monitor in-process continuous pre-heat temperatures. QA Inspector spoke with QC Inspector Jose Salazar and Mr. Salazar explained that welding amps were recorded as 1220 amps/25.2 volts, travel speed at 271mm/min. and a pre-heat temperature recorded at 225 Fahrenheit. QA Inspector verified Mr. Igor Frolov was currently qualified for this welding process/position and randomly recorded pre-heat temperatures of approximately 225 Fahrenheit. QA Inspector noted that Mr. Igor Frolov appeared to be in compliance with the applicable approved welding procedure specification (WPS 7003). See attached picture below.
