**DEPARTMENT OF TRANSPORTATION**

Contract #: 04-0120F4Cty: SF/ALA Rte: 80 PM: 13.2/13.9File #: 69.28**WELDING INSPECTION REPORT****Resident Engineer:** Pursell, Gary**Address:** 333 Burma Road**City:** Oakland, CA 94607**Report No:** WIR-007866**Date Inspected:** 30-Jun-2009**Project Name:** SAS Superstructure**OSM Arrival Time:** 645**Prime Contractor:** American Bridge/Fluor Enterprises, a JV**OSM Departure Time:** 1700**Contractor:** Zhenhua Port Machinery Company, Ltd (ZPMC), Changxing Island **Location:** Shanghai, China**CWI Name:** Li Yan Hua**CWI Present:** Yes No**Inspected CWI report:** Yes No N/A**Rod Oven in Use:** Yes No N/A**Electrode to specification:** Yes No N/A**Weld Procedures Followed:** Yes No N/A**Qualified Welders:** Yes No N/A**Verified Joint Fit-up:** Yes No N/A**Approved Drawings:** Yes No N/A**Approved WPS:** Yes No N/A**Delayed / Cancelled:** Yes No N/A**Bridge No:** 34-0006**Component:** OBG Assembly**Summary of Items Observed:**

# WELDING INSPECTION REPORT

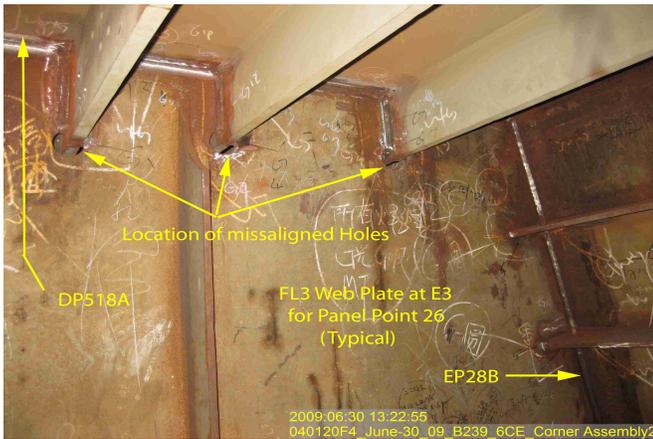
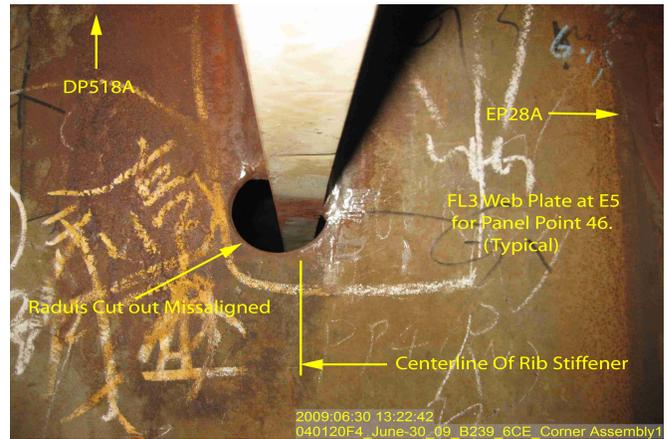
During random in process visual inspection of the internal components of Segment 6CE, Caltrans Quality Assurance (QA) Inspector discovered that the radius cut outs in the floor beam web plate, for deck panel 518A rib stiffener penetrations, were misaligned in way of E5 at the following panel points; 44, 45, 46, 46.5 and 47. A total of (11) eleven locations were noted with the fabrication issue as mentioned above. See incident report for this date.
