**DEPARTMENT OF TRANSPORTATION**

Contract #: 04-0120F4Cty: SF/ALA Rte: 80 PM: 13.2/13.9File #: 69.28**WELDING INSPECTION REPORT****Resident Engineer:** Pursell, Gary**Address:** 333 Burma Road**City:** Oakland, CA 94607**Report No:** WIR-007912**Date Inspected:** 16-Jul-2009**Project Name:** SAS Superstructure**OSM Arrival Time:** 1900**Prime Contractor:** American Bridge/Fluor Enterprises, a JV**OSM Departure Time:** 700**Contractor:** Zhenhua Port Machinery Company, Ltd (ZPMC), Changxing Island **Location:** Shanghai, China**CWI Name:** Wu Zhi Cheng**CWI Present:** Yes No**Inspected CWI report:** Yes No N/A**Rod Oven in Use:** Yes No N/A**Electrode to specification:** Yes No N/A**Weld Procedures Followed:** Yes No N/A**Qualified Welders:** Yes No N/A**Verified Joint Fit-up:** Yes No N/A**Approved Drawings:** Yes No N/A**Approved WPS:** Yes No N/A**Delayed / Cancelled:** Yes No N/A**Bridge No:** 34-0006**Component:** Segment 1AAE and CB5**Summary of Items Observed:**

# WELDING INSPECTION REPORT

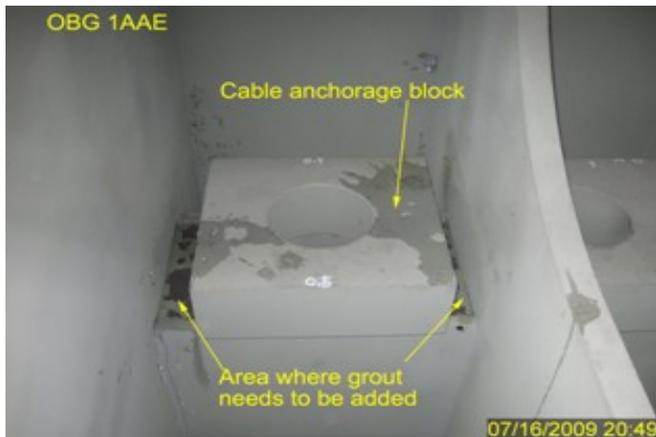
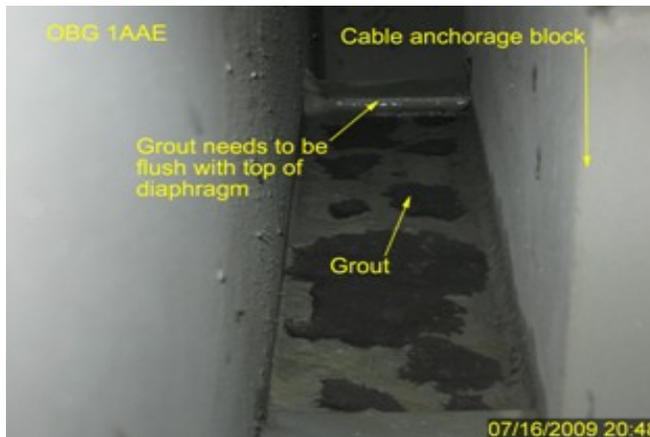
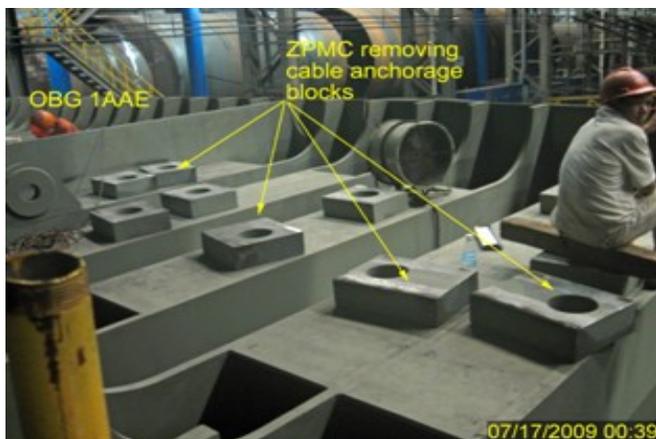
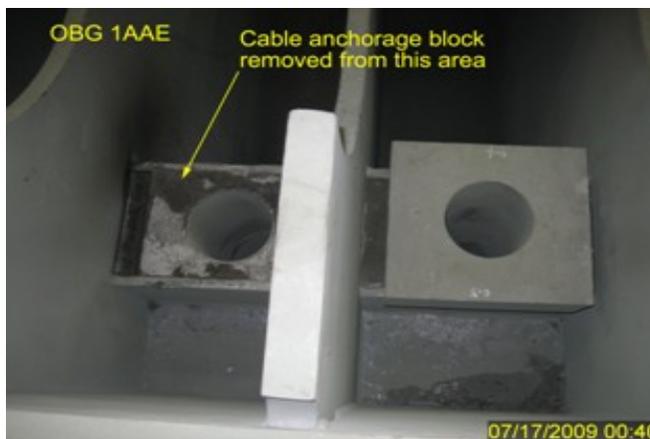
This QA observed ZPMC personnel removing parts identified as cable anchorage blocks from this segment. According to American Bridge Fluor (ABF) representative Mr. Peter Shaw, ZPMC is removing these blocks because the specifications require them to mill to bear. ZPMC QC along with ABF QA inspectors determined that fit up of these parts did not meet the mill to bear acceptance criteria. Mr. Shaw also informed this QA that the grout around the cable anchorage holes in this segment appears to have shrunk during the curing process and that ZPMC would have to add some more grout in order to bring it up flush with the top of the diaphragms around the cable anchorage holes.

ZPMC QA identified as Mr. Shen Xuejun informed this QA that ABF inspectors have performed final Visual Testing (VT) of the welds in this crossbeam after ZPMC and Caltrans QA performed the required Non Destructive Testing (NDT). ABF inspectors have rejected some of the welds and are requiring ZPMC to do the necessary weld repairs. This QA informed Mr. Shen that both ZPMC and Caltrans QA would have to perform additional NDT on the repaired areas after the repairs have been completed. Mr. Shen concurred and informed this QA that ZPMC

would submit an NDT notification to Caltrans QA after the repairs have been accepted by ZPMC QC and ABF QA inspectors.
