DEPARTMENT OF TRANSPORTATION

Contract #: 04-0120F4Cty: SF/ALA Rte: 80 PM: 13.2/13.9File #: 13.28**WELDING INSPECTION REPORT****Resident Engineer:** Pursell, Gary**Address:** 333 Burma Road**City:** Oakland, CA 94607**Report No:** WIR-007935**Date Inspected:** 24-Jul-2009**Project Name:** SAS Superstructure**OSM Arrival Time:** 700**Prime Contractor:** American Bridge/Fluor Enterprises, a JV**OSM Departure Time:** 1530**Contractor:** Oregon Iron Works Clackamas, Or.**Location:** Clackamas, OR**CWI Name:** Mike Gregson, Jose Salazar**CWI Present:** Yes No**Inspected CWI report:** Yes No N/A**Rod Oven in Use:** Yes No N/A**Electrode to specification:** Yes No N/A**Weld Procedures Followed:** Yes No N/A**Qualified Welders:** Yes No N/A**Verified Joint Fit-up:** Yes No N/A**Approved Drawings:** Yes No N/A**Approved WPS:** Yes No N/A**Delayed / Cancelled:** Yes No N/A**Bridge No:** 34-0006**Component:** Hinge K Pipe Beams**Summary of Items Observed:**

The Quality Assurance Inspector Sean Vance arrived on site at Oregon Iron Works, Inc (OIW) in Clackamas, OR, to randomly observe the in process welding of the Hinge K Pipe Beam assemblies. The QA Inspector arrived on site to randomly obse

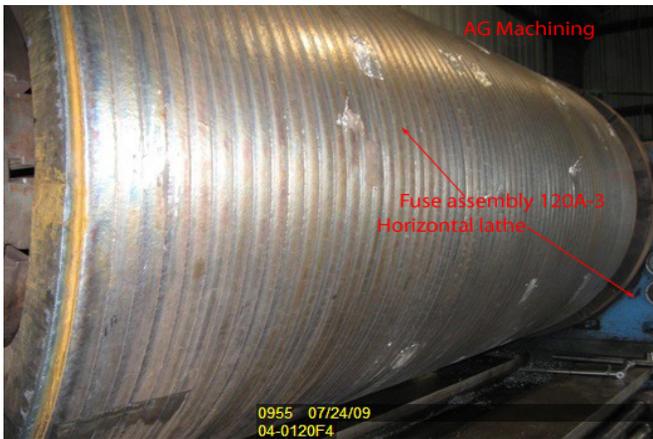
Hinge-K Pipe Beam Fuse Assembly 120A-3: 7/24/09

QA Inspector spoke with lead QC Inspector Mike Gregson and Mr. Gregson explained that OIW had previously loaded fuse assembly 120A-3 on a trailer and was in process of transferring fuse assembly to AG Machining, for final machining on the exterior ESW overlay. QA Inspector arrived at AG Machining at approximately 1000 hrs. and noticed that the fuse assembly 120A-3 had previously arrived and had been placed in the horizontal lathe. QA Inspector spoke with AG Machinist and AG explained that machining would begin on 7/27/09 and end result machining would be completed, to a finished outside diameter measurement of 1925mm, per OIW Project Manager Bill Pender. See attached pictures below.
