DEPARTMENT OF TRANSPORTATION

Quality Assurance and Source Inspection

Contract #: 04-0120F4Cty: SF/ALA Rte: 80 PM: 13.2/13.9File #: 69.28**WELDING INSPECTION REPORT****Resident Engineer:** Pursell, Gary**Address:** 333 Burma Road**City:** Oakland, CA 94607**Report No:** WIR-008000**Date Inspected:** 05-Jul-2009**Project Name:** SAS Superstructure**OSM Arrival Time:** 1900**Prime Contractor:** American Bridge/Fluor Enterprises, a JV**OSM Departure Time:** 700**Contractor:** Zhenhua Port Machinery Company, Ltd (ZPMC), Changxing Island **Location:** Shanghai, China**CWI Name:** Zhang Zhi Neng**CWI Present:** Yes No**Inspected CWI report:** Yes No N/A**Rod Oven in Use:** Yes No N/A**Electrode to specification:** Yes No N/A**Weld Procedures Followed:** Yes No N/A**Qualified Welders:** Yes No N/A**Verified Joint Fit-up:** Yes No N/A**Approved Drawings:** Yes No N/A**Approved WPS:** Yes No N/A**Delayed / Cancelled:** Yes No N/A**Bridge No:** 34-0006**Component:** Tower&OBG**Summary of Items Observed:**

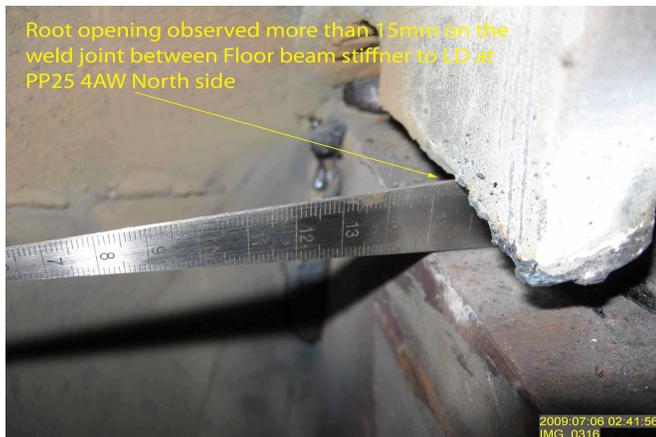
During the random visual inspection this Caltrans QA Inspector observed the root opening between floor beam stiffener to short Longitudinal Diaphragm more than 15mm at PP25 in segment 4AW North side. According to ZPMC CWI this joint is CJP but ZPMC performed welding without making groove. For additional information see photo below. For this issue informed to task leader and other supervisor.

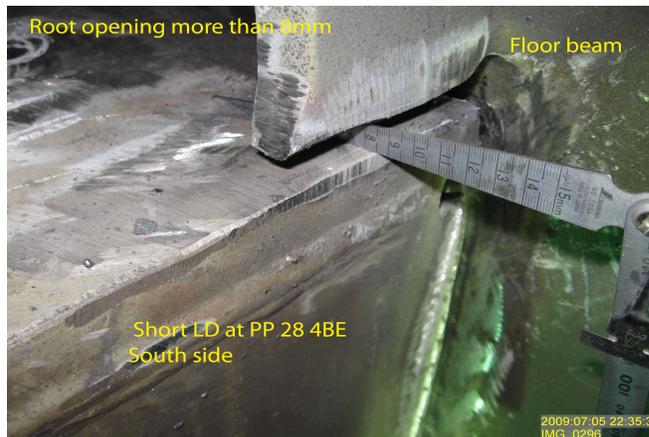
During the random Visual inspection this Caltrans QA Inspector observed the root opening between floor beam stiffener to Longitudinal Diaphragm more than 8mm at PP28 in segment 4BE South side. According to ZPMC CWI this joint is CJP but ZPMC performed welding without making groove. For additional information see photo below.

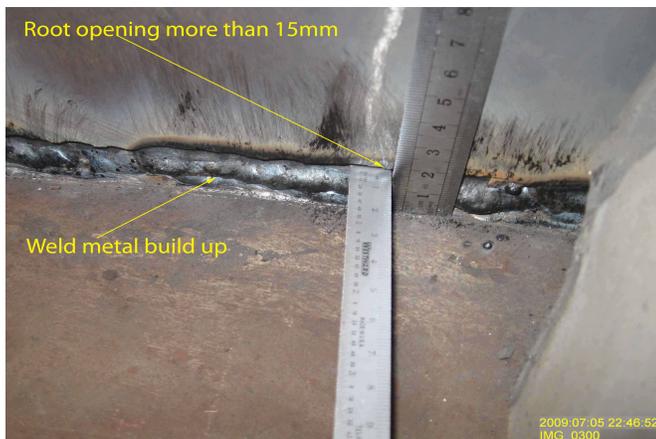
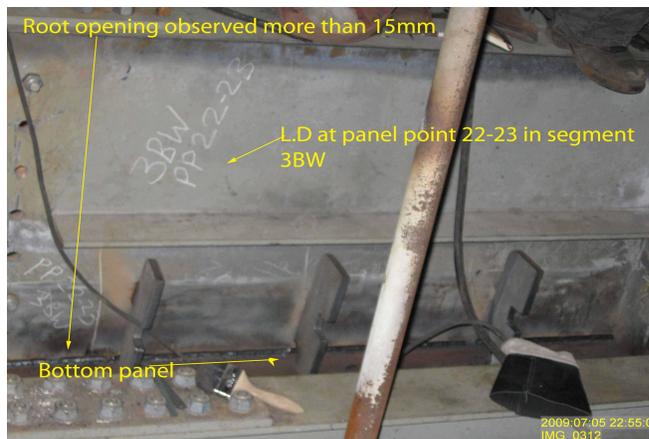
During random in-process visual inspection in trial assembly of segment 3BW, Caltrans Quality Assurance (QA) Inspector observed the root opening of the weld joint between Longitudinal Diaphragm to Bottom panel (SEG013B-15, 16) to be more than 15mm. This root opening exceeds the tolerances specified in AWS D1.5 2002. Incident report issued. For additional information see photo below.
