DEPARTMENT OF TRANSPORTATION

Quality Assurance and Source Inspection

Contract #: 04-0120F4Cty: SF/ALA Rte: 80 PM: 13.2/13.9File #: 69.28**WELDING INSPECTION REPORT****Resident Engineer:** Pursell, Gary**Address:** 333 Burma Road**City:** Oakland, CA 94607**Report No:** WIR-008464**Date Inspected:** 14-Aug-2009**Project Name:** SAS Superstructure**OSM Arrival Time:** 700**Prime Contractor:** American Bridge/Fluor Enterprises, a JV**OSM Departure Time:** 1900**Contractor:** Zhenhua Port Machinery Company, Ltd (ZPMC), Changxing Island **Location:** Shanghai, China**CWI Name:** Lv Li Qing / Shen Fu You**CWI Present:** Yes No**Inspected CWI report:** Yes No N/A**Rod Oven in Use:** Yes No N/A**Electrode to specification:** Yes No N/A**Weld Procedures Followed:** Yes No N/A**Qualified Welders:** Yes No N/A**Verified Joint Fit-up:** Yes No N/A**Approved Drawings:** Yes No N/A**Approved WPS:** Yes No N/A**Delayed / Cancelled:** Yes No N/A**Bridge No:** 34-0006**Component:** OBG Assembly**Summary of Items Observed:**

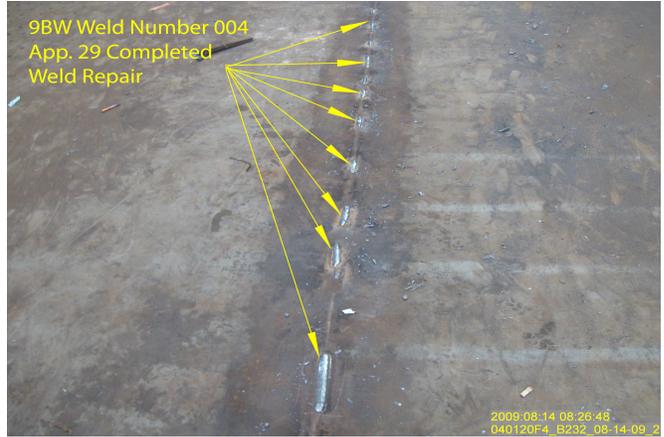
The QA inspector observed in assembly 9BW SEG051A weld number 004 which is Bottom Panel (BP) BP44A welded to BP152A there was approximately 29 weld repairs completed by ZPMC. See photograph 040120F4_B2332_08-14-09_2 for additional information (not all 29 repairs could be shown in the Photograph)
