DEPARTMENT OF TRANSPORTATION

Contract #: 04-0120F4Cty: SF/ALA Rte: 80 PM: 13.2/13.9File #: 69.28**WELDING INSPECTION REPORT****Resident Engineer:** Pursell, Gary**Address:** 333 Burma Road**City:** Oakland, CA 94607**Report No:** WIR-008602**Date Inspected:** 05-Aug-2009**Project Name:** SAS Superstructure**OSM Arrival Time:** 700**Prime Contractor:** American Bridge/Fluor Enterprises, a JV**OSM Departure Time:** 1900**Contractor:** Zhenhua Port Machinery Company, Ltd (ZPMC), Changxing Island **Location:** Shanghai, China**CWI Name:** ZPMC and ABF**CWI Present:** Yes No**Inspected CWI report:** Yes No N/A**Rod Oven in Use:** Yes No N/A**Electrode to specification:** Yes No N/A**Weld Procedures Followed:** Yes No N/A**Qualified Welders:** Yes No N/A**Verified Joint Fit-up:** Yes No N/A**Approved Drawings:** Yes No N/A**Approved WPS:** Yes No N/A**Delayed / Cancelled:** Yes No N/A**Bridge No:** 34-0006**Component:** SAS Tower**Summary of Items Observed:**

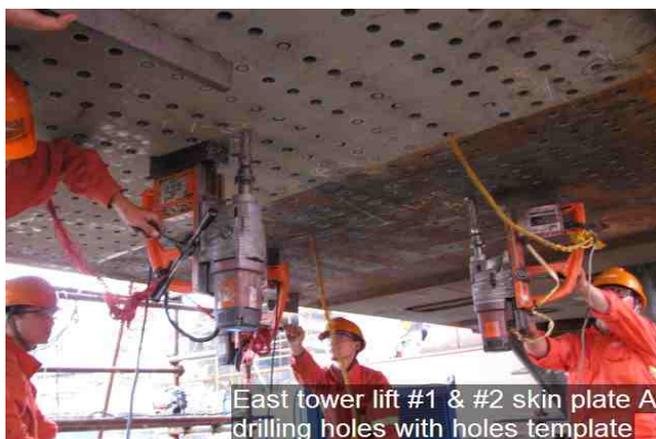
East Tower Lift #1 & #2:- Caltrans QA Inspector observed six ZPMC workers performed drilling process on two tower connection areas of the skin plate A for east tower lift #1 & #2. The holes template has been installed and secured by hold devices, the alignment of holes template has accepted by ZPMC and ABF prior drilling hole. The drilling process has cancelled approximately 1030 due to the heat from the sun affect the alignment of skin plates. Based on Caltrans QA inspector observations, no discrepancies were noted.

East tower lift #1 & #2 skin plate A drilling holes with holes template
