**DEPARTMENT OF TRANSPORTATION**

Contract #: 04-0120F4Cty: SF/ALA Rte: 80 PM: 13.2/13.9File #: 69.28**WELDING INSPECTION REPORT****Resident Engineer:** Pursell, Gary**Address:** 333 Burma Road**City:** Oakland, CA 94607**Report No:** WIR-008693**Date Inspected:** 30-Aug-2009**Project Name:** SAS Superstructure**OSM Arrival Time:** 700**Prime Contractor:** American Bridge/Fluor Enterprises, a JV**OSM Departure Time:** 1900**Contractor:** Zhenhua Port Machinery Company, Ltd (ZPMC), Changxing Island **Location:** Shanghai, China**CWI Name:** Lv Li Qing / Shen Fu You**CWI Present:** Yes No**Inspected CWI report:** Yes No N/A**Rod Oven in Use:** Yes No N/A**Electrode to specification:** Yes No N/A**Weld Procedures Followed:** Yes No N/A**Qualified Welders:** Yes No N/A**Verified Joint Fit-up:** Yes No N/A**Approved Drawings:** Yes No N/A**Approved WPS:** Yes No N/A**Delayed / Cancelled:** Yes No N/A**Bridge No:** 34-0006**Component:** OBG Assembly**Summary of Items Observed:**

# WELDING INSPECTION REPORT

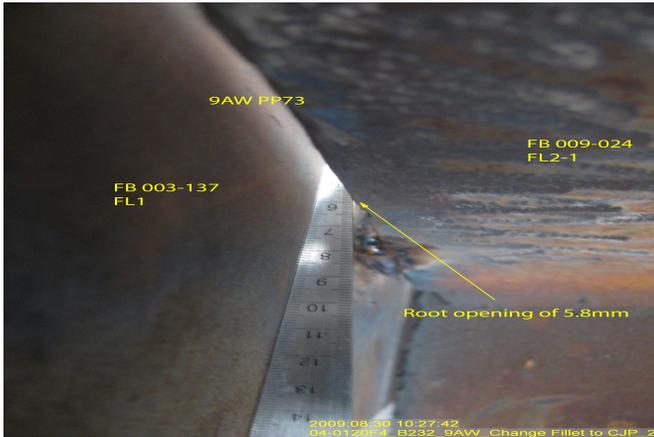
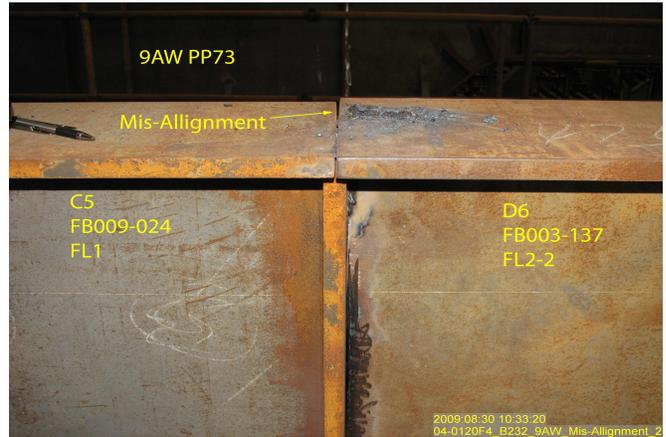
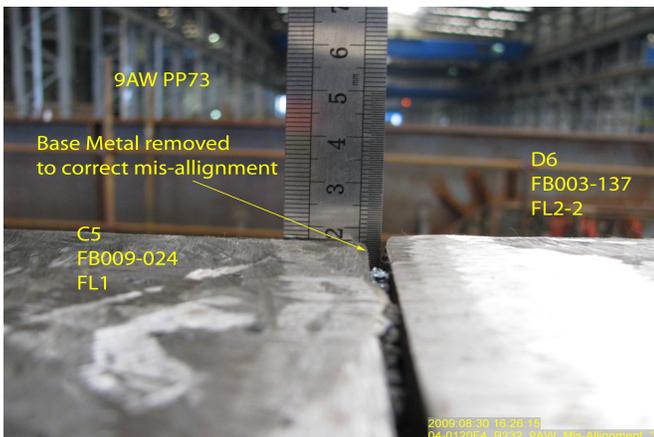
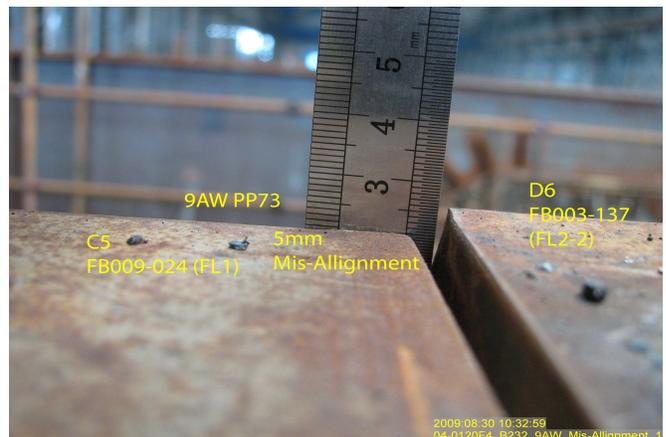
This Quality Assurance Inspector (QA) observed that it appears the contractor will deviate from the weld joint design specified on the approved drawings. The contractor appears to have Fit-Up Floor Beam located at Panel Point (PP) 73 with a root opening of greater than 5mm which will require a CJP weld and not a Fillet weld which is required on the approved drawings.. This condition exists in the following location; OBG segment 9AW @ PP073 for weld joining Floor Beam FB003-131 to Floor Beam FB016-029.

This Quality Assurance Inspector (QA) observed that the contractor corrected misalignment on 9AW PP73 Floor Beam FB009-024 (FL1) to FB009-137 (FL2-2) by removing base metal by grinding from FB003-137. Approximately 5mm of base metal was removed on FB003-137.

Flux Cored Arc Welding (FCAW) on floor beam (FL1) to floor beam (FL2-2) of weld joint SEG058 - SSD19 - PP83 for OBG assembly weld number 135 for Segment 9EE. The ZPMC welders identified as 055564 was welding in the 3G position. The ZPMC QC identified as Zhong Guo Hui was monitoring the welding and recording the weld variables. The welding variables recorded by ZPMC QC appeared to comply with the

Flux Cored Arc Welding (FCAW) on floor beam (FL1) to floor beam (FL2-2) of weld joint SEG058 - SSD19A - PP83 for OBG assembly weld number 131 for Segment 9EE. The ZPMC welders identified as 055564 was welding in the 3G position. The ZPMC QC identified as Zhong Guo Hui was monitoring the welding and recording the weld variables. The welding variables recorded by ZPMC QC appeared to comply with the WPS-B-T-2233-B-U2-F.

Flux Cored Arc Welding (FCAW) on Longitudinal Diaphragm to bottom panel of weld joint SEG056C for OBG assembly weld number 038 and 039 for Segment 9DE. The ZPMC welders identified as 214945 was welding in the 2F position. The ZPMC QC identified as Zhong Guo Hui was monitoring the welding and recording the weld variables. The welding variables recorded by ZPMC QC appeared to comply with the WPS-B-T-2132.
