Contract #: 04-0120F4Cty: SF/ALA Rte: 80 PM: 13.2/13.9File #: 13.28**WELDING INSPECTION REPORT****Resident Engineer:** Pursell, Gary**Address:** 333 Burma Road**City:** Oakland, CA 94607**Report No:** WIR-008879**Date Inspected:** 08-Sep-2009**Project Name:** SAS Superstructure**OSM Arrival Time:** 1300**Prime Contractor:** American Bridge/Fluor Enterprises, a JV**OSM Departure Time:** 2130**Contractor:** Oregon Iron Works Clackamas, Or.**Location:** Clackamas, OR**CWI Name:** Mike Gregson, Jose Salazar**CWI Present:** Yes No**Inspected CWI report:** Yes No N/A**Rod Oven in Use:** Yes No N/A**Electrode to specification:** Yes No N/A**Weld Procedures Followed:** Yes No N/A**Qualified Welders:** Yes No N/A**Verified Joint Fit-up:** Yes No N/A**Approved Drawings:** Yes No N/A**Approved WPS:** Yes No N/A**Delayed / Cancelled:** Yes No N/A**Bridge No:** 34-0006**Component:** Hinge K Pipe Beams**Summary of Items Observed:**

Hinge-K Pipe Beam Assembly 102A-1: 9/8/09

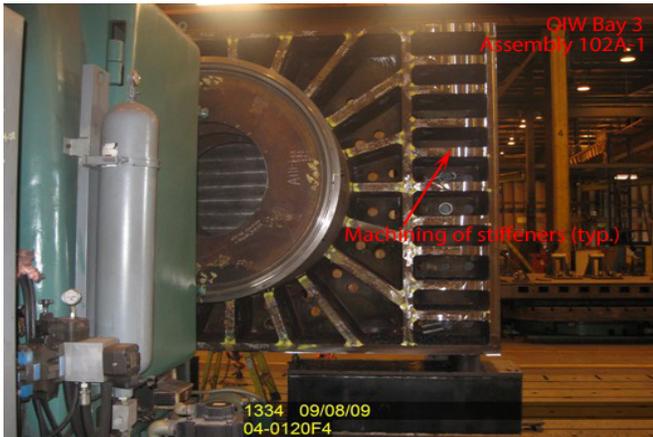
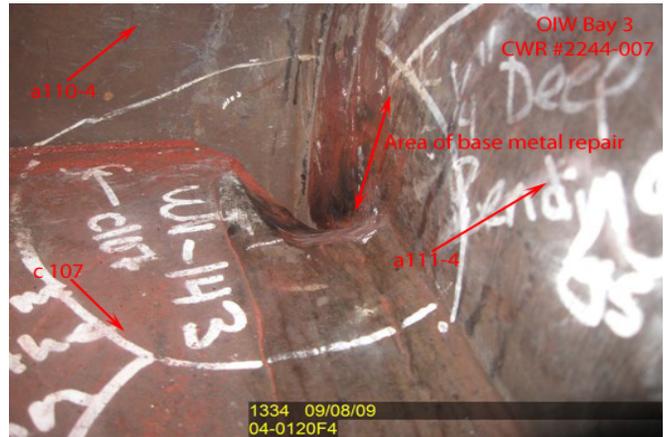
QA Inspector noticed that OIW had previously placed this forging assembly 102A-1 in position and was in-process of machining the completed stiffeners, utilizing a mechanical machining bit, as shown in attached picture below. QA Inspector had previously measured the stiffener heights to be approximately 662mm and noted that approximately 12mm of material (485W) was in process of being removed, to achieve a desired result of 650mm (+3mm/-10mm), which is in accordance to contract requirements. QA Inspector spoke with OIW machinist and OIW explained that the mechanical machining bit was set to remove approximately 1/32" (.8mm) of material (485W), per each cutting pass. QA Inspector noted that once the machining process is complete, OIW will perform dimensional measurements utilizing a laser tracker, prior to fitting the a109 (Post Tension Cap) plates. See attached picture below.
