**DEPARTMENT OF TRANSPORTATION**

Contract #: 04-0120F4Cty: SF/ALA Rte: 80 PM: 13.2/13.9File #: 69.28**WELDING INSPECTION REPORT****Resident Engineer:** Pursell, Gary**Address:** 333 Burma Road**City:** Oakland, CA 94607**Report No:** WIR-009203**Date Inspected:** 13-Sep-2009**Project Name:** SAS Superstructure**OSM Arrival Time:** 1845**Prime Contractor:** American Bridge/Fluor Enterprises, a JV**OSM Departure Time:** 645**Contractor:** Zhenhua Port Machinery Company, Ltd (ZPMC), Changxing Island **Location:** Shanghai, China**CWI Name:** Shi Lin**CWI Present:** Yes No**Inspected CWI report:** Yes No N/A**Rod Oven in Use:** Yes No N/A**Electrode to specification:** Yes No N/A**Weld Procedures Followed:** Yes No N/A**Qualified Welders:** Yes No N/A**Verified Joint Fit-up:** Yes No N/A**Approved Drawings:** Yes No N/A**Approved WPS:** Yes No N/A**Delayed / Cancelled:** Yes No N/A**Bridge No:** 34-0006**Component:** OBG and Tower**Summary of Items Observed:**

**OBG Trial Assembly-**

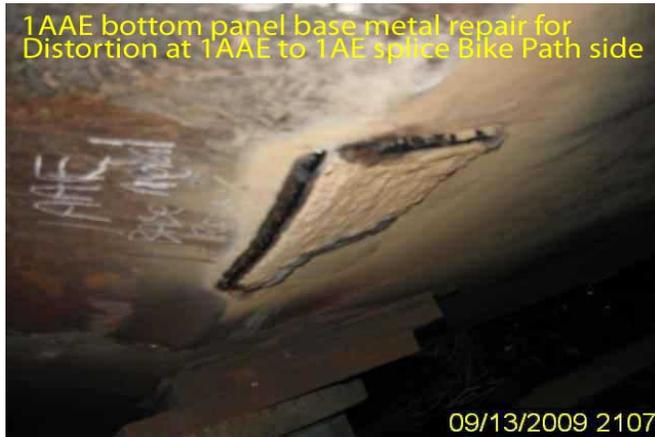
This Quality Control Inspector observed ZPMC personnel performing the following work: Shielded Metal Arc Welding of OBG segment 1AAE bottom panel base material adjacent to 1AAE to 1AE transverse Splice weld (bike path side) and 1AE side panel base material adjacent to the bottom panel to Side panel longitudinal splice weld. The welding appeared to be for correcting distortion. Caltrans QA generated an incident report for this date. The welder was identified as 045196. ZPMC QC was identified as Shi Lin. The welding procedure specification listed on the Weld repair report 7493 and 7494 was WPS-345-SMAW-4G (4F)-FCM Repair. See attached photograph.
