DEPARTMENT OF TRANSPORTATION

Contract #: 04-0120F4Cty: SF/ALA Rte: 80 PM: 13.2/13.9File #: 69.28**WELDING INSPECTION REPORT****Resident Engineer:** Pursell, Gary**Address:** 333 Burma Road**City:** Oakland, CA 94607**Report No:** WIR-009279**Date Inspected:** 24-Sep-2009**Project Name:** SAS Superstructure**OSM Arrival Time:** 700**Prime Contractor:** American Bridge/Fluor Enterprises, a JV**OSM Departure Time:** 1900**Contractor:** Zhenhua Port Machinery Company, Ltd (ZPMC), Changxing Island **Location:** Shanghai, China**CWI Name:** Chen Xi**CWI Present:** Yes No**Inspected CWI report:** Yes No N/A**Rod Oven in Use:** Yes No N/A**Electrode to specification:** Yes No N/A**Weld Procedures Followed:** Yes No N/A**Qualified Welders:** Yes No N/A**Verified Joint Fit-up:** Yes No N/A**Approved Drawings:** Yes No N/A**Approved WPS:** Yes No N/A**Delayed / Cancelled:** Yes No N/A**Bridge No:** 34-0006**Component:** OBG Crossbeams**Summary of Items Observed:**

OBG CROSS BEAM CB1

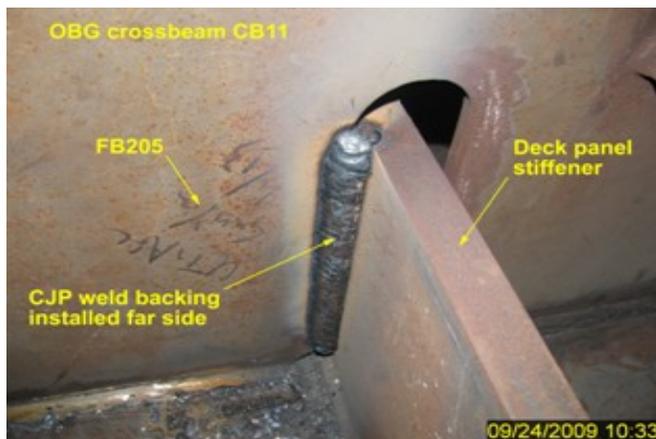
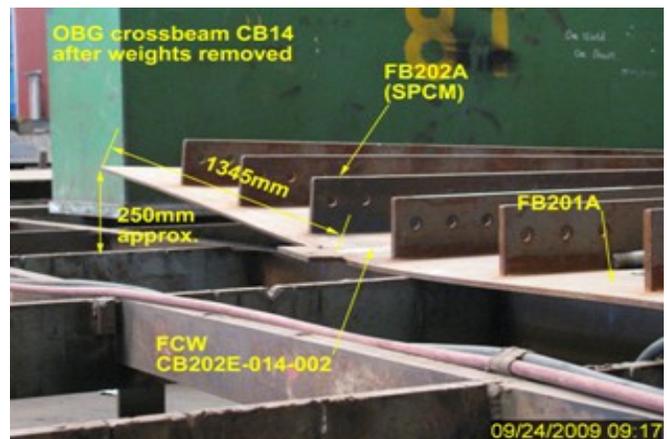
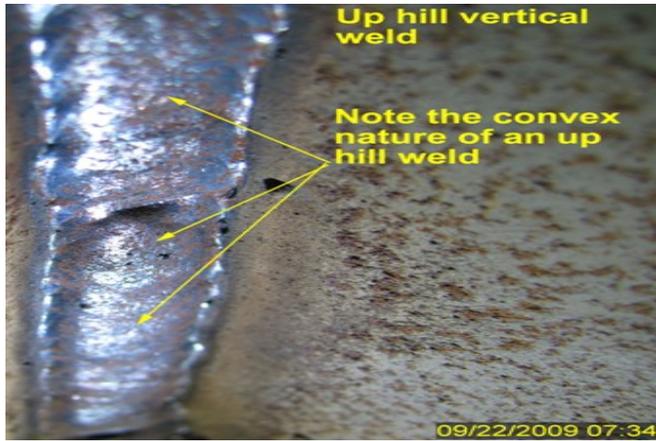
This QA observed that the contractor appears to have deviated from the weld joint design specified on the approved drawings. The contractor appears to have changed the weld joints from fillet welds to Complete Joint Penetration (CJP) welds without the Engineers approval. According to the contractors QC inspector, the weld design was changed in order to compensate for a joint root opening in excess of 5mm. The QA inspector observed that the contractors welding personnel have welded the following weld joints from one side with the backing still in place: CB202G-030-021 and 023, CB202G-031-001 and 002, CB202G-029-030 and 031, CB202G-030-001 and 002. AWS D1.5 2002 section 3.3.1 states "The parts to be joined by fillet welds shall be brought into as close contact as practicable. The root opening shall not exceed 5 mm"... AWS D1.5 2002 section 3.7.4 states "Prior approval of the Engineer shall be obtained for repairs to base metal (other than those required by 3.2), repair of major or delayed cracks, repairs to ESW and EGW welds with internal defects, or for a revised design to compensate for deficiencies". State letter No. 05.03.01-004548 dated July 01, 2009 Submittal 200, Rev. 2-Update 1 specifies; "Submit weld maps of all locations where "The out of tolerance assembly gap of T-shaped joint" procedure has been previously utilized for the Engineer to evaluate their suitability" and "Repair procedures require the Engineer's approval prior to each case of repair". This QA notified ABF inspector identified as Mr. Kelvin Cheung and ZPMC QA identified as Mr. Zhang Wei that an incident report would be generated for this issue. See attached photos.

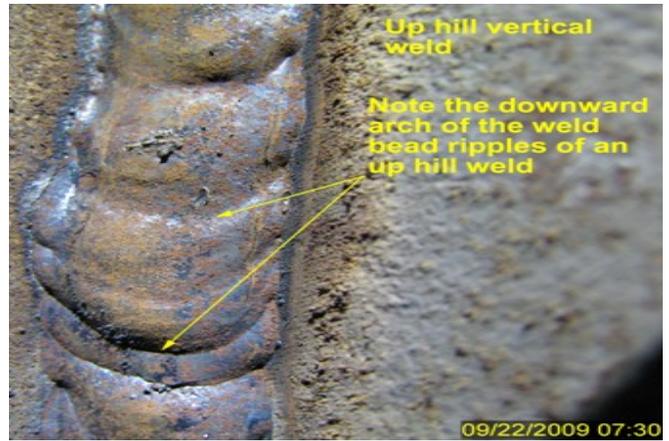
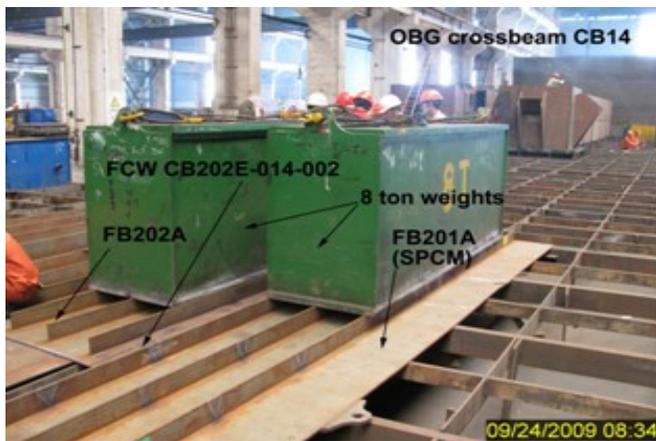
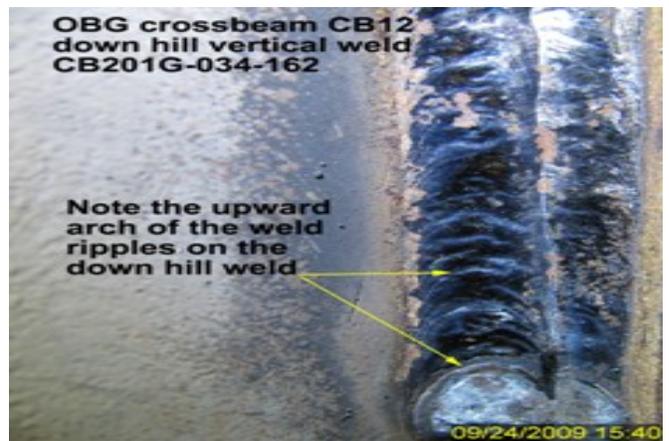
During random in process Visual Testing (VT) of the above mentioned crossbeam this Quality Assurance Inspector (QA) observed that the contractors welding personnel appears to have performed 7 vertical weld repairs in a downward progression. The repair welds appeared to exhibit typical visual characteristics of a weld performed in a downward progression. The welds are identified as CB201G-034-161, CB201G-035-143, 161, 145 and CB201G-036-163. AWS D1.5 2002 section 4.6.8 states "The progression for all passes in the vertical position shall be upward, unless a downward progression is qualified by tests approved by the Engineer". This QA notified ABF inspector identified as Mr. Kelvin Cheung and ZPMC QA identified as Mr. Zhang Wei that an incident report would be generated for this issue. VT of this crossbeam also revealed numerous welds that appeared to be non compliant to the contract documents. See attached photos for details.

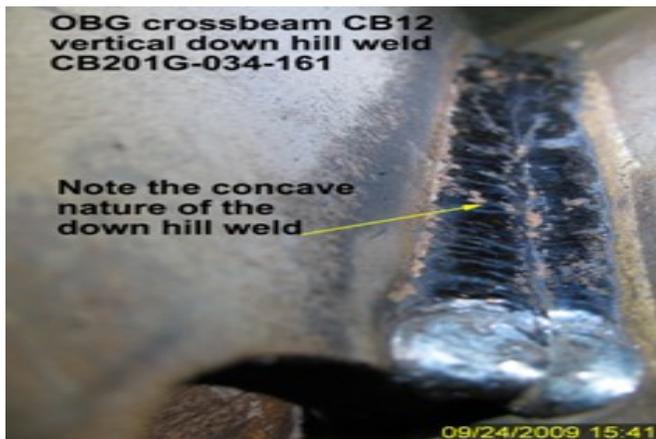
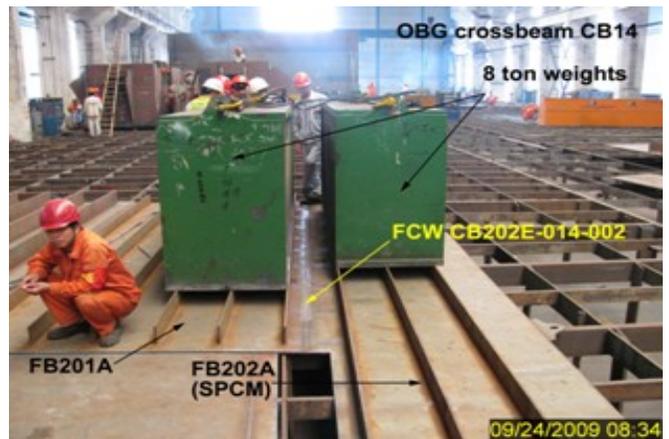
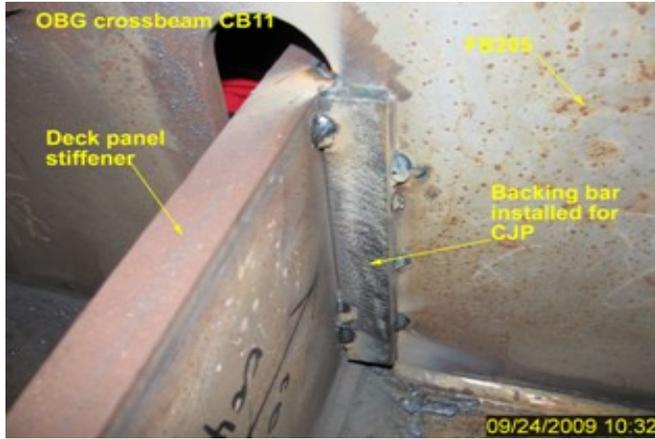
This QA observed that the contractor appeared to be “cold bending” Seismic Performance Critical Material (SPCM) and a Fracture Critical Weld (FCW). This QA observed two eight (8) ton weights had been placed on the material near the FCW. The weights appeared to be for the purpose of correcting excessive weld distortion of the material. The SPCM is identified as FB202A. The FCW joint is identified as CB202E-014-002. This QA previously issued two incident reports concerning this same condition for the same component and weld dated 09/18/09 and 09/20/09. AWS D1.5 2002 section 12.12 states “Cold bending shall be prohibited for all fracture critical steels”. This QA notified ABF inspector identified as Mr. Wang Wen Bin and ZPMC QC CWI identified as Mr. Chen Xi of the above mentioned issue and that an incident report would be generated. See attached photos for details.
