DEPARTMENT OF TRANSPORTATION

Contract #: 04-0120F4Cty: SF/ALA Rte: 80 PM: 13.2/13.9File #: 69.28**WELDING INSPECTION REPORT****Resident Engineer:** Pursell, Gary**Address:** 333 Burma Road**City:** Oakland, CA 94607**Report No:** WIR-009286**Date Inspected:** 30-Sep-2009**Project Name:** SAS Superstructure**OSM Arrival Time:** 700**Prime Contractor:** American Bridge/Fluor Enterprises, a JV**OSM Departure Time:** 1900**Contractor:** Zhenhua Port Machinery Company, Ltd (ZPMC), Changxing Island **Location:** Shanghai, China**CWI Name:** Chen Xi**CWI Present:** Yes No**Inspected CWI report:** Yes No N/A**Rod Oven in Use:** Yes No N/A**Electrode to specification:** Yes No N/A**Weld Procedures Followed:** Yes No N/A**Qualified Welders:** Yes No N/A**Verified Joint Fit-up:** Yes No N/A**Approved Drawings:** Yes No N/A**Approved WPS:** Yes No N/A**Delayed / Cancelled:** Yes No N/A**Bridge No:** 34-0006**Component:** OBG Crossbeams**Summary of Items Observed:**

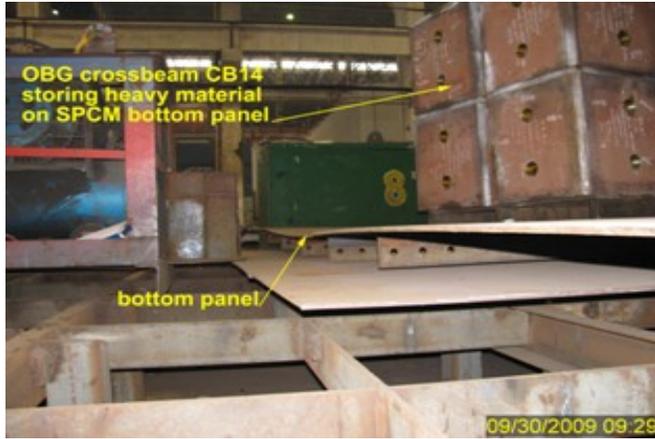
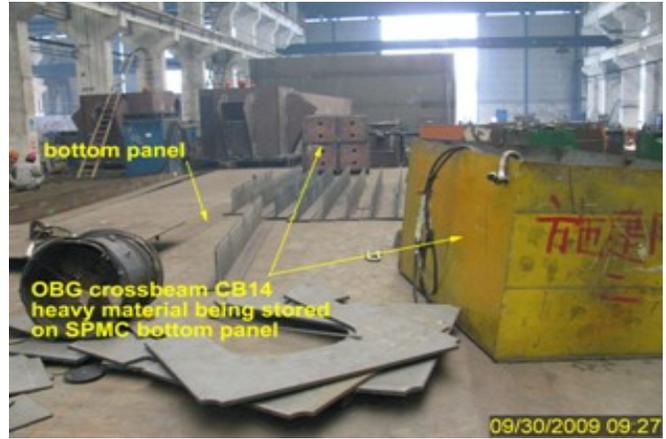
This QA observed that the contractor was storing heavy material on top of the SPCM bottom panel for this crossbeam. This QA took photos of the storage issue and informed ABF inspector identified as Mr. Wang Wen Bin of the issue. Mr. Wang instructed ZPMC workers to remove the materials from the panel. After the material was removed this QA noted that no apparent damage was done to the panel. This QA asked Mr. Wang to discourage the workers from storing other material on top of Caltrans material as this is in violation of the contract documents.
