DEPARTMENT OF TRANSPORTATION

Quality Assurance and Source Inspection

Contract #: 04-0120F4Cty: SF/ALA Rte: 80 PM: 13.2/13.9File #: 13.28**WELDING INSPECTION REPORT****Resident Engineer:** Pursell, Gary**Address:** 333 Burma Road**City:** Oakland, CA 94607**Report No:** WIR-009525**Date Inspected:** 09-Oct-2009**Project Name:** SAS Superstructure**OSM Arrival Time:** 700**Prime Contractor:** American Bridge/Fluor Enterprises, a JV**OSM Departure Time:** 1530**Contractor:** Oregon Iron Works Clackamas, Or.**Location:** Clackamas, OR**CWI Name:** Mike Gregson, Jose Salazar**CWI Present:** Yes No**Inspected CWI report:** Yes No N/A**Rod Oven in Use:** Yes No N/A**Electrode to specification:** Yes No N/A**Weld Procedures Followed:** Yes No N/A**Qualified Welders:** Yes No N/A**Verified Joint Fit-up:** Yes No N/A**Approved Drawings:** Yes No N/A**Approved WPS:** Yes No N/A**Delayed / Cancelled:** Yes No N/A**Bridge No:** 34-0006**Component:** Hinge K Pipe Beams**Summary of Items Observed:**

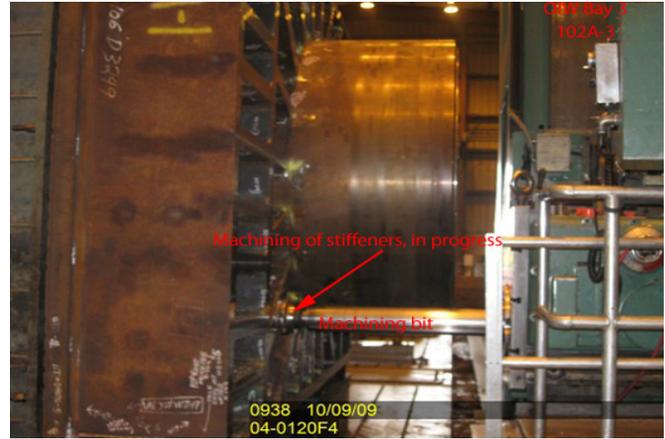
Hinge-K Pipe Beam Assembly 102A-3: 10/9/09

QA Inspector noticed this assembly 102A-3 had been previously placed in position and welder #J6, Mr. Craig

Jacobson, was in process of performing submerged arc welding, on the c107 radial stiffener plate to a111-3 tubular forging, designated as weld joint #W1-163, in the flat position. QA Inspector noted that this weld joint was designated as a partial joint penetration (AWS D1.5 TC-P5-S) and QA Inspector noted that Mr. Jacobson was currently performing the submerged arc welding on the root pass. QA Inspector noted that Mr. Jacobson was utilizing OIW approved welding procedure specification (WPS 4016) and randomly recorded pre-heat temperatures of approximately 350 degrees Fahrenheit (177 C) and in-process welding parameters of 420 amps/30 volts. QA Inspector noticed QC Inspector Jose Salazar was present to monitor in-process welding parameters (amps/volts) and noted that Mr. Salazar had previously recorded in-process welding parameters of 430 amps and 30 volts, which appears to be in-compliance with the applicable welding procedure specification (WPS 4016). QA Inspector later spoke with QC Inspector Jose Salazar and Mr. Salazar explained that the above mentioned weld joint, in addition to weld joint #161, was completed by Mr. Jacobson, by end of shift. Mr. Salazar explained that 100% magnetic particle testing was performed on the completed weld joint root passes and no rejectable indications were found, per AWS D1.5 and contract requirements. See attached picture below.

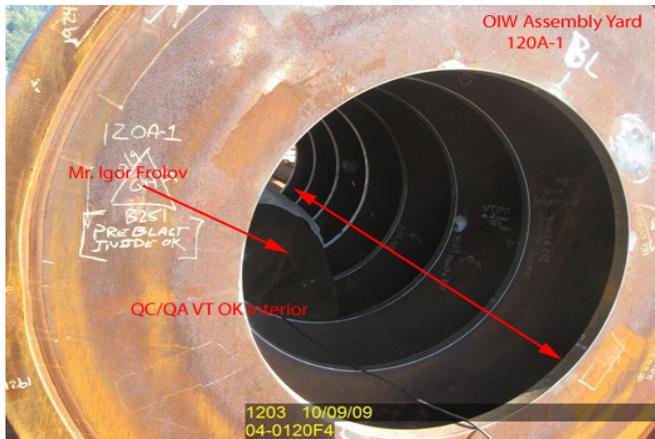
Hinge-K Pipe Beam Fuse Assembly 120A-1 and Hinge-K Pipe Beam Fuse Assembly 120A-7: 10/9/09
a124-5 Half Fuse to a124-15 Half Fuse and a124-6 Half Fuse to a124-7 Half Fuse

QA Inspector spoke with QC Inspector Jose Salazar and Mr. Salazar explained that welder #F17, Mr. Igor Frolov, was currently in-process, of performing the weld clean-up and grinding, on the previously marked interior of fuse assemblies 120A-1 and 120A-7. Mr. Salazar explained to QA Inspector that additional weld clean-up, on the interior base metal/ring stiffeners, would be needed, prior to transfer to OIW Vancouver painting facility, to meet the criteria of AWS D1.5 and contract requirements. Mr. Salazar explained that the interior areas that were marked up included weld blending, excessive weld spatter, sharp edges and various minor base metal gauges, to be blended and transitioned on the fuse assembly base metal and interior stiffener rings.

Note: QC Inspector Jose Salazar later notified QA Inspector that welder #F17, Mr. Igor Frolov had completed the weld-clean up on the previously marked areas on these fuse assemblies 120A-1/120A-7 and Mr. Salazar had verified that the work had been completed and visually accepted these above mentioned fuse assemblies. QA Inspector also verified that the previously marked up areas by Mr. Salazar had been completed and noted additional interior weld spatter, to be removed. QA Inspector informed Mr. Frolov of the additional weld spatter that needed to be removed and QA Inspector witnessed Mr. Frolov performing this.
