Contract #: 04-0120F4Cty: SF/Ala Rte: 80 PM: 13.2/13.9File #: 69.28**WELDING INSPECTION REPORT****Resident Engineer:** Pursell, Gary**Address:** 333 Burma Road**City:** Oakland, CA 94607**Report No:** WIR-009551**Date Inspected:** 09-Oct-2009**Project Name:** SAS Superstructure**OSM Arrival Time:** 1900**Prime Contractor:** American Bridge/Fluor Enterprises, a JV**OSM Departure Time:** 700**Contractor:** Zhenhua Port Machinery Company, Ltd (ZPMC), Changxing Island **Location:** Shanghai, China**CWI Name:** See below**CWI Present:** Yes No**Inspected CWI report:** Yes No N/A**Rod Oven in Use:** Yes No N/A**Electrode to specification:** Yes No N/A**Weld Procedures Followed:** Yes No N/A**Qualified Welders:** Yes No N/A**Verified Joint Fit-up:** Yes No N/A**Approved Drawings:** Yes No N/A**Approved WPS:** Yes No N/A**Delayed / Cancelled:** Yes No N/A**Bridge No:** 34-0006**Component:** Tower Components**Summary of Items Observed:**

WELDING INSPECTION REPORT

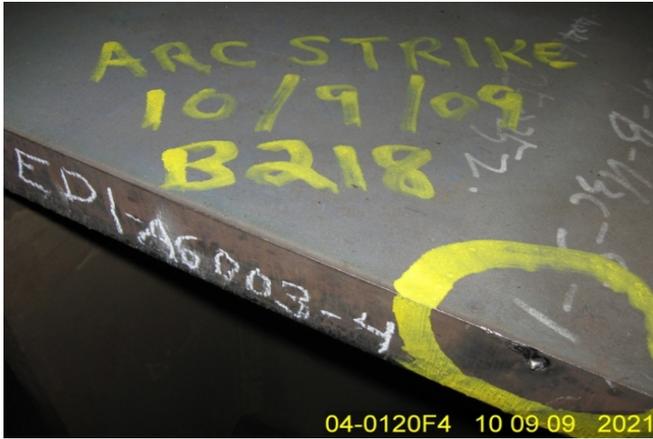
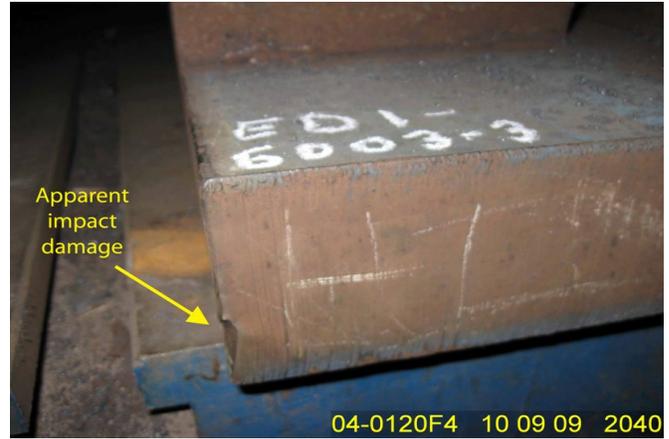
This QA Inspector observed tower struts with what appeared to be minor impact damage at the outer edges. The most significant damage observed was to the lower outer corner on PCMK ED1-6003-3. A photo of that damage can be seen below. An arc strike was also observed at the top middle edge on PCMK ED1-6003-4. These issues were brought to the attention of ABF Representative Xie Yan (ABF1). ABF1 told this QA Inspector that she was aware of these issues and informed this QA Inspector that these parts were not yet ready for inspection.
