Contract #: 04-0120F4Cty: SF/ALA Rte: 80 PM: 13.2/13.9File #: 69.28**WELDING INSPECTION REPORT****Resident Engineer:** Pursell, Gary**Address:** 333 Burma Road**City:** Oakland, CA 94607**Report No:** WIR-009638**Date Inspected:** 12-Oct-2009**Project Name:** SAS Superstructure**OSM Arrival Time:** 700**Prime Contractor:** American Bridge/Fluor Enterprises, a JV**OSM Departure Time:** 1900**Contractor:** Zhenhua Port Machinery Company, Ltd (ZPMC), Changxing Island **Location:** Shanghai, China**CWI Name:** Yu Dong Ping, Feng Guo.**CWI Present:** Yes No**Inspected CWI report:** Yes No N/A**Rod Oven in Use:** Yes No N/A**Electrode to specification:** Yes No N/A**Weld Procedures Followed:** Yes No N/A**Qualified Welders:** Yes No N/A**Verified Joint Fit-up:** Yes No N/A**Approved Drawings:** Yes No N/A**Approved WPS:** Yes No N/A**Delayed / Cancelled:** Yes No N/A**Bridge No:** 34-0006**Component:** Tower**Summary of Items Observed:**

Bay 11 Tower Connection Bracket

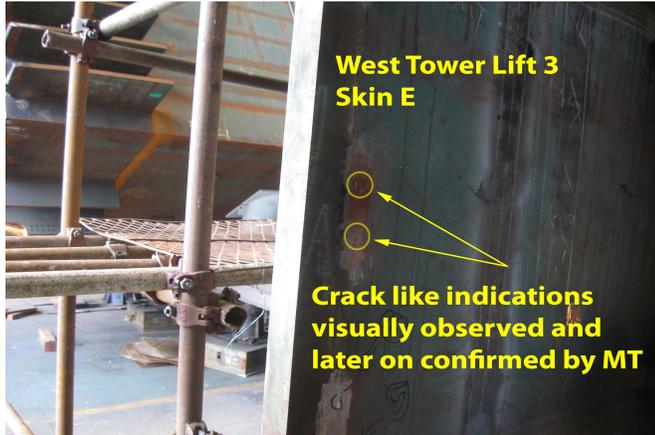
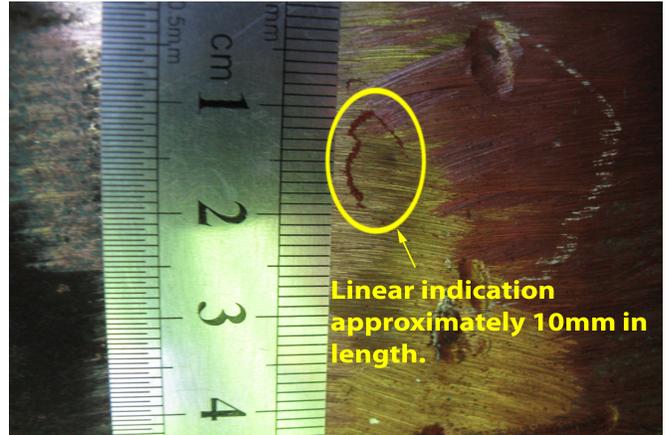
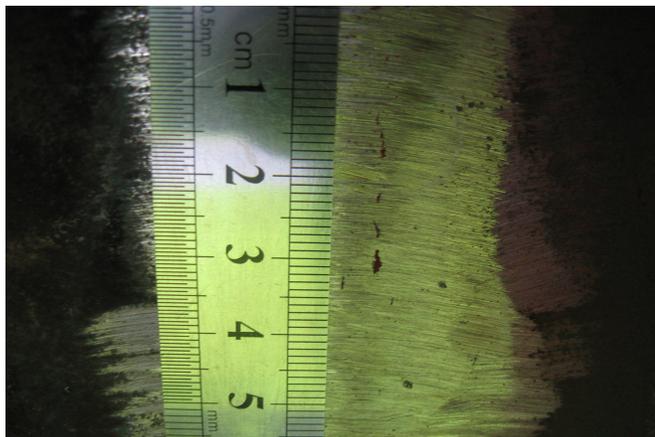
During random verification Visual Testing (VT), Caltrans Quality Assurance (QA) Inspector observed crack like indication on temporary weld removed area of skin E of west tower lift 3. After confirmation by MT, linear

indications observed.

The attached photographs provide additional detail.
