DEPARTMENT OF TRANSPORTATION

Quality Assurance and Source Inspection

Contract #: 04-0120F4Cty: SF/ALA Rte: 80 PM: 13.2/13.9File #: 69.28**WELDING INSPECTION REPORT****Resident Engineer:** Pursell, Gary**Address:** 333 Burma Road**City:** Oakland, CA 94607**Report No:** WIR-009675**Date Inspected:** 03-Sep-2009**Project Name:** SAS Superstructure**OSM Arrival Time:** 700**Prime Contractor:** American Bridge/Fluor Enterprises, a JV**OSM Departure Time:** 1900**Contractor:** Zhenhua Port Machinery Company, Ltd (ZPMC), Changxing Island **Location:** Shanghai, China**CWI Name:** ZPMC and ABF**CWI Present:** Yes No**Inspected CWI report:** Yes No N/A**Rod Oven in Use:** Yes No N/A**Electrode to specification:** Yes No N/A**Weld Procedures Followed:** Yes No N/A**Qualified Welders:** Yes No N/A**Verified Joint Fit-up:** Yes No N/A**Approved Drawings:** Yes No N/A**Approved WPS:** Yes No N/A**Delayed / Cancelled:** Yes No N/A**Bridge No:** 34-0006**Component:** SAS Tower**Summary of Items Observed:**

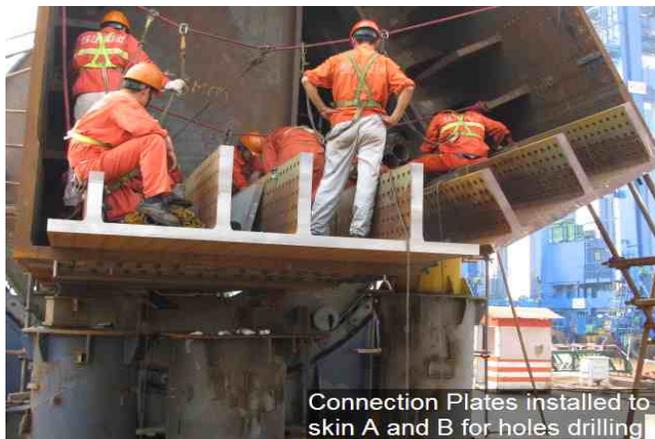
East Tower Lift #2:- Caltrans QA Inspector observed five ZPMC workers installed two connection plates which connect to skin plate B and C for holes drilling. The connection plates have been secured by few bolts and clamps prior drilling. The holes drilling process was monitored and recorded by ZPMC and ABF QC inspector. Based on Caltrans QA Inspector observations, no discrepancies were noted.

Connection Plates installed to skin A and B for holes drilling

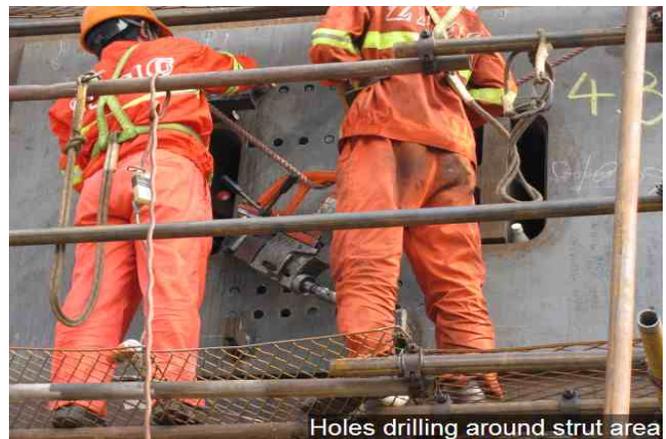
East Tower Lift #1:- Caltrans QA Inspector observed four ZPMC workers performed drilling process on two strut connection areas for the skin plate C of east tower lift #1. The holes template has been removed after holes has been marked and secured. The holes drilling process was monitored and recorded by ZPMC and ABF QC inspector. Based on Caltrans QA Inspector observations, no discrepancies were noted.

Holes drilling around strut area
