DEPARTMENT OF TRANSPORTATION

Contract #: 04-0120F4Cty: SF/ALA Rte: 80 PM: 13.2/13.9File #: 69.28**WELDING INSPECTION REPORT****Resident Engineer:** Pursell, Gary**Address:** 333 Burma Road**City:** Oakland, CA 94607**Report No:** WIR-009835**Date Inspected:** 26-Oct-2009**Project Name:** SAS Superstructure**OSM Arrival Time:** 1900**Prime Contractor:** American Bridge/Fluor Enterprises, a JV**OSM Departure Time:** 700**Contractor:** Zhenhua Port Machinery Company, Ltd (ZPMC), Changxing Island **Location:** Shanghai, China**CWI Name:** Shen Fu You, Li Jia**CWI Present:** Yes No**Inspected CWI report:** Yes No N/A**Rod Oven in Use:** Yes No N/A**Electrode to specification:** Yes No N/A**Weld Procedures Followed:** Yes No N/A**Qualified Welders:** Yes No N/A**Verified Joint Fit-up:** Yes No N/A**Approved Drawings:** Yes No N/A**Approved WPS:** Yes No N/A**Delayed / Cancelled:** Yes No N/A**Bridge No:** 34-0006**Component:** Tower/OBG**Summary of Items Observed:**

WELDING INSPECTION REPORT

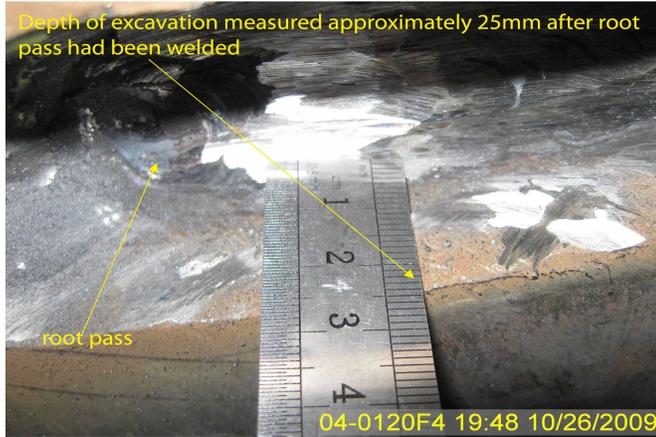
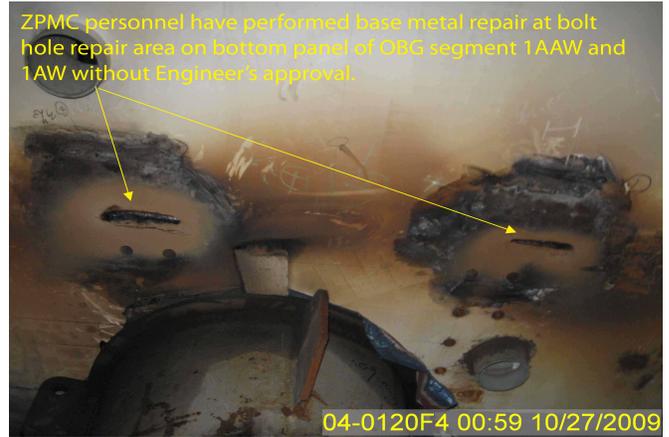
This Quality Assurance Inspector observed ZPMC personnel have performed base metal repairs at three different locations of bolt hole repair area on the bottom panel of OBG segment 1AAW and 1AW without Engineer's approval. The location of the repairs as below.

- 1) Location measured approximately 950mm from splice weld between OBG segment 1AAW and 1AW towards 1AAW and 1000mm from cross beam side.
- 2) Location measured 3000mm from splice weld between OBG segment 1AAW and 1AW towards 1AW and 650mm from counter weight side.
- 3) Location measured 4000mm from splice weld between OBG segment 1AAW and 1AW towards 1AW and

650mm from counter weight side.

For additional information see photos below. Incident report was issued for this issue.
