DEPARTMENT OF TRANSPORTATION

Contract #: 04-0120F4Cty: SF/ALA Rte: 80 PM: 13.2/13.9File #: 69.28**WELDING INSPECTION REPORT****Resident Engineer:** Pursell, Gary**Address:** 333 Burma Road**City:** Oakland, CA 94607**Report No:** WIR-009907**Date Inspected:** 09-Oct-2009**Project Name:** SAS Superstructure**OSM Arrival Time:** 645**Prime Contractor:** American Bridge/Fluor Enterprises, a JV**OSM Departure Time:** 1845**Contractor:** Zhenhua Port Machinery Company, Ltd (ZPMC), Changxing Island **Location:** Shanghai, China**CWI Name:** Zhan Bo, An Qin Xiang.**CWI Present:** Yes No**Inspected CWI report:** Yes No N/A**Rod Oven in Use:** Yes No N/A**Electrode to specification:** Yes No N/A**Weld Procedures Followed:** Yes No N/A**Qualified Welders:** Yes No N/A**Verified Joint Fit-up:** Yes No N/A**Approved Drawings:** Yes No N/A**Approved WPS:** Yes No N/A**Delayed / Cancelled:** Yes No N/A**Bridge No:** 34-0006**Component:** Tower Components**Summary of Items Observed:**

WELDING INSPECTION REPORT

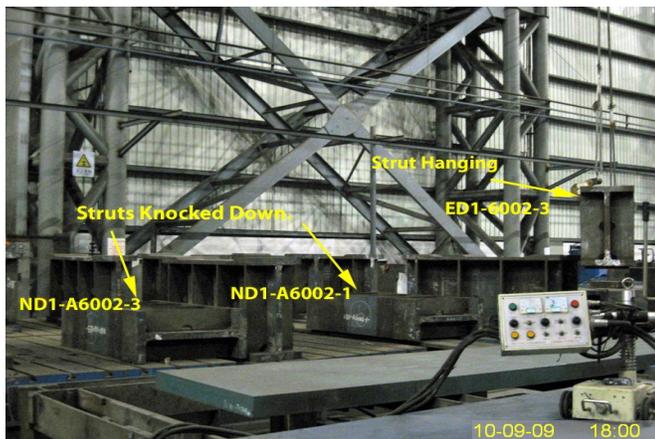
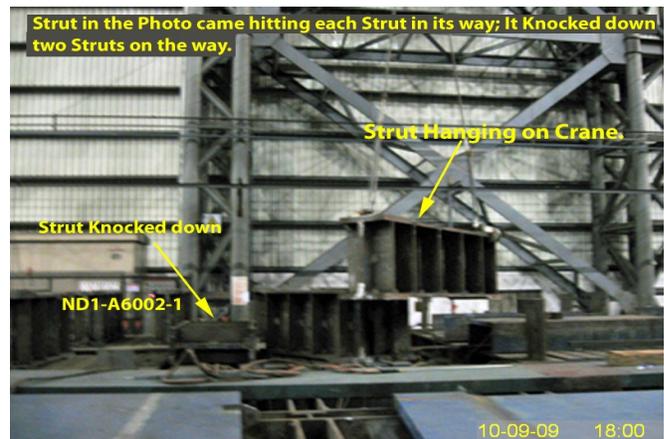
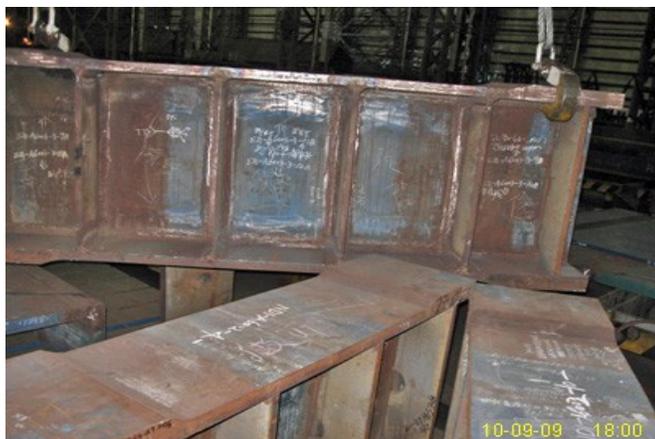
This Caltrans Quality Assurance (QA) Inspector observed ZPMC Crane operator lost control over crane while moving Srtut. Strut hanging hit several Struts in the way & Knocked down two(2) Struts Identified as ND1-A6002-3 & ND1-6002-1. No damages found on the other struts except few scratches. The strut which are knocked down to be checked for damages after ZPMC lift it up again. No incident report submitted on this issue. The attached photographs provide additional detail
