Contract #: 04-0120F4Cty: SF/ALA Rte: 80 PM: 13.2/13.9File #: 13.28**WELDING INSPECTION REPORT****Resident Engineer:** Pursell, Gary**Address:** 333 Burma Road**City:** Oakland, CA 94607**Report No:** WIR-009988**Date Inspected:** 02-Nov-2009**Project Name:** SAS Superstructure**OSM Arrival Time:** 700**Prime Contractor:** American Bridge/Fluor Enterprises, a JV**OSM Departure Time:** 1530**Contractor:** Oregon Iron Works Clackamas, Or.**Location:** Clackamas, OR

Bridge No: 34-0006**Component:** Hinge K Pipe Beams**Summary of Items Observed:**

Hinge-K Pipe Beam Assembly 102A-3: 11/2/09

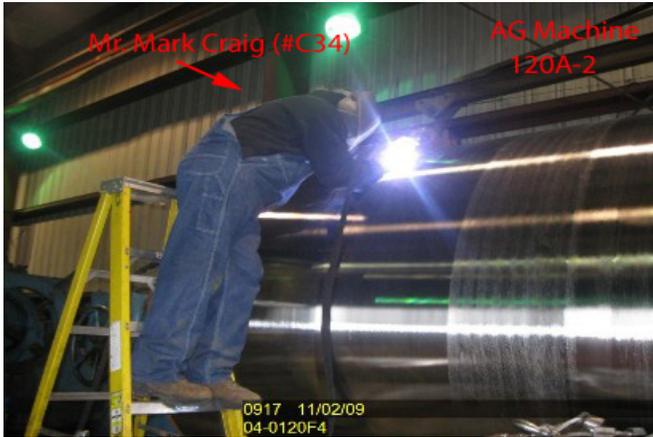
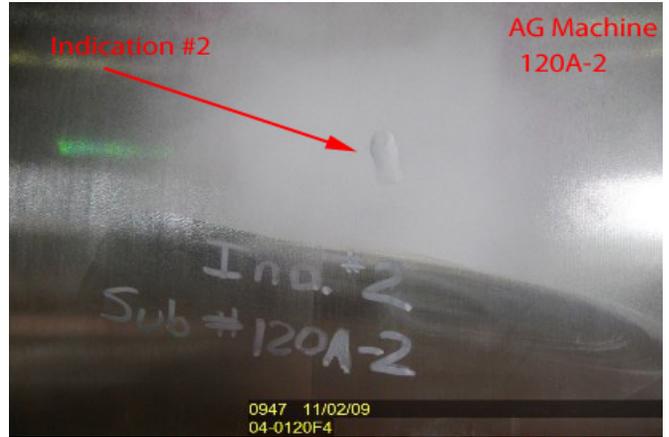
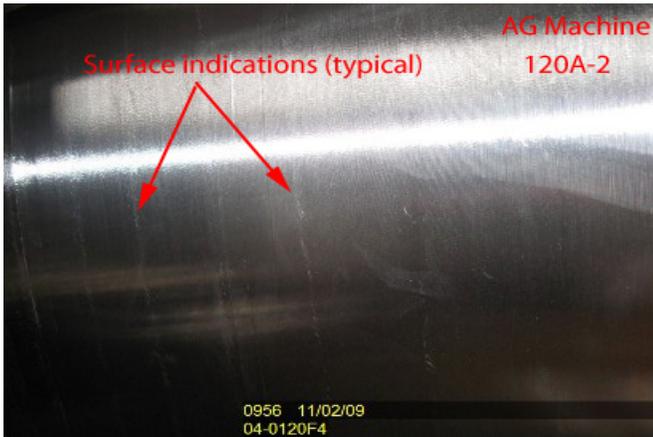
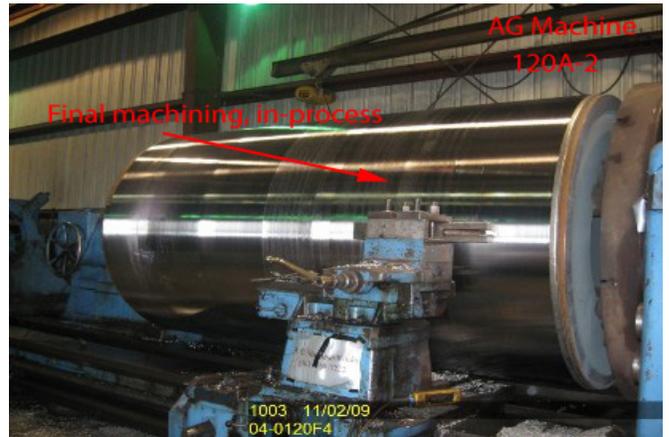
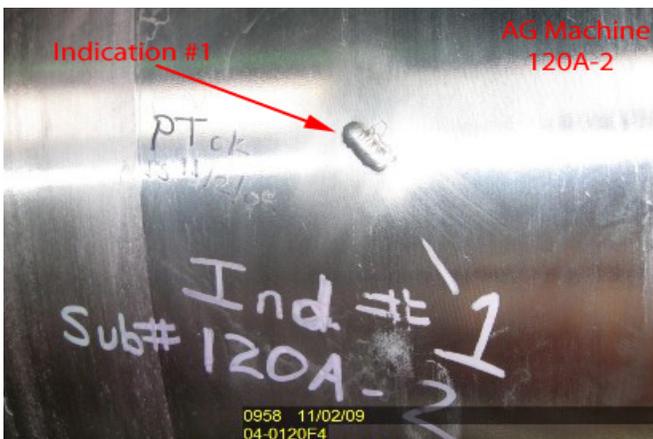
QA Inspector arrived at AG Machine, on this date and noted that OIW welder #C34, Mr. Mark Craig and OIW QC Inspector, Mr. Jose Salazar, had previously arrived at AG at approximately 0630 and were in process of performing the weld repairs, on the previously noted indications, on this fuse assembly 120A-2. QA Inspector spoke with QC Inspector Jose Salazar and Mr. Salazar explained that a total of 2 indications, previously noted by AG during the second final machining cut pass, had been excavated out, utilizing a mechanical grinder and Mr. Salazar had measured and labeled these excavated areas as indication #1 and indication #2. Mr. Salazar explained that he had previously taken measurements on the excavations, which were located on the a124-11 half fuse and these were recorded as follows: Indication #1-Depth of 1.5mm, length of 19mm and width of 6mm. Indication #2-Depth of 2.5mm, length of 21mm and width of 8mm. Mr. Salazar also explained to QA Inspector that 100% penetrant testing was performed and no rejectable indications were noted, on either excavation #1 or #2, per AWS D1.5. QA Inspector witnessed Mr. Craig preparing to set-up and start the gas tungsten arc welding (GTAW), on the 2 excavations, utilizing welding procedure specification, (WPS 8022) and that the fuse assembly 120A-2 was currently rotated in the horizontal lathe, so the 1st indication repair, would be performed in the flat position, per the applicable WPS 8022. QA Inspector witnessed and noted that prior to performing the GTAW, Mr. Craig had applied pre-heat to the weld repair area, (indication #1) and surrounding heat affected zone/base metal and QC Inspector Jose Salazar had recorded a pre-heat temperature of 150 degrees Fahrenheit (65 Celsius), utilizing a digital thermometer. QA Inspector witnessed and noted that Mr. Craig had started the GTAW on the area marked as indication #1 and Mr. Salazar was performing in-process welding parameter verifications of 121 amps/15.1 volts, which appears to be in compliance with the applicable WPS 8022. QA Inspector noted that Mr. Craig had soon completed the GTAW repair on indication #1 and had started the pre-heating on the excavation, labeled as indication #2. QA Inspector witnessed QC Inspector Jose Salazar performing a temperature check on the area and surrounding base metal and noted that the pre-heat was approximately 160 degrees Fahrenheit (71 Celsius). QA Inspector noted that the excavation, was then rotated to the flat position, in the horizontal lathe and Mr. Craig had then started the GTAW, on the repair. QA Inspector witnessed Jose Salazar performing and recording in-process welding parameters of 125 amps and 15.2 volts, which is in accordance to the applicable WPS 8022. QA Inspector noted that Mr. Craig had soon completed the second weld repair and QC Inspector Jose Salazar explained that once the repair areas cool to ambient temperature, 100% informational penetrant testing will then be performed, on the repairs. QA Inspector later witnessed Mr. Salazar performing the penetrant testing and noted that no rejectable indications were found, per AWS D1.5. QA Inspector noted that the above mentioned weld repairs that were performed by OIW personell at AG Machine shop, appeared to be in compliance with the applicable WPS 8020 and contract requirements. See attached pictures after the repairs were completed, below.

Note: QA Inspector previously noted that the above mentioned indications appeared to be small, circular slag inclusions that were deposited during the electroslag overlay welding process performed by OIW.

QA Inspector later spoke with AG machinist and AG explained that the 2nd cut pass would resume on 11/3/09 and any additional visual indications will be noted after finished and AG will then inform OIW personell and OIW will perform the required weld repairs at AG. QA Inspector was previously informed by AG that a third cut pass would be needed, set to a depth of approximately 1mm, utilizing a cutting bit and the final finish profile of .8µm will then be achieved, utilizing a “superfinisher” (a block of honing stones, for finishing).
