DEPARTMENT OF TRANSPORTATION

Contract #: 04-0120F4Cty: SF/ALA Rte: 80 PM: 13.2/13.9File #: 69.28**WELDING INSPECTION REPORT****Resident Engineer:** Pursell, Gary**Address:** 333 Burma Road**City:** Oakland, CA 94607**Report No:** WIR-010009**Date Inspected:** 31-Oct-2009**Project Name:** SAS Superstructure**OSM Arrival Time:** 1900**Prime Contractor:** American Bridge/Fluor Enterprises, a JV**OSM Departure Time:** 700**Contractor:** Zhenhua Port Machinery Company, Ltd (ZPMC), Changxing Island **Location:** Shanghai, China**CWI Name:** Wan Wen Zhong, Li Ming**CWI Present:** Yes No**Inspected CWI report:** Yes No N/A**Rod Oven in Use:** Yes No N/A**Electrode to specification:** Yes No N/A**Weld Procedures Followed:** Yes No N/A**Qualified Welders:** Yes No N/A**Verified Joint Fit-up:** Yes No N/A**Approved Drawings:** Yes No N/A**Approved WPS:** Yes No N/A**Delayed / Cancelled:** Yes No N/A**Bridge No:** 34-0006**Component:** Tower/OBG**Summary of Items Observed:**

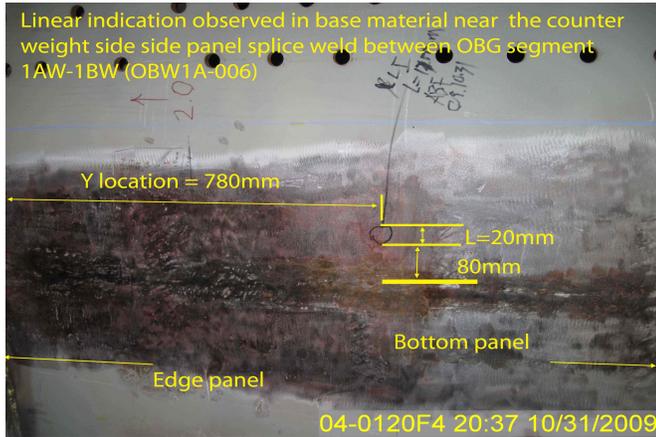
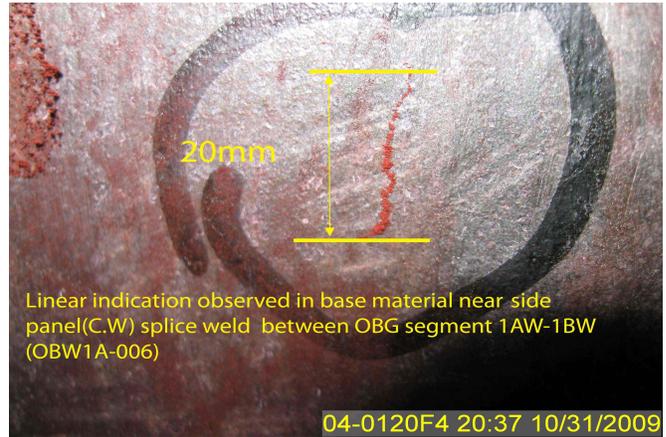
Magnetic Particle Testing (MT) performed on repair area portion of OBW 1A-007 and OBW1A-006. During the Magnetic Particle Inspection This QA identified ABF Inspector found one transverse linear indication which is in base material approximately 80mm away from the weld OBW1A-006. The 'Y' location measured approximately 780mm from counter weight side edge panel. The length of indication measured approximately 20mm. see the attached photo.
