DEPARTMENT OF TRANSPORTATION

Contract #: 04-0120F4Cty: SF/ALA Rte: 80 PM: 13.2/13.9File #: 13.28**WELDING INSPECTION REPORT****Resident Engineer:** Pursell, Gary**Address:** 333 Burma Road**City:** Oakland, CA 94607**Report No:** WIR-010017**Date Inspected:** 05-Nov-2009**Project Name:** SAS Superstructure**OSM Arrival Time:** 700**Prime Contractor:** American Bridge/Fluor Enterprises, a JV**OSM Departure Time:** 1530**Contractor:** Oregon Iron Works Clackamas, Or.**Location:** Clackamas, OR**CWI Name:** Mike Gregson, Jose Salazar**CWI Present:** Yes No**Inspected CWI report:** Yes No N/A**Rod Oven in Use:** Yes No N/A**Electrode to specification:** Yes No N/A**Weld Procedures Followed:** Yes No N/A**Qualified Welders:** Yes No N/A**Verified Joint Fit-up:** Yes No N/A**Approved Drawings:** Yes No N/A**Approved WPS:** Yes No N/A**Delayed / Cancelled:** Yes No N/A**Bridge No:** 34-0006**Component:** Hinge K Pipe Beams**Summary of Items Observed:**

Hinge-K Pipe Beam Assembly 102A-3: 11/5/09

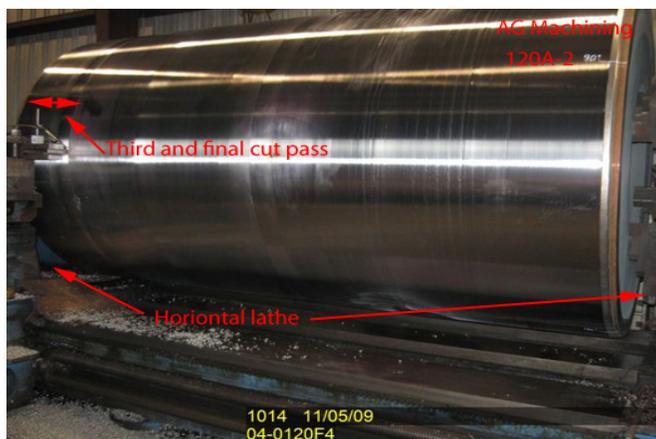
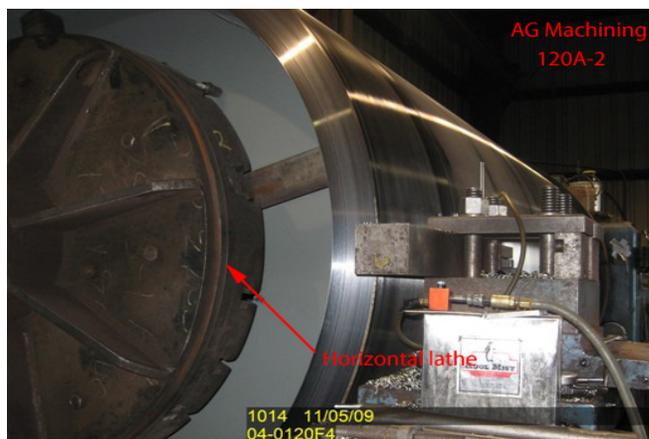
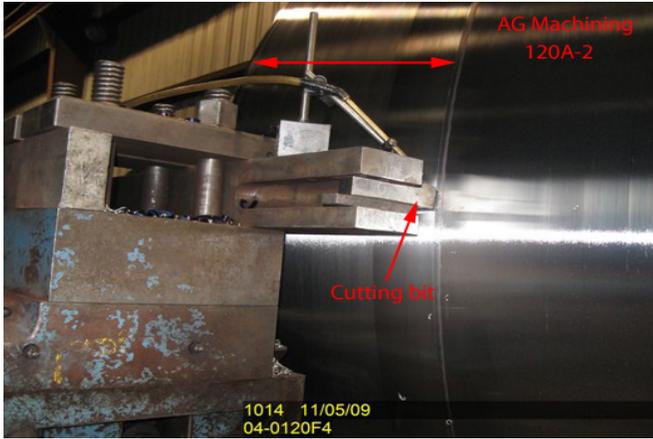
Hinge-K Pipe Beam Fuse Assembly 120A-2: 11/5/09

machining cut pass was in-process, on this fuse assembly 120A-2. AG explained that the final cut pass was set to approximately 1/32" (.6mm deep), to achieve a final outside diameter of 75.630" (1921mm), per contract requirements of 1920mm (+- 1mm) and was approximately 16" (406mm) into the cut. AG explained that approximately 8-10 visual inclusions were present, at this time, with depths of approximately 1mm and lengths of approximately 10-300mm. AG explained to QA Inspector that after the final machining cut pass was approximately 50% complete, AG will notify OIW PM Bill Pender of the results and OIW will decide how to proceed, with the remaining machining that is left. See attached pictures below.

Note: QA Inspector noted that after the above mentioned cut pass is complete, the final finish profile of .8µm will then be achieved, utilizing a "superfinisher" (a block of honing stones, for finishing).
