**DEPARTMENT OF TRANSPORTATION**

Contract #: 04-0120F4Cty: SF/ALA Rte: 80 PM: 13.2/13.9File #: 69.28**WELDING INSPECTION REPORT****Resident Engineer:** Pursell, Gary**Address:** 333 Burma Road**City:** Oakland, CA 94607**Report No:** WIR-010073**Date Inspected:** 13-Sep-2009**Project Name:** SAS Superstructure**OSM Arrival Time:** 700**Prime Contractor:** American Bridge/Fluor Enterprises, a JV**OSM Departure Time:** 1900**Contractor:** Zhenhua Port Machinery Company, Ltd (ZPMC), Changxing Island **Location:** Shanghai, China**CWI Name:** Chen Ying Xin, Du Zhi Qun.**CWI Present:** Yes No**Inspected CWI report:** Yes No N/A**Rod Oven in Use:** Yes No N/A**Electrode to specification:** Yes No N/A**Weld Procedures Followed:** Yes No N/A**Qualified Welders:** Yes No N/A**Verified Joint Fit-up:** Yes No N/A**Approved Drawings:** Yes No N/A**Approved WPS:** Yes No N/A**Delayed / Cancelled:** Yes No N/A**Bridge No:** 34-0006**Component:** Tower**Summary of Items Observed:**

# WELDING INSPECTION REPORT

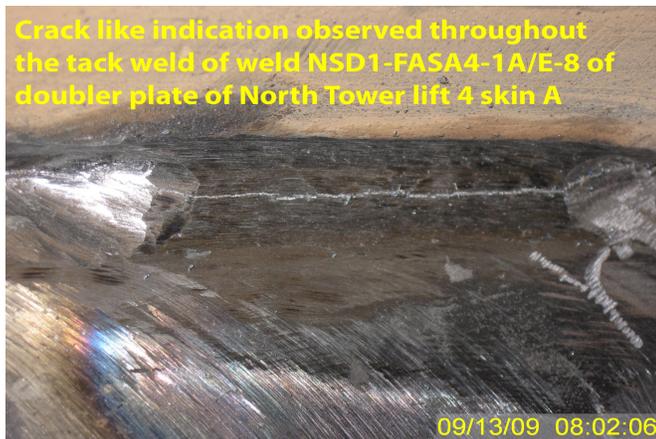
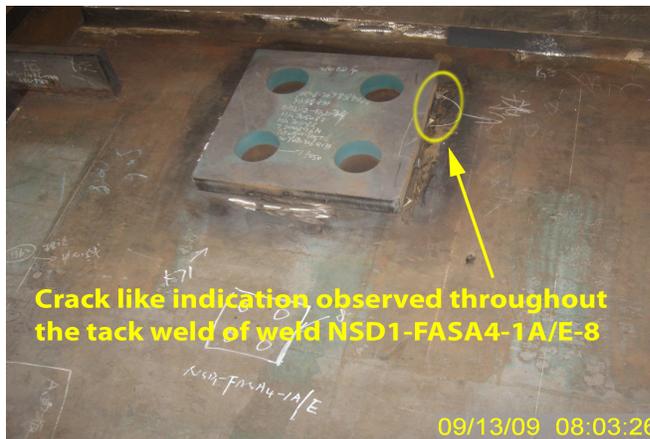
During random Visual Inspection of doubler plate of north tower lift 4, weld NSD1-FASA4-1A/E-8 located in the Tower Bay no.10, Caltrans Quality Assurance (QA) Inspector observed a crack like indication throughout the tack weld. This area was not tested and accepted by ZPMC NDT personnel. The attached photographs provide additional detail.
