**DEPARTMENT OF TRANSPORTATION**

Contract #: 04-0120F4Cty: SF/ALA Rte: 80 PM: 13.2/13.9File #: 13.28**WELDING INSPECTION REPORT****Resident Engineer:** Pursell, Gary**Address:** 333 Burma Road**City:** Oakland, CA 94607**Report No:** WIR-010084**Date Inspected:** 12-Nov-2009**Project Name:** SAS Superstructure**OSM Arrival Time:** 700**Prime Contractor:** American Bridge/Fluor Enterprises, a JV**OSM Departure Time:** 1530**Contractor:** Oregon Iron Works Clackamas, Or.**Location:** Clackamas, OR**CWI Name:** Mike Gregson, Jose Salazar**CWI Present:** Yes No**Inspected CWI report:** Yes No N/A**Rod Oven in Use:** Yes No N/A**Electrode to specification:** Yes No N/A**Weld Procedures Followed:** Yes No N/A**Qualified Welders:** Yes No N/A**Verified Joint Fit-up:** Yes No N/A**Approved Drawings:** Yes No N/A**Approved WPS:** Yes No N/A**Delayed / Cancelled:** Yes No N/A**Bridge No:** 34-0006**Component:** Hinge K Pipe Beams**Summary of Items Observed:**

Hinge-K Pipe Beam Assembly 102A-3: 11/12/09

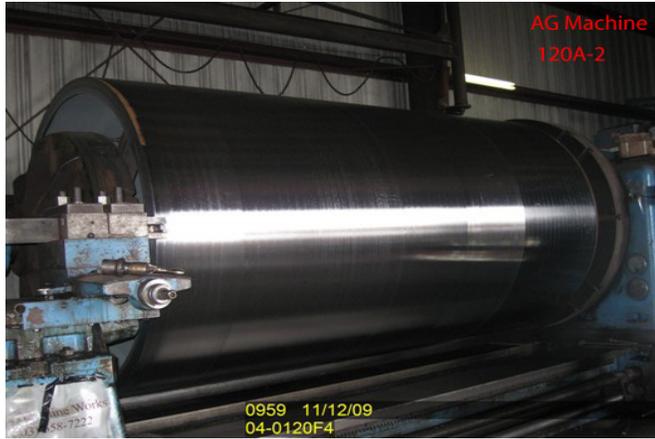
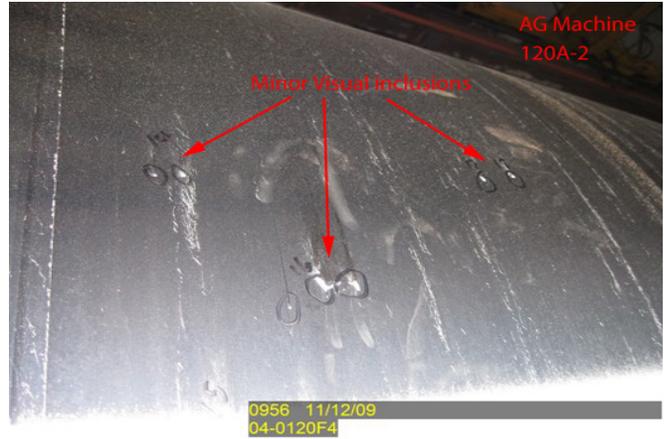
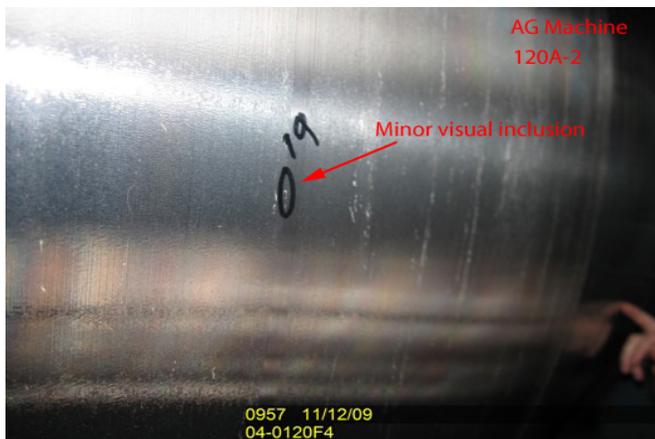
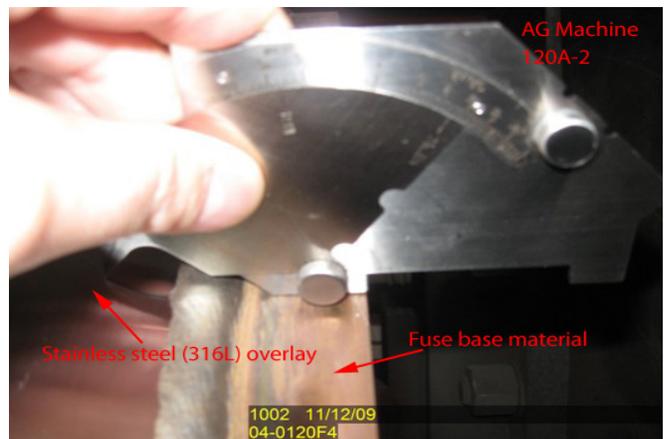
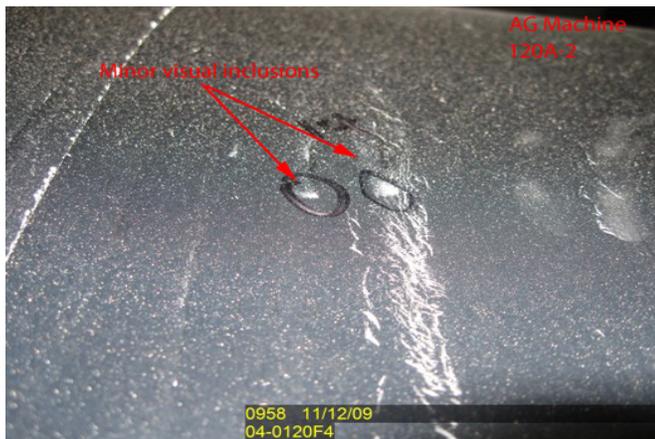
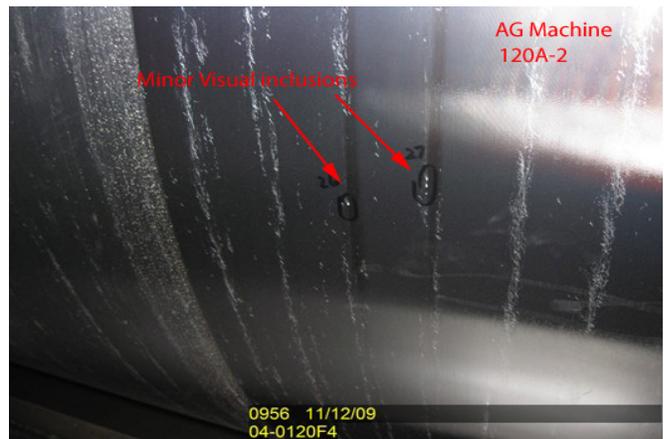
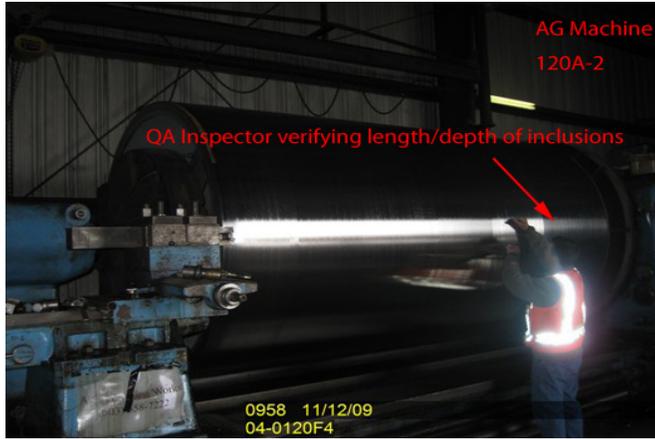
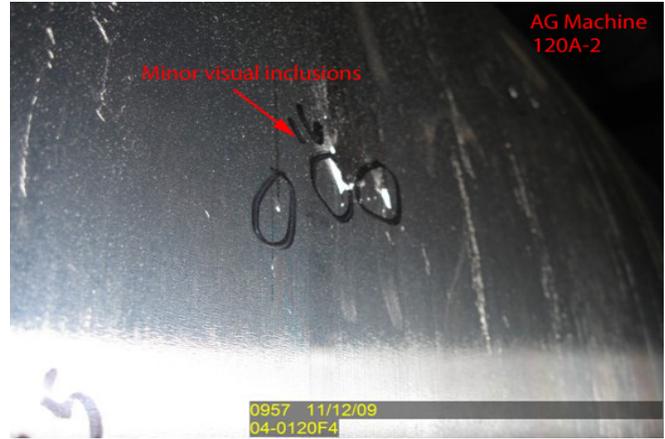
cut pass, had been previously completed and approximately 30 visual indications were present on the outside, finished machined overlay surface. QA Inspector visually confirmed the indications were present and noted that the above mentioned indications appeared to be small, circular slag inclusions that were deposited during the electroslag overlay welding process performed by OIW. QA Inspector measured the depth of the indications to be approximately .25mm and lengths of approximately 2mm-10mm. QA Inspector measured the remaining overlay thickness to be approximately 8mm and noted that the above mentioned indications were present in the second layer of ESW 316L. AG explained that OIW Project Manager Bill Pender was previously notified of the results and Mr. Pender had instructed AG not continue with machining additional layers and OIW will pick up this fuse assembly 120A-2. AG explained that OIW will then perform the weld repairs and apply an additional layer of 316L, consumable strip overlay, at the Clackamas fabrication shop. See attached pictures below.

Note: AG explained that OIW Project Manager Bill Pender was previously notified, that the above mentioned indications were present, after final machining and Mr. Pender had instructed AG to machine approximately 1/8" (3.175mm) of additional material, as mentioned above, to possibly remove the visual indications, that were present after the third and final machining cut pass.

QA Inspector noted that contract requirements require a final outside diameter measurement of 1920mm (+/-1mm) and AG had previously machined to a final diameter of 1921mm. Because of the additional 1/8" (3.175mm) machining cut pass, the outside diameter measurement will be out of tolerance and OIW is required to apply an additional layer of 316L overlay, per contract requirements. Once the weld repairs and overlay pass is complete, OIW will then send back to AG, for additional machining, to meet the diameter requirements and final finish overlay surface of .8µm.
