**DEPARTMENT OF TRANSPORTATION**

Contract #: 04-0120F4Cty: SF/ALA Rte: 80 PM: 13.2/13.9File #: 69.28**WELDING INSPECTION REPORT****Resident Engineer:** Pursell, Gary**Address:** 333 Burma Road**City:** Oakland, CA 94607**Report No:** WIR-010198**Date Inspected:** 13-Oct-2009**Project Name:** SAS Superstructure**OSM Arrival Time:** 645**Prime Contractor:** American Bridge/Fluor Enterprises, a JV**OSM Departure Time:** 1845**Contractor:** Zhenhua Port Machinery Company, Ltd (ZPMC), Changxing Island **Location:** Shanghai, China**CWI Name:** Chan Ying Xin**CWI Present:** Yes No**Inspected CWI report:** Yes No N/A**Rod Oven in Use:** Yes No N/A**Electrode to specification:** Yes No N/A**Weld Procedures Followed:** Yes No N/A**Qualified Welders:** Yes No N/A**Verified Joint Fit-up:** Yes No N/A**Approved Drawings:** Yes No N/A**Approved WPS:** Yes No N/A**Delayed / Cancelled:** Yes No N/A**Bridge No:** 34-0006**Component:** Tower COMPONENT**Summary of Items Observed:**

## WELDING INSPECTION REPORT

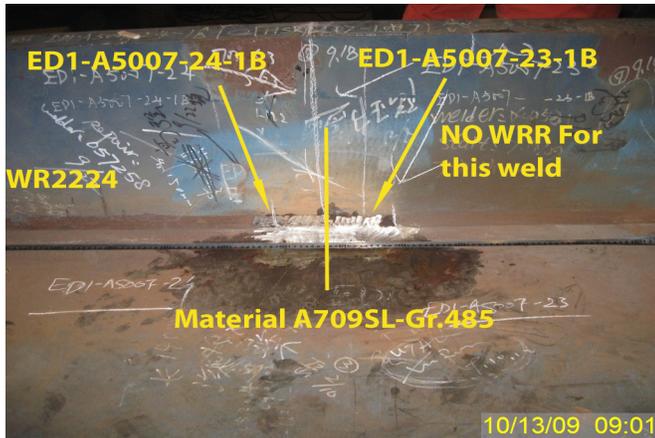
During random in-process visual inspection the QA inspector observed ZPMC personal repaired the weld area on Corner Angle Plate without any welding repair report. This QA Inspector informed to ZPMC QC Mr. Zhang Jaidi to provide Weld Repair Report for mention weld joint.

The Weld number is noted as ED1-A5007-23-1A/B.

For details see attached picture for details.
