DEPARTMENT OF TRANSPORTATION

Quality Assurance and Source Inspection

Contract #: 04-0120F4Cty: SF/ALA Rte: 80 PM: 13.2/13.9File #: 69.28**WELDING INSPECTION REPORT****Resident Engineer:** Pursell, Gary**Address:** 333 Burma Road**City:** Oakland, CA 94607**Report No:** WIR-010278**Date Inspected:** 24-Oct-2009**Project Name:** SAS Superstructure**OSM Arrival Time:** 645**Prime Contractor:** American Bridge/Fluor Enterprises, a JV**OSM Departure Time:** 1845**Contractor:** Zhenhua Port Machinery Company, Ltd (ZPMC), Changxing Island **Location:** Shanghai, China**CWI Name:** An Qin Xiang.**CWI Present:** Yes No**Inspected CWI report:** Yes No N/A**Rod Oven in Use:** Yes No N/A**Electrode to specification:** Yes No N/A**Weld Procedures Followed:** Yes No N/A**Qualified Welders:** Yes No N/A**Verified Joint Fit-up:** Yes No N/A**Approved Drawings:** Yes No N/A**Approved WPS:** Yes No N/A**Delayed / Cancelled:** Yes No N/A**Bridge No:** 34-0006**Component:** Tower Components**Summary of Items Observed:**

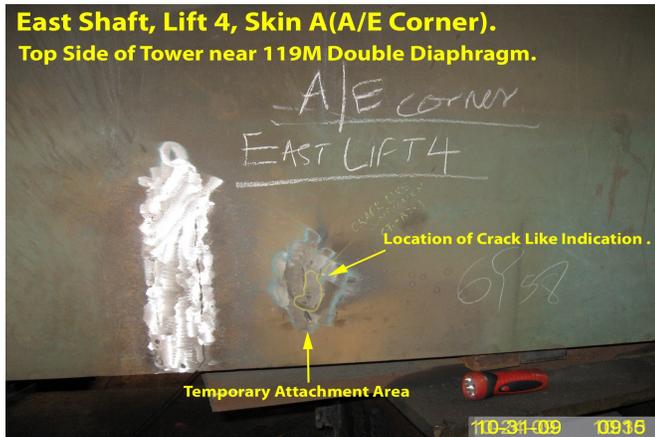
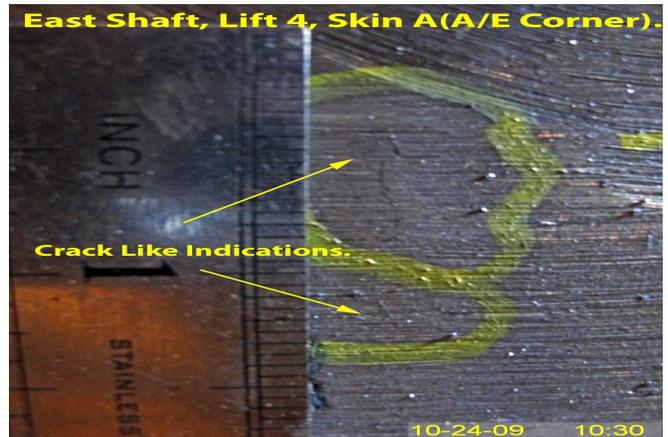
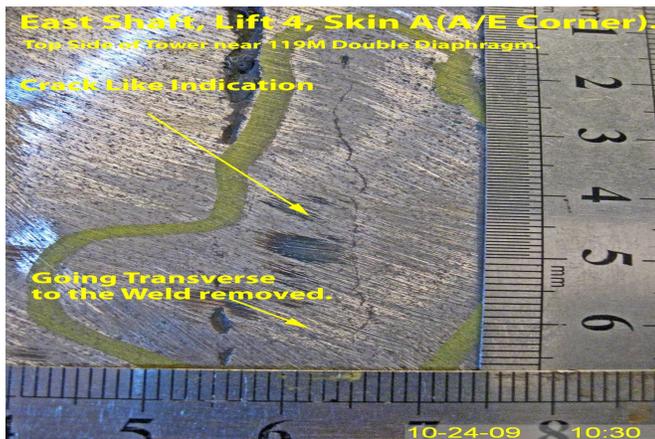
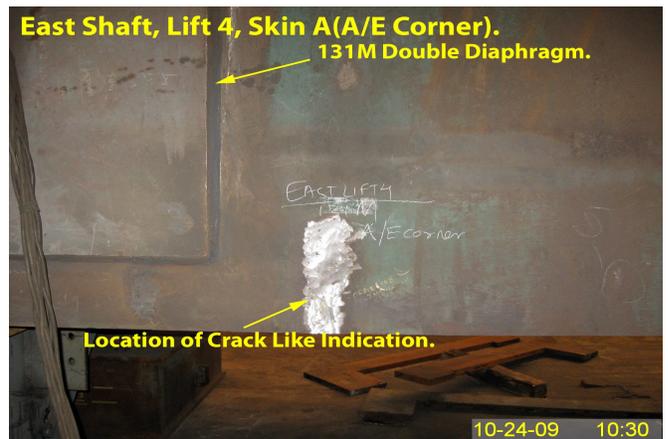
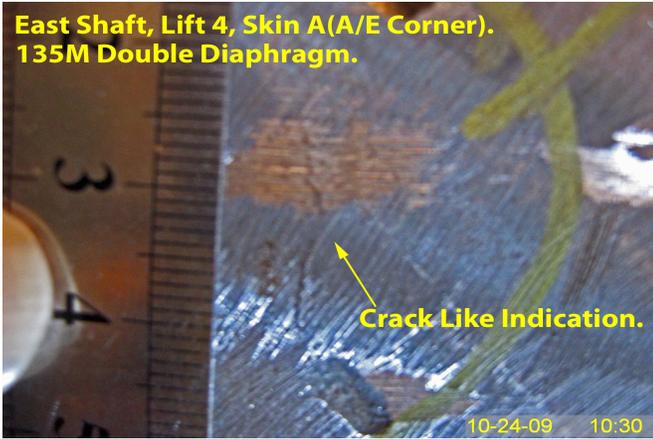
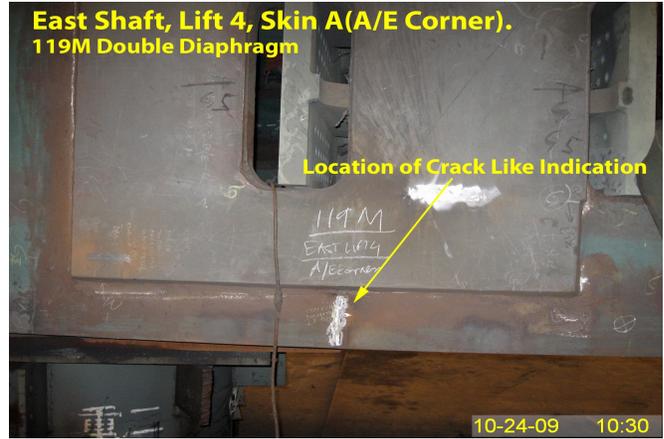
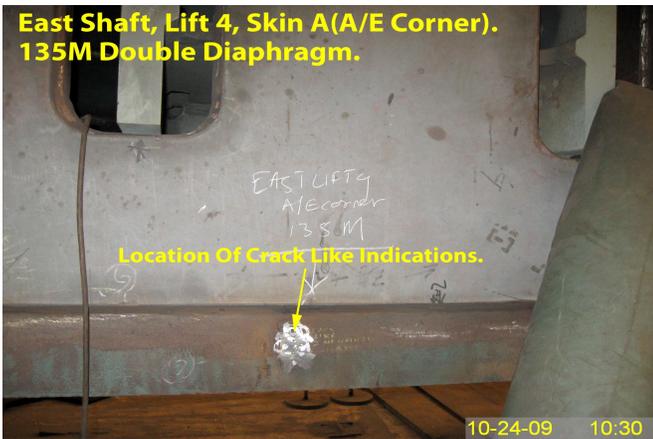
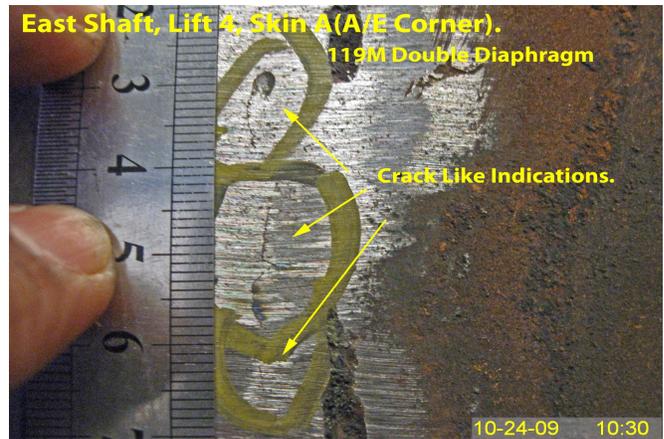
During random visual inspection at South Shaft, Lift 4, Skin A (Temporary Attachment Area near Corner Seam A/E) this Caltrans Quality Assurance (QA) Inspector observed "Crack Like" indications at the removed Temporary attachment Weld area. The indications were shown to ZPMC and ABF QC Inspectors. No Incident Report has been written on this issue. The attached photographs provide additional detail.
