DEPARTMENT OF TRANSPORTATION

Quality Assurance and Source Inspection

Contract #: 04-0120F4Cty: SF/ALA Rte: 80 PM: 13.2/13.9File #: 69.28**WELDING INSPECTION REPORT****Resident Engineer:** Pursell, Gary**Address:** 333 Burma Road**City:** Oakland, CA 94607**Report No:** WIR-010389**Date Inspected:** 03-Nov-2009**Project Name:** SAS Superstructure**OSM Arrival Time:** 700**Prime Contractor:** American Bridge/Fluor Enterprises, a JV**OSM Departure Time:** 1900**Contractor:** Zhenhua Port Machinery Company, Ltd (ZPMC), Changxing Island **Location:** Shanghai, China**CWI Name:** Chen Xi**CWI Present:** Yes No**Inspected CWI report:** Yes No N/A**Rod Oven in Use:** Yes No N/A**Electrode to specification:** Yes No N/A**Weld Procedures Followed:** Yes No N/A**Qualified Welders:** Yes No N/A**Verified Joint Fit-up:** Yes No N/A**Approved Drawings:** Yes No N/A**Approved WPS:** Yes No N/A**Delayed / Cancelled:** Yes No N/A**Bridge No:** 34-0006**Component:** OBG Crossbeams**Summary of Items Observed:**

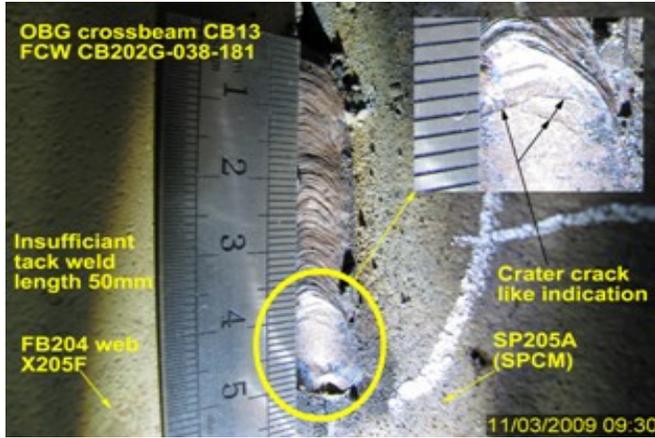
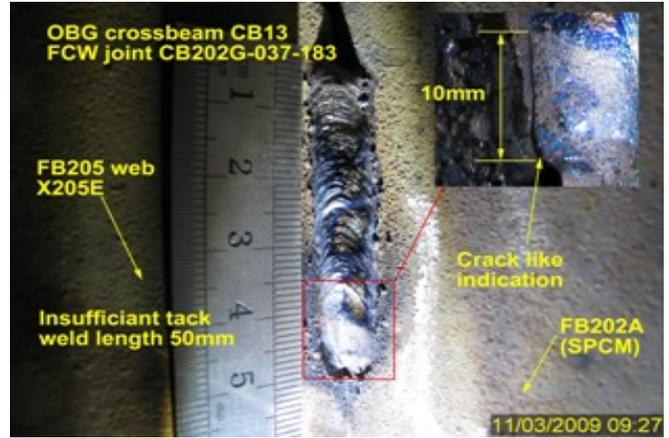
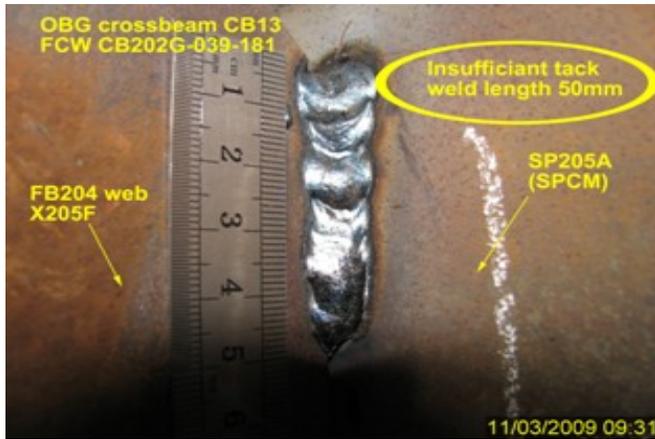
The tack welds joining the floor beam diaphragms to the SPCM area of the intermediate panel and the east and west side panels do not appear to comply with the requirements of the contract documents. The length of the tack welds measure approximately 50mm. AWS D1.5 section 12 table 12.2 requires the tack weld length to be a minimum of 75mm. Additionally, ABF QA inspector identified as Mr. Zou Hu visually confirmed that some of the tack welds exhibit cracking.

The affected welds and members are identified as floor beams FB204, FB205, FB202A (SPCM) and side panels SP202A (SPCM) and SP205A (SPCM). Weld joints are identified as CB202G-037/038/039/040-181, CB202G-037/038/039/040-183 and CB202G-037/038/039/040-185. The following FCW tack welds appeared to exhibit crack like indications in the crater areas: CB202G-037-183 and CB202G-038-181. See attached photos for details. This QA notified ABF inspector identified as Mr. Zou Hu and ZPMC QA identified as Mr. Zhang Wei of these issues and that an incident report would be generated.
