DEPARTMENT OF TRANSPORTATION

Contract #: 04-0120F4Cty: SF/ALA Rte: 80 PM: 13.2/13.9File #: 69.28**WELDING INSPECTION REPORT****Resident Engineer:** Pursell, Gary**Address:** 333 Burma Road**City:** Oakland, CA 94607**Report No:** WIR-010406**Date Inspected:** 21-Nov-2009**Project Name:** SAS Superstructure**OSM Arrival Time:** 1900**Prime Contractor:** American Bridge/Fluor Enterprises, a JV**OSM Departure Time:** 700**Contractor:** Zhenhua Port Machinery Company, Ltd (ZPMC), Changxing Island **Location:** Shanghai, China**CWI Name:** Xu Yumin**CWI Present:** Yes No**Inspected CWI report:** Yes No N/A**Rod Oven in Use:** Yes No N/A**Electrode to specification:** Yes No N/A**Weld Procedures Followed:** Yes No N/A**Qualified Welders:** Yes No N/A**Verified Joint Fit-up:** Yes No N/A**Approved Drawings:** Yes No N/A**Approved WPS:** Yes No N/A**Delayed / Cancelled:** Yes No N/A**Bridge No:** 34-0006**Component:** OBG**Summary of Items Observed:**

OBG SEGMENT 4AW-4BW

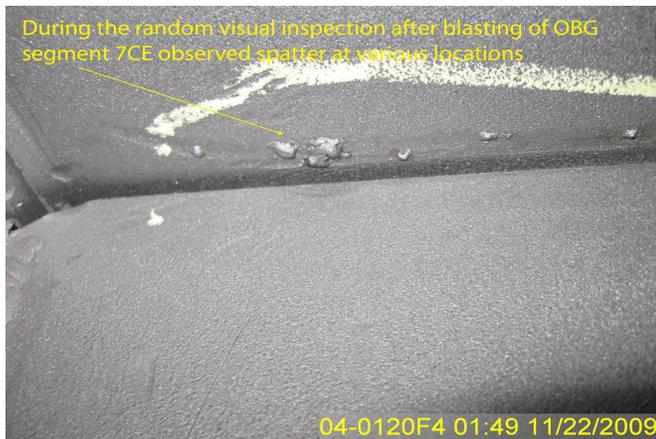
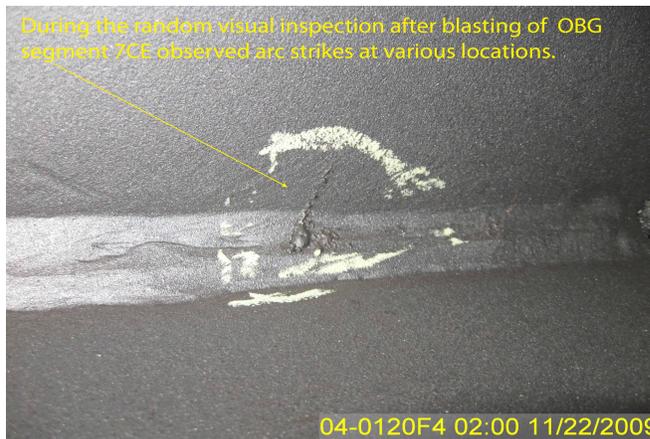
This Quality Assurance (QA) Inspector performed random visual inspection after blasting along with Caltrans Quality Assurance (QA) Inspector Mr. Paul Dawson inside upper panel, floor beam, inside corner assembly and Deck panel diaphragm of OBG segment 7CE. During the inspection we found normal minor gouges, arc strikes, spatter, undercut. See attached photos for additional information.
