DEPARTMENT OF TRANSPORTATION

Office of Structural Materials

Contract #: 04-0120F4Cty: SF/ALA Rte: 80 PM: 13.2/13.9File #: 69.28**WELDING INSPECTION REPORT****Resident Engineer:** Pursell, Gary**Address:** 333 Burma Road**City:** Oakland, CA 94607**Report No:** WIR-010418**Date Inspected:** 19-Nov-2009**Project Name:** SAS Superstructure**OSM Arrival Time:** 645**Prime Contractor:** American Bridge/Fluor Enterprises, a JV**OSM Departure Time:** 1845**Contractor:** Zhenhua Port Machinery Company, Ltd (ZPMC), Changxing Island **Location:** Shanghai, China**CWI Name:** Liu Fawen**CWI Present:** Yes No**Inspected CWI report:** Yes No N/A**Rod Oven in Use:** Yes No N/A**Electrode to specification:** Yes No N/A**Weld Procedures Followed:** Yes No N/A**Qualified Welders:** Yes No N/A**Verified Joint Fit-up:** Yes No N/A**Approved Drawings:** Yes No N/A**Approved WPS:** Yes No N/A**Delayed / Cancelled:** Yes No N/A**Bridge No:** 34-0006**Component:** Orthotropic Box Girder Components**Summary of Items Observed:**

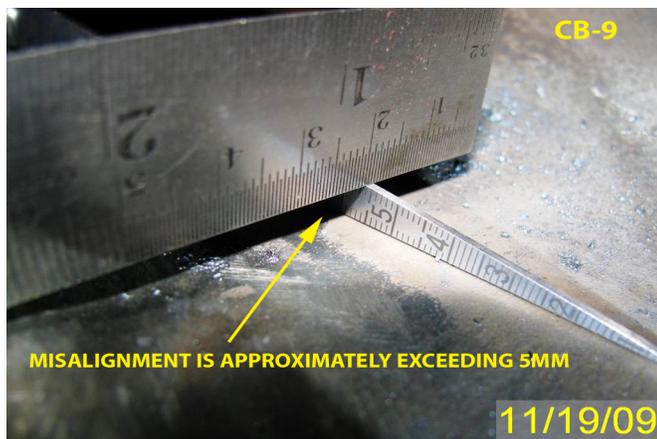
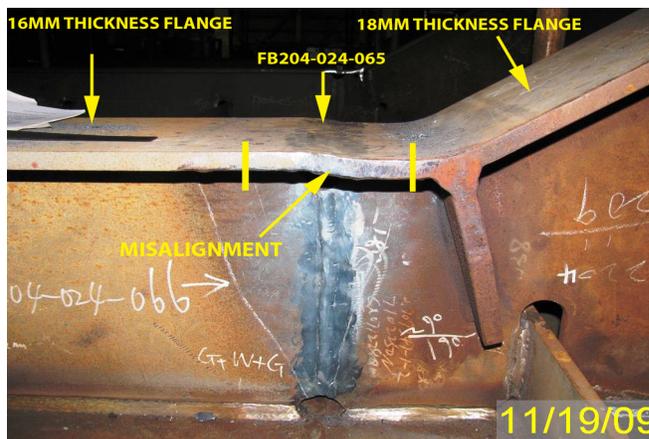
During random visual inspection in Cross Beam - 9 at Bay # 6, Caltrans Quality Assurance (QA) Inspector observed misalignment approximately exceeding 5mm at weld FB204 – 024 – 065 between straight to corner section of the floor beam diaphragm at panel point 24. In no case the misalignment shall be more than 3mm [1/8 in.] unless otherwise shown on the drawings.

Applicable reference: AWS D1.5 2002 section(s): 3

3.3.3 “Parts to be joined by groove welds shall be carefully aligned. Where the parts are effectively restrained against bending due to eccentricity in alignment, the offset from theoretical alignment shall not exceed 10 percent of thickness of the thinner part joined, but in no case shall be more than 3mm [1/8 in.]. In correcting misalignment in such cases, the parts shall not be drawn in to a greater slope than 12mm [1/2 in.] in 300mm [12 in.]”
