**DEPARTMENT OF TRANSPORTATION**

Contract #: 04-0120F4Cty: SF/ALA Rte: 80 PM: 13.2/13.9File #: 13.28**WELDING INSPECTION REPORT****Resident Engineer:** Pursell, Gary**Address:** 333 Burma Road**City:** Oakland, CA 94607**Report No:** WIR-010454**Date Inspected:** 24-Nov-2009**Project Name:** SAS Superstructure**OSM Arrival Time:** 600**Prime Contractor:** American Bridge/Fluor Enterprises, a JV**OSM Departure Time:** 1830**Contractor:** Oregon Iron Works Clackamas, Or.**Location:** Clackamas, OR**CWI Name:** Mike Gregson, Jose Salazar**CWI Present:** Yes No**Inspected CWI report:** Yes No N/A**Rod Oven in Use:** Yes No N/A**Electrode to specification:** Yes No N/A**Weld Procedures Followed:** Yes No N/A**Qualified Welders:** Yes No N/A**Verified Joint Fit-up:** Yes No N/A**Approved Drawings:** Yes No N/A**Approved WPS:** Yes No N/A**Delayed / Cancelled:** Yes No N/A**Bridge No:** 34-0006**Component:** Hinge K Pipe Beams**Summary of Items Observed:**

# WELDING INSPECTION REPORT

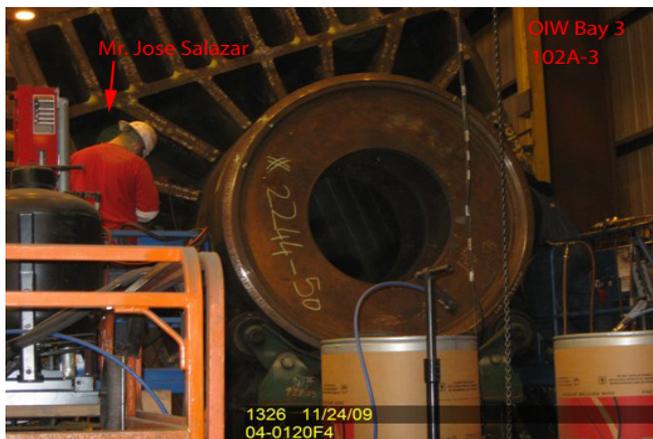
QA Inspector noticed that the partial joint penetration and fillet welds were previously completed, on the HPS 485W stiffeners and OIW production personell were in-process of performing weld clean-up, on the above mentioned stiffeners. QA Inspector spoke with QC Inspector Jose Salazar and Mr. Salazar explained that OIW welders # O6, Mr. Tim O'Brian and #T23, Mr. John Tellone were blending the weld start/stops, removing weld spatter and grinding all areas, which were previously marked by OIW QC Inspectors. Mr. Salazar also explained that the completed fillet and PJP welds on above mentioned stiffeners, which were found to be visually acceptable per AWS D1.5 and contract requirements, will then be 100% magnetic particle tested by qualified OIW QC Inspectors. QA Inspector noted that the in-process visual testing by OIW QC Inspector Jose Salazar, appeared to be in compliance with AWS D1.5 and contract requirements. See attached picture below.

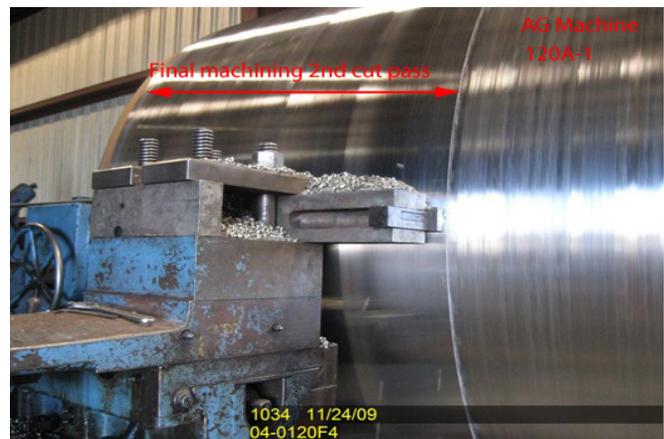
QA Inspector arrived at AG Machine Shop at approximately 1100 hrs, on this date and noted that AG was currently in process of final machining on the exterior overlay, for this fuse assembly 120A-1. QA Inspector spoke with AG Machinist and AG explained that the second cut pass was set to a depth of approximately .150" (4mm) and this second cut pass was approximately 25% complete. AG Machinist explained that approximately 8-10 visible surface indications were present on the exterior overlay, at this time. AG explained that no visible indications were present after the 1st cut pass and that these indications were starting to show up during this second cut pass. AG explained that they were going to continue machining during the day and notify OIW PM Bill Pender, of these results. OIW will then decide whether to do the in-process TIG repairs at AG, as done previously, or continue to machine out the indications and possibly add another ESW layer. AG explained that a third cut pass will be required, to meet a final outside diameter tolerance of 1920mm (+/- 1mm). See attached picture below.

Note: QA Inspector noted that these visible surface indications were similar in length/depths as the previous indications that were discovered at AG, during the final machining of fuse assembly 120A-2. The indications on 120A-2, previously appeared during the second machining cut pass (as in this case) and OIW performed the TIG weld repairs at AG. OIW had previously instructed AG to continue machining out the indications, past the final tolerance of 1920mm (+/- 1mm) and the assembly was eventually transferred back to OIW.
