DEPARTMENT OF TRANSPORTATION

Contract #: 04-0120F4Cty: SF/ALA Rte: 80 PM: 13.2/13.9File #: 13.28**WELDING INSPECTION REPORT****Resident Engineer:** Pursell, Gary**Address:** 333 Burma Road**City:** Oakland, CA 94607**Report No:** WIR-010468**Date Inspected:** 30-Nov-2008**Project Name:** SAS Superstructure**OSM Arrival Time:** 1000**Prime Contractor:** American Bridge/Fluor Enterprises, a JV**OSM Departure Time:** 1830**Contractor:** Oregon Iron Works Clackamas, Or.**Location:** Clackamas, OR

CWI Name:	M. Gregson, J. Salazar, S. Barnett	CWI Present:	Yes	No
Inspected CWI report:	Yes No N/A	Rod Oven in Use:	Yes	No N/A
Electrode to specification:	Yes No N/A	Weld Procedures Followed:	Yes	No N/A
Qualified Welders:	Yes No N/A	Verified Joint Fit-up:	Yes	No N/A
Approved Drawings:	Yes No N/A	Approved WPS:	Yes	No N/A
		Delayed / Cancelled:	Yes	No N/A
Bridge No:	34-0006	Component:	Hinge K Pipe Beams

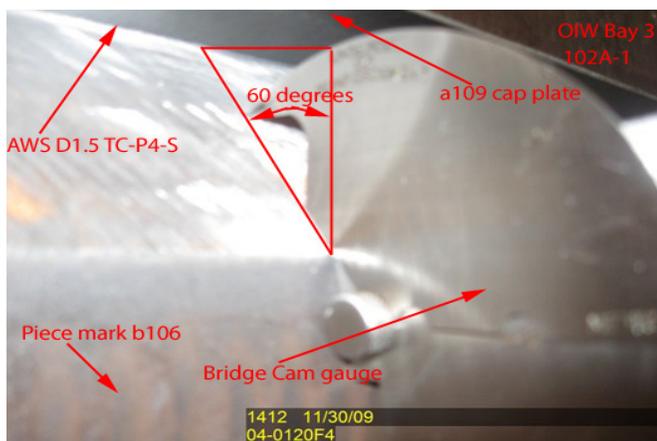
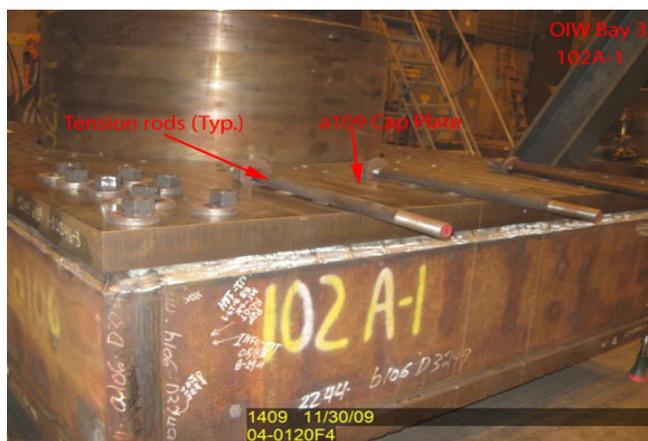
QA Inspector witnessed welder #H49, Mr. Rick Hinckle and welding foreman Troy Smith, cutting the bevel on the a106/a106 and b106 plates, in preparation for fitting the a109 Post Tension Cap plate. QA Inspector noted that an automatic beveling machine was positioned on each plate and was set to cut a bevel prep-angle of 60 degrees. QA Inspector reviewed the contract requirements on the joint details and noted that this was designated as a AWS D1.5 TC-P4-S, partial penetration (PJP) groove weld, with a 60 degree bevel prep and 30mm weld size. QA Inspector randomly measured, utilizing a bridge cam gauge and verified the previously beveled areas to be 60 degrees, which appears to be in-compliance with the weld joint details and contract requirements.

Note. QA Inspector later noticed that the beveling was complete, on the above mentioned plates and OIW was in-process of fitting the a109 Cap plate and was currently placing the threaded rods in place, to prevent Cap plate moving and/or distortion during the SAW on these PJP weld joints. See attached pictures below.
