Contract #: 04-0120F4Cty: SF/ALA Rte: 80 PM: 13.2/13.9File #: 69.28**WELDING INSPECTION REPORT**

Report No: WIR-010470
Date Inspected: 29-Nov-2009

Project Name: SAS Superstructure **OSM Arrival Time:** 1900
Prime Contractor: American Bridge/Fluor Enterprises, a JV **OSM Departure Time:** 700
Contractor: Zhenhua Port Machinery Company, Ltd (ZPMC), Changxing Island **Location:** Shanghai, China

WELDING INSPECTION REPORT

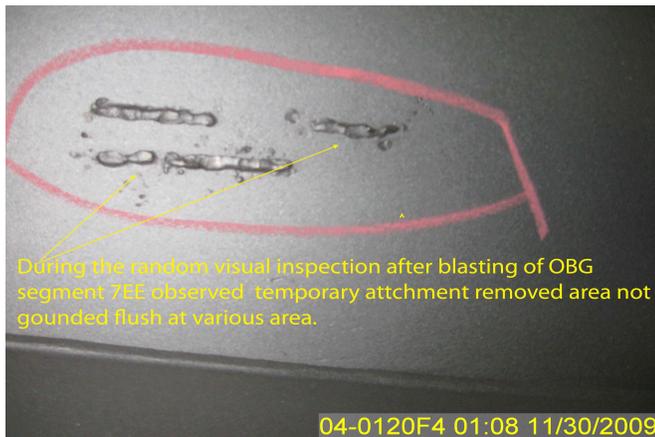
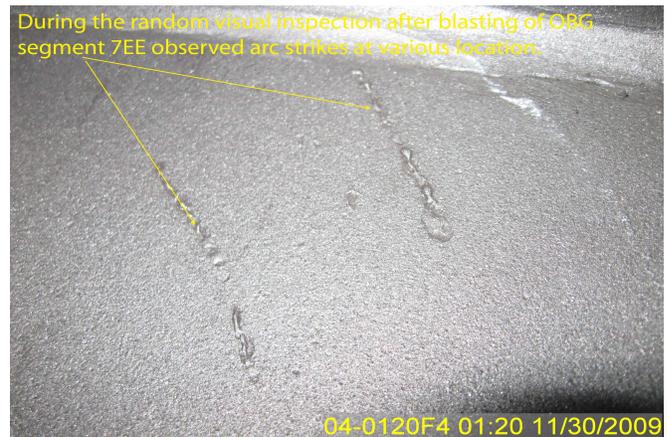
OBG SEGMENT 7EE

This Quality Assurance (QA) Inspector performed random visual inspection after blasting along with Caltrans Quality Assurance (QA) Inspector Mr. Paul Dawson on inside upper panel, floor beam and inside corner assembly diaphragm of OBG segment 7DE. During the inspection we found normal minor gouges, arc strikes, spatter, undercut like discontinuities. For additional information see attached photos.
