DEPARTMENT OF TRANSPORTATION

Contract #: 04-0120F4Cty: SF/ALA Rte: 80 PM: 13.2/13.9File #: 69.28**WELDING INSPECTION REPORT****Resident Engineer:** Pursell, Gary**Address:** 333 Burma Road**City:** Oakland, CA 94607**Report No:** WIR-010509**Date Inspected:** 30-Nov-2009**Project Name:** SAS Superstructure**OSM Arrival Time:** 645**Prime Contractor:** American Bridge/Fluor Enterprises, a JV**OSM Departure Time:** 1845**Contractor:** Zhenhua Port Machinery Company, Ltd (ZPMC), Changxing Island **Location:** Shanghai, China**CWI Name:** Chen Xi**CWI Present:** Yes No**Inspected CWI report:** Yes No N/A**Rod Oven in Use:** Yes No N/A**Electrode to specification:** Yes No N/A**Weld Procedures Followed:** Yes No N/A**Qualified Welders:** Yes No N/A**Verified Joint Fit-up:** Yes No N/A**Approved Drawings:** Yes No N/A**Approved WPS:** Yes No N/A**Delayed / Cancelled:** Yes No N/A**Bridge No:** 34-0006**Component:** Orthotropic Box Girder (OBG)**Summary of Items Observed:**

OBG # BAY 2

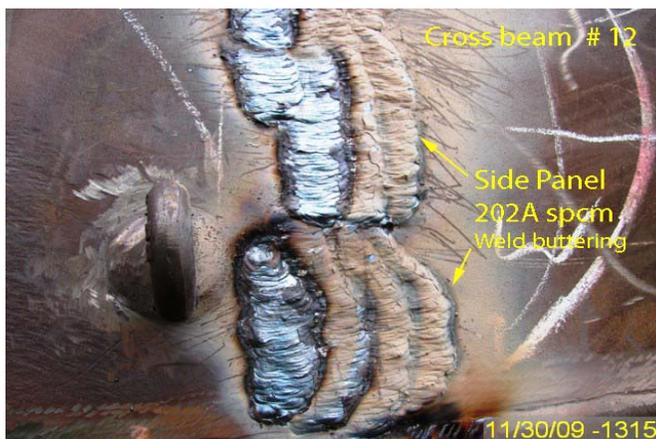
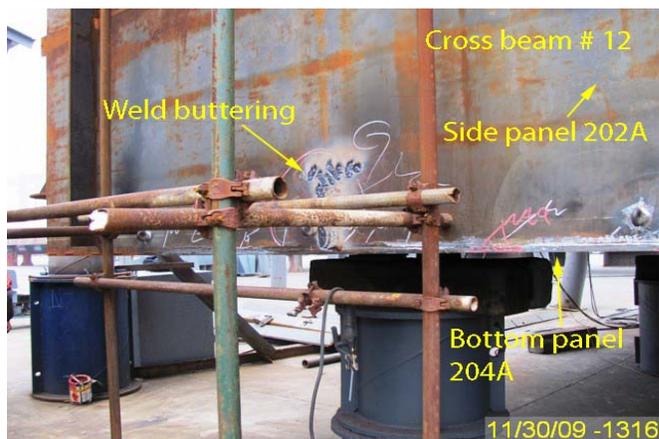
OBG # CROSS BEAM 12

This QA observed ZPMC qualified welding personnel identified as 066179 perform Shield Metal Arc Welding Process (SMAW) welding on base metal repair after removing lifting lugs. ZPMC QC identified as Sun yan fei was present to monitor the welding process. The welding parameters as measured using QC's calibrated instruments appeared to be in general compliance with WPS-345-SMAW-3G (3F)-FCM-Repair. Critical weld repair (CWR) number B-CWR 911 (Rev no: 1). See attached picture below.
