DEPARTMENT OF TRANSPORTATION

Office of Structural Materials

Contract #: 04-0120F4Cty: SF/ALA Rte: 80 PM: 13.2/13.9File #: 69.28**WELDING INSPECTION REPORT****Resident Engineer:** Pursell, Gary**Address:** 333 Burma Road**City:** Oakland, CA 94607**Report No:** WIR-010542**Date Inspected:** 04-Dec-2009**Project Name:** SAS Superstructure**OSM Arrival Time:** 645**Prime Contractor:** American Bridge/Fluor Enterprises, a JV**OSM Departure Time:** 1845**Contractor:** Zhenhua Port Machinery Company, Ltd (ZPMC), Changxing Island **Location:** Shanghai, China**CWI Name:** Liu Fawen**CWI Present:** Yes No**Inspected CWI report:** Yes No N/A**Rod Oven in Use:** Yes No N/A**Electrode to specification:** Yes No N/A**Weld Procedures Followed:** Yes No N/A**Qualified Welders:** Yes No N/A**Verified Joint Fit-up:** Yes No N/A**Approved Drawings:** Yes No N/A**Approved WPS:** Yes No N/A**Delayed / Cancelled:** Yes No N/A**Bridge No:** 34-0006**Component:** Orthotropic Box Girder (OBG) Components**Summary of Items Observed:**

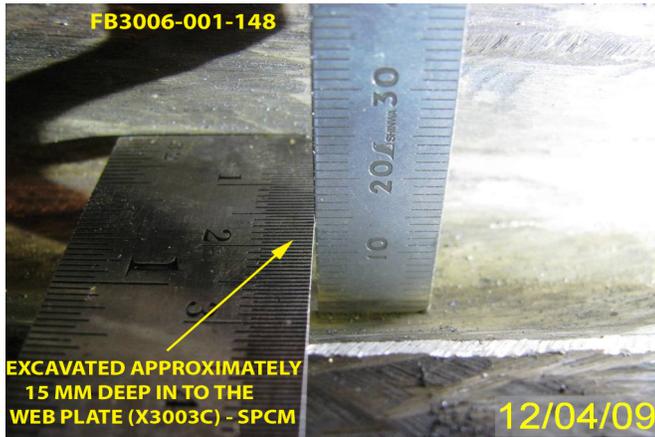
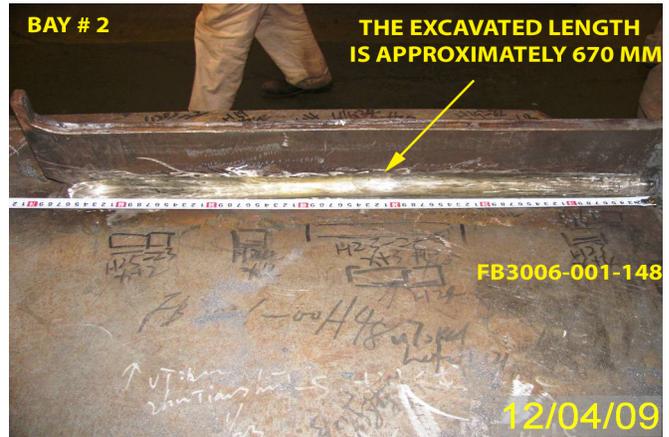
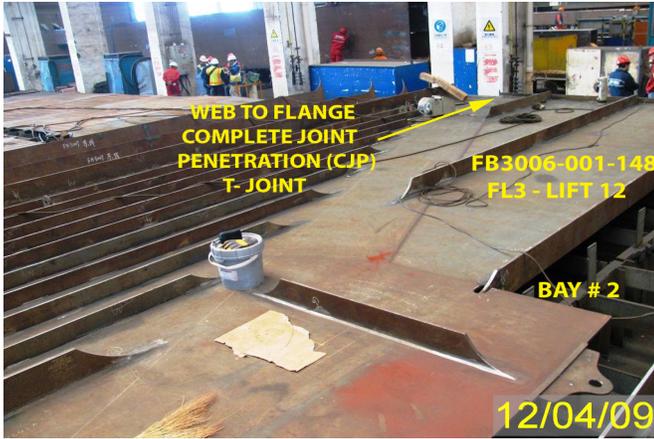
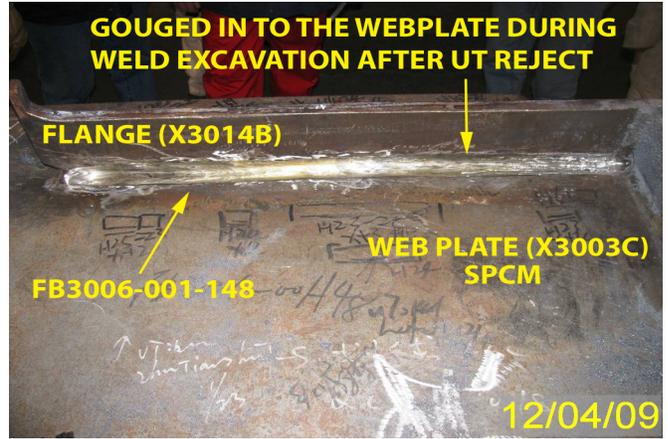
During random in process visual inspection at Bay # 2, this Quality Assurance Inspector (QA) observed an OBG FL3 lift 12 floor beam web plate-X3003C had been arc gouged approximately 15 mm deep in to the base material during the excavation of Complete Joint Penetration (CJP) web to flange T-weld joint after Ultrasonic Testing (UT) reject by ZPMC UT technicians.

FB3006-001-148 (Web to flange)

Complete Joint Penetration (CJP) T- joint

Web plate – X3003C, SPCM

Flange – X3014B

3.7.1 “The removal of the weld metal or portions of the base metal may be done by machining, carbon arc cutting and gouging, thermal cutting, chipping, or grinding. It shall be done in such a manner that the remaining weld metal or base metal is not nicked or undercut.”

“Unacceptable portions of the weld shall be removed without substantial removal of the base metal.”

This QA notified ZPMC QC identified as Mr. Yang Qing Feng and ABF inspector identified as Mr. Luo Gui Lin of the above issue and that an incident report will be generated.
